Service Bulletin

Bulletin No.: PIP6095

Subject: 6T40 Harsh Garage Shift into Drive or Reverse

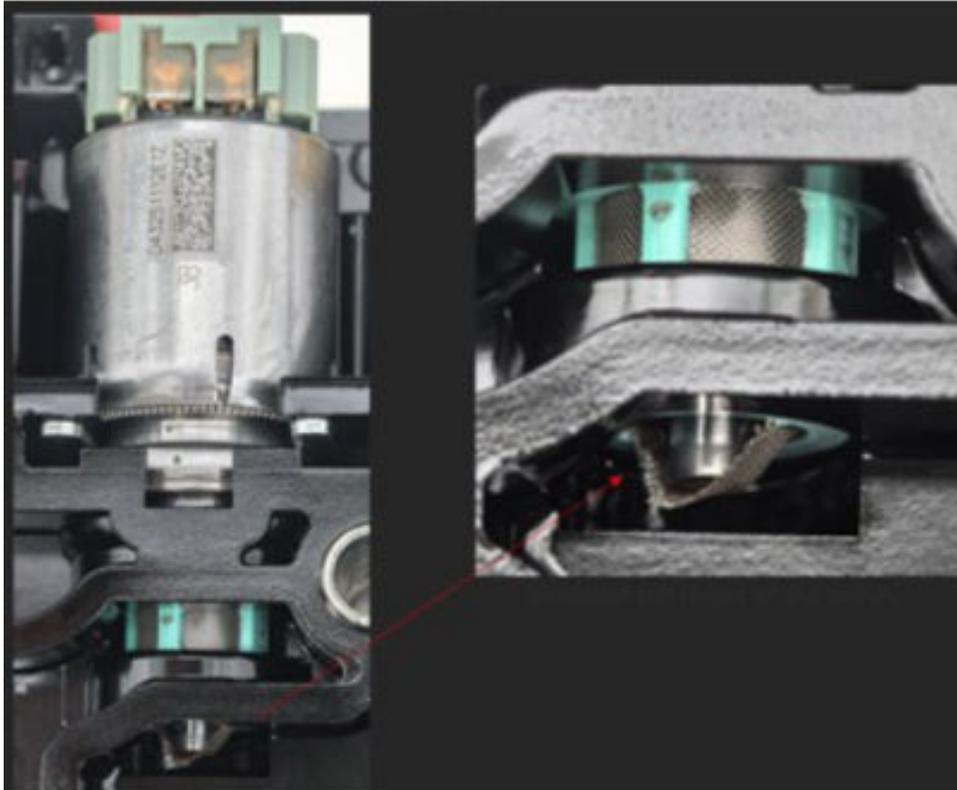
7046070

Involved Region or Country	GMNA, South Korea, China, Japan
Condition	Some customers may complain of harsh garage shifts into reverse or drive.
Cause	<p>There may be an issue with the normally high solenoids in the control solenoid valve and transmission control module assembly (TEHCM) having a valve over travel and contact or rupture the solenoid screen as shown below.</p>

6. If the solenoid valve is found to be touching or pushing through the screen, replace the control solenoid valve and transmission control module assembly (TEHCM) and the control valve body per SI instructions.

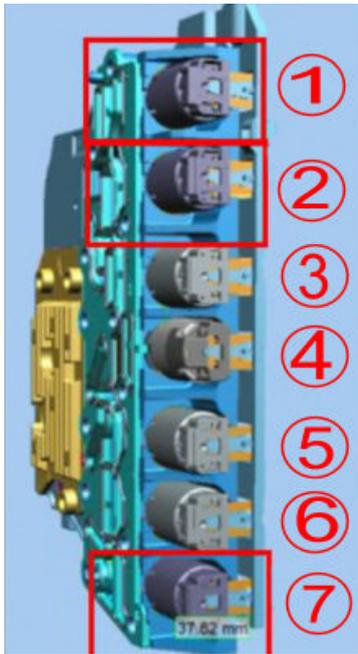
7046068

1. Verify your vehicle was built after 5/1/25. If so, your vehicle is within the suspect window.
2. Test drive to verify the customer concern.
3. If any applicable DTCs are set, root cause per SI diagnostics for your specific DTCs before moving to the following steps.
4. If no DTCs are set, start by removing the control solenoid valve and transmission control module assembly (TEHCM) from the transmission.
5. Check the below locations for the solenoid valve touching the screen as shown in the cause section.
