TECHNICAL SERVICE BULLETIN

Rattle From The Right Loadspace Trim Panel At High Audio System Volumes

25-2637

Ford 2025 Bronco	Equipped with B&O audio system
----------------------------	--------------------------------

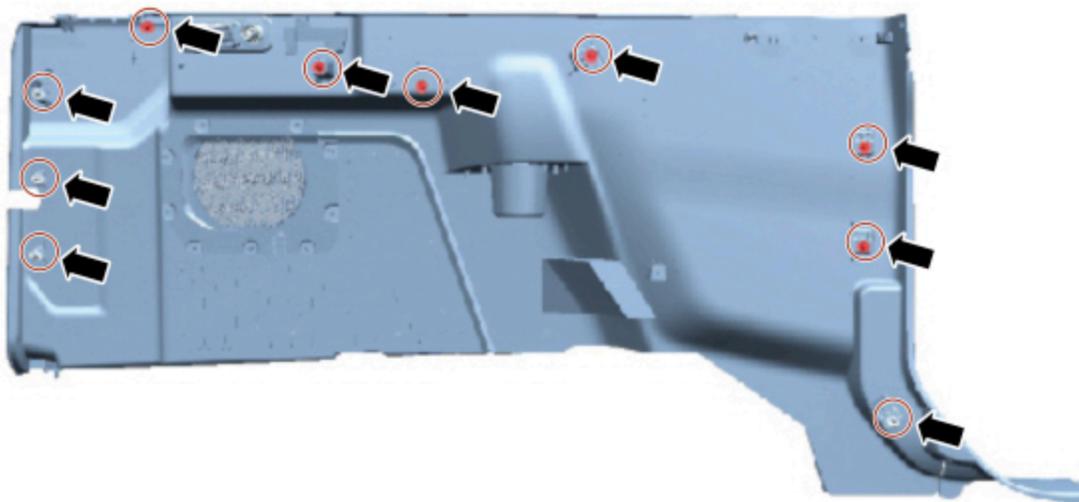
E442436

Figure 1 - 3-door loadspace trim panel shown

1. Remove the right loadspace trim panel. Refer to the WSM, Section 501-05 Interior Trim Ornamentation
2. Replace all loadspace trim panel retaining clips. (Figures 1-2)

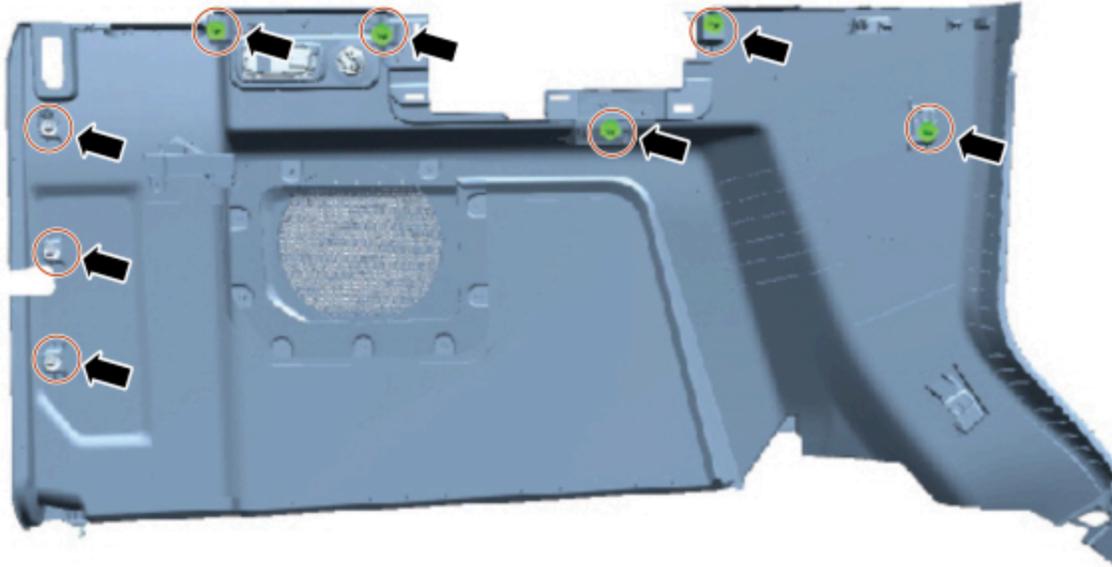
E442437

Figure 2 - 5-door loadspace trim panel shown

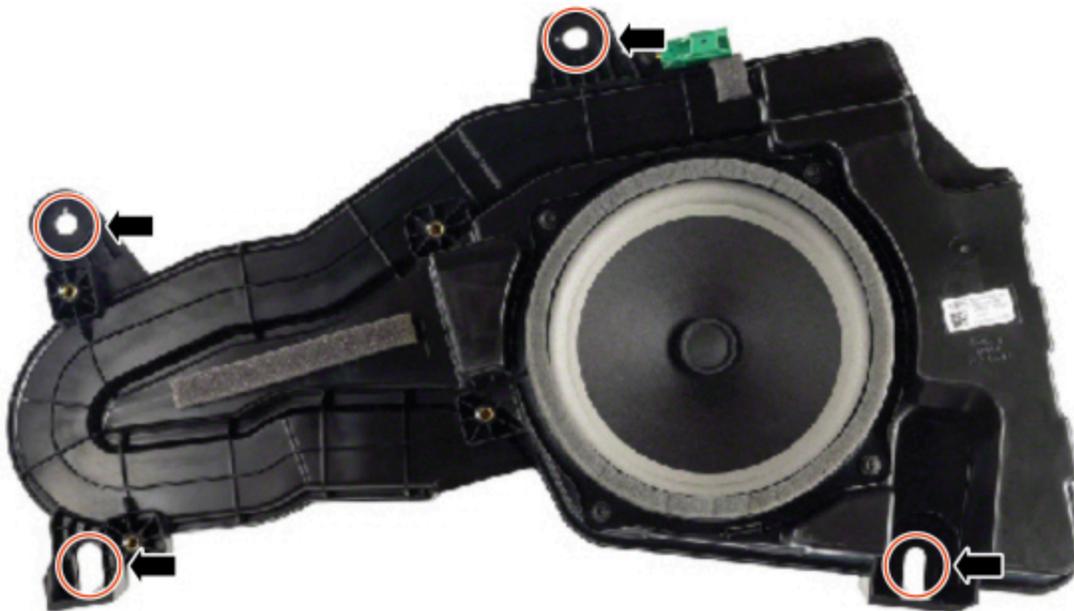
Figure 3

3. Remove the subwoofer and inspect the subwoofer for broken plastic mounting tabs. Refer to the WSM, Section 415-00 Information and Entertainment System. (Figure 3)

1. Yes - replace the subwoofer. Proceed to Step 5.
2. No - proceed to Step 5.

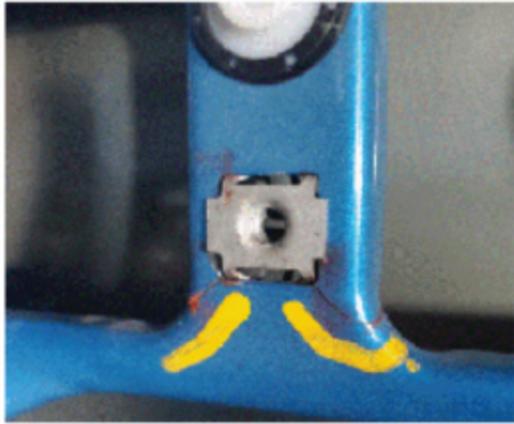
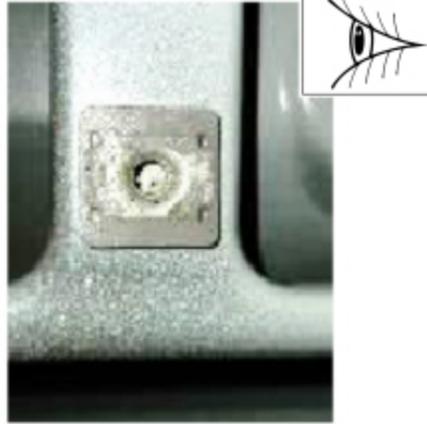
E442442

Figure 4 - Left image shows metal retaining nut, right image shows rubber insulated retaining nut

5. Remove and discard the retaining nut located in Figure 4.
