## Rearview Camera Noise Optimization

Topic number	LI54.71-P-080180
Version	1
Function group	54.71 - Camera and radar-assisted assistance systems
Date	1/20/26
Validity	167 Facelift (GLE) with the following:  - Model Year 2024 and later (Option code 804, 805, etc...)  - Option Code 491 (Steel Spring Variant)  - Option Code 235 (PARKTRONIC with Active Parking Assist)
Reason for change

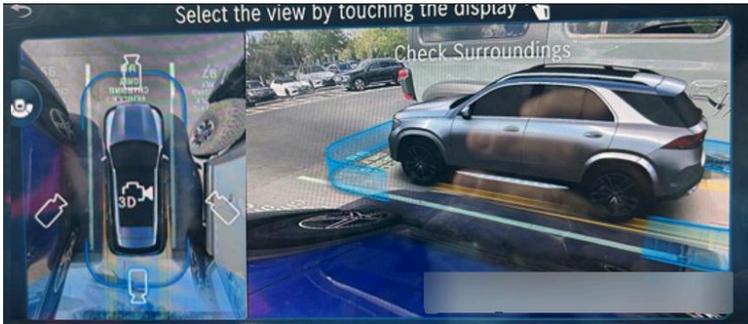
View PRIOR to SCN Coding:

**IMPORTANT:** After both control units have been SCN coded, the "Movable 3D View" feature in the head unit will no longer be available. With this change there will be two distinct differences:

Update both control units and perform on SCN coding:

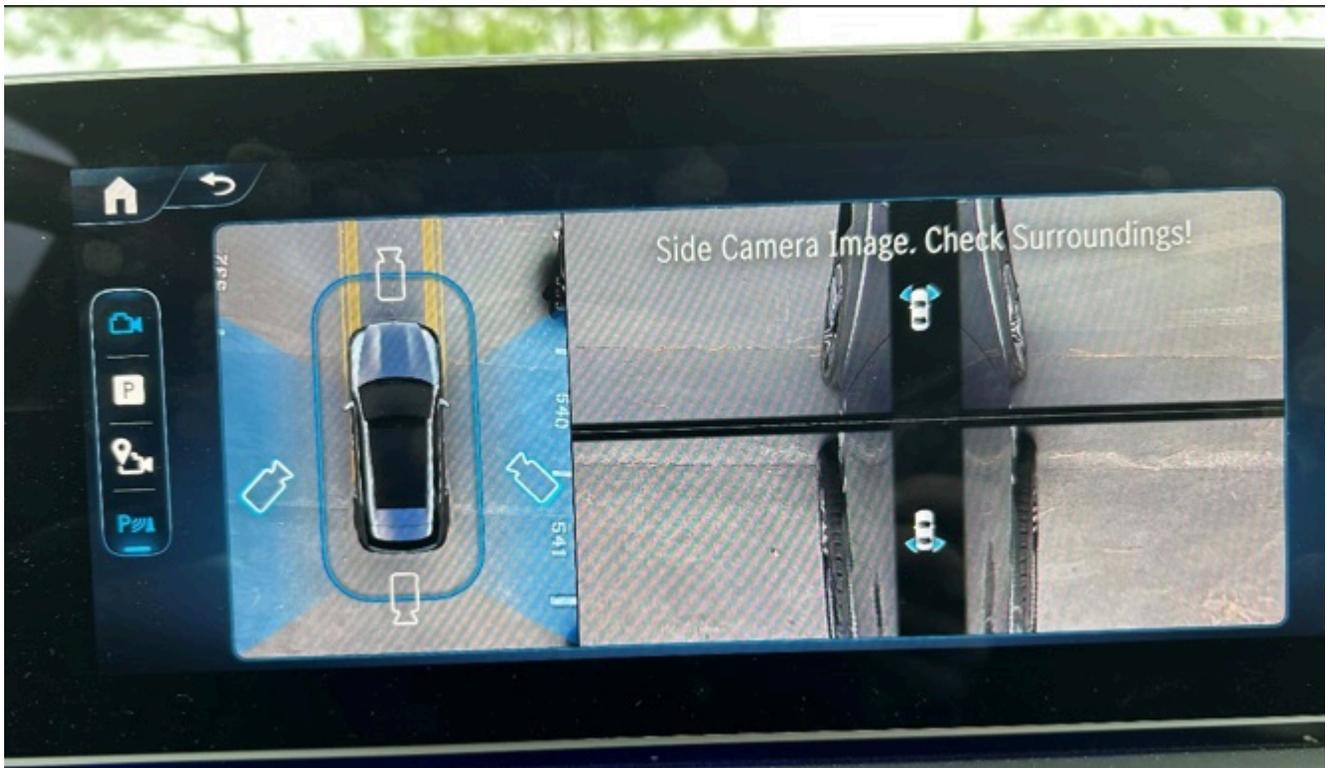
View AFTER SCN Coding:

- 1) The "3D" icon when in the top down vehicle view, will no longer be present on the head unit.
- 2) The digital rendering of the vehicle with the ability to spatially move around the vehicle is no longer possible. This view is replaced with 2D static images of the left and right sides.

- Rear camera flap when calibrating after a key cycle bus sleep will stay open to 29 MPH and then close. Will re-open, when calibrating, at 9 MPH.
- The head unit screens mentioned above appear the same as "View AFTER SCN Coding" as shown in the attachment.
