SIB 11 04 25

SERVICE ACTION: S68T ENGINE REPLACE UPPER OIL PAN SCREWS

2026-01-02

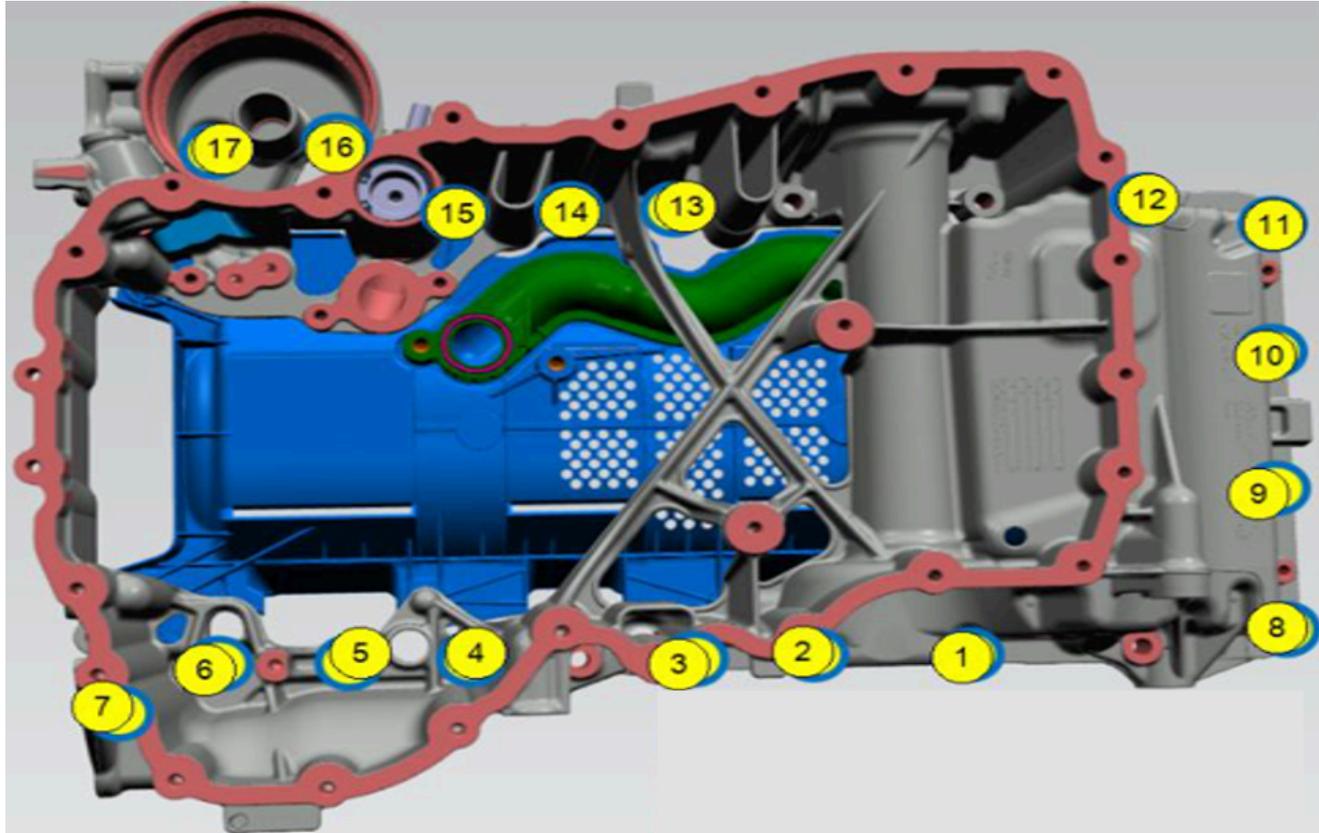
Due to an assembly error the upper oil pan screws may not have been torqued correctly.

3. Remove, replace and torque each screw **one at a time** using the sequence of numbers in the illustration below.

Torque the new screws to the following:

Joining Torque: 10 Nm

Angle Torque: 90 degrees
