SIB 24 02 25

DELIVERY STOP: KSG SUPPLY LINE

2026-01-08

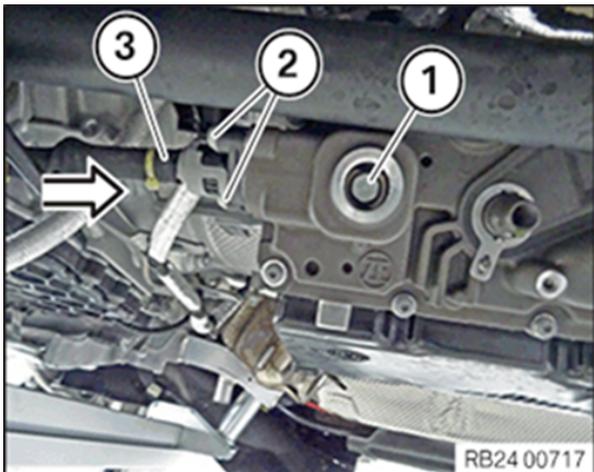
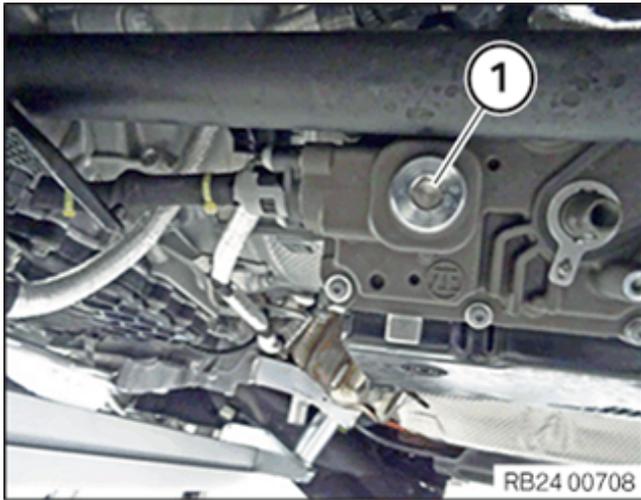
The threaded connection at the 48 power electronics (EME 48) may not have been properly secured. Further loosening of the connection could lead to a no-start or breakdown.

Retighten the threaded connection (1) of the MHEV supply line (3) to 19 Nm.
