SIB 31 01 22

DIAGNOSING FRONT AXLES ISSUES

2026-01-02

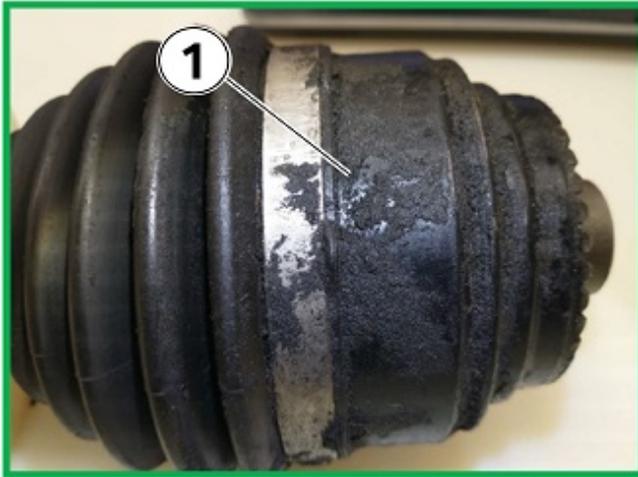
A. The following are examples of good axles/boots. Do not replace.

Example of dirt/contamination from outside influence (1).

Surface contamination and/or grease build-up is normal. Do not replace the CV boot (inner) or axle half-shaft (outer).

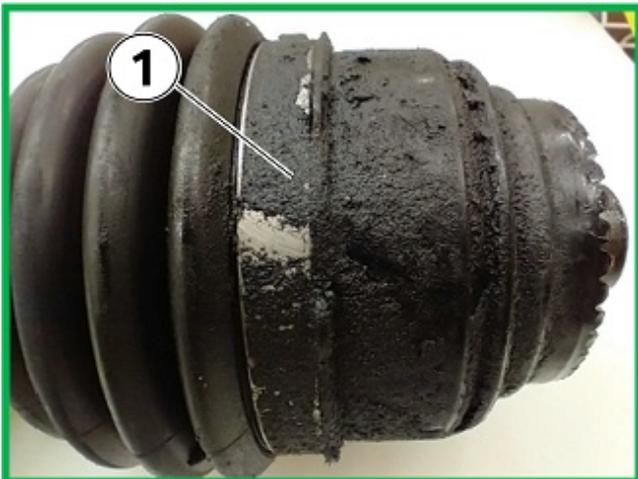
Example of dirt/contamination from outside influence (1).

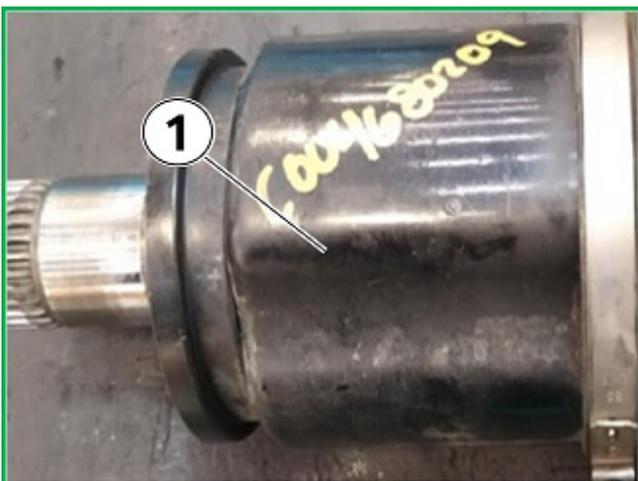
Example of dirt/contamination from outside influence (1).

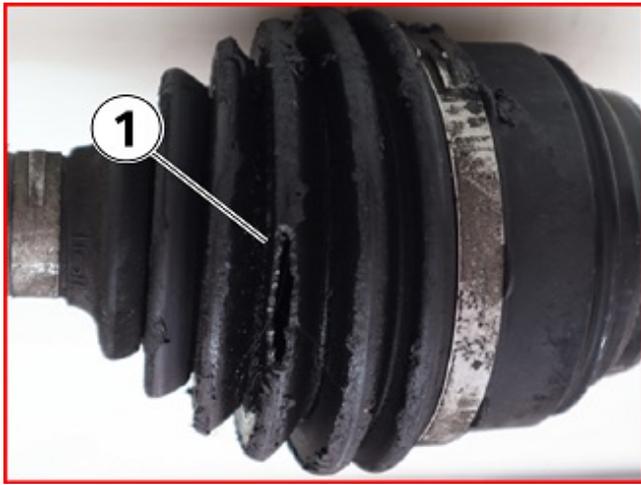
Tear in the boot (1).

B. The following are examples of torn and/or leaking CV boots that require the necessary corresponding repair to be performed (CV boot/bellows repair kit installation or axle/output shaft replacement)

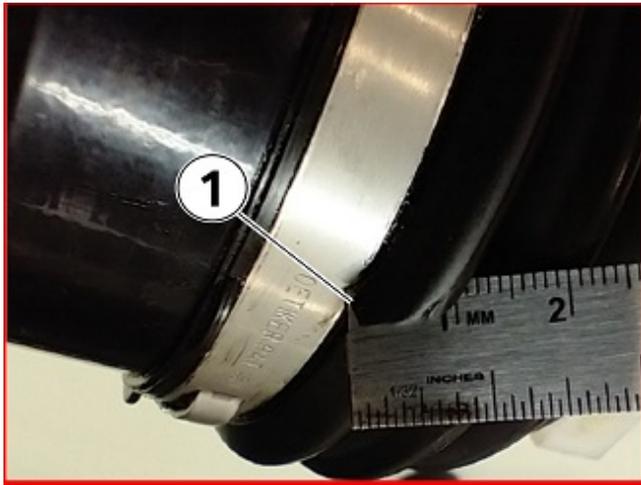
Tear or cut in the boot (1).

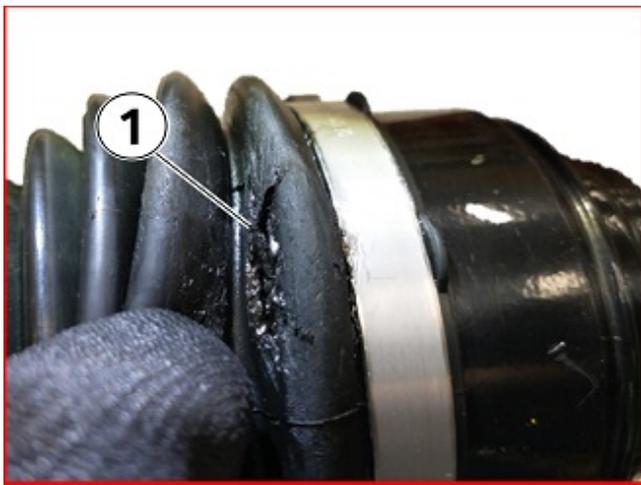
Tear or cut in the boot (1).

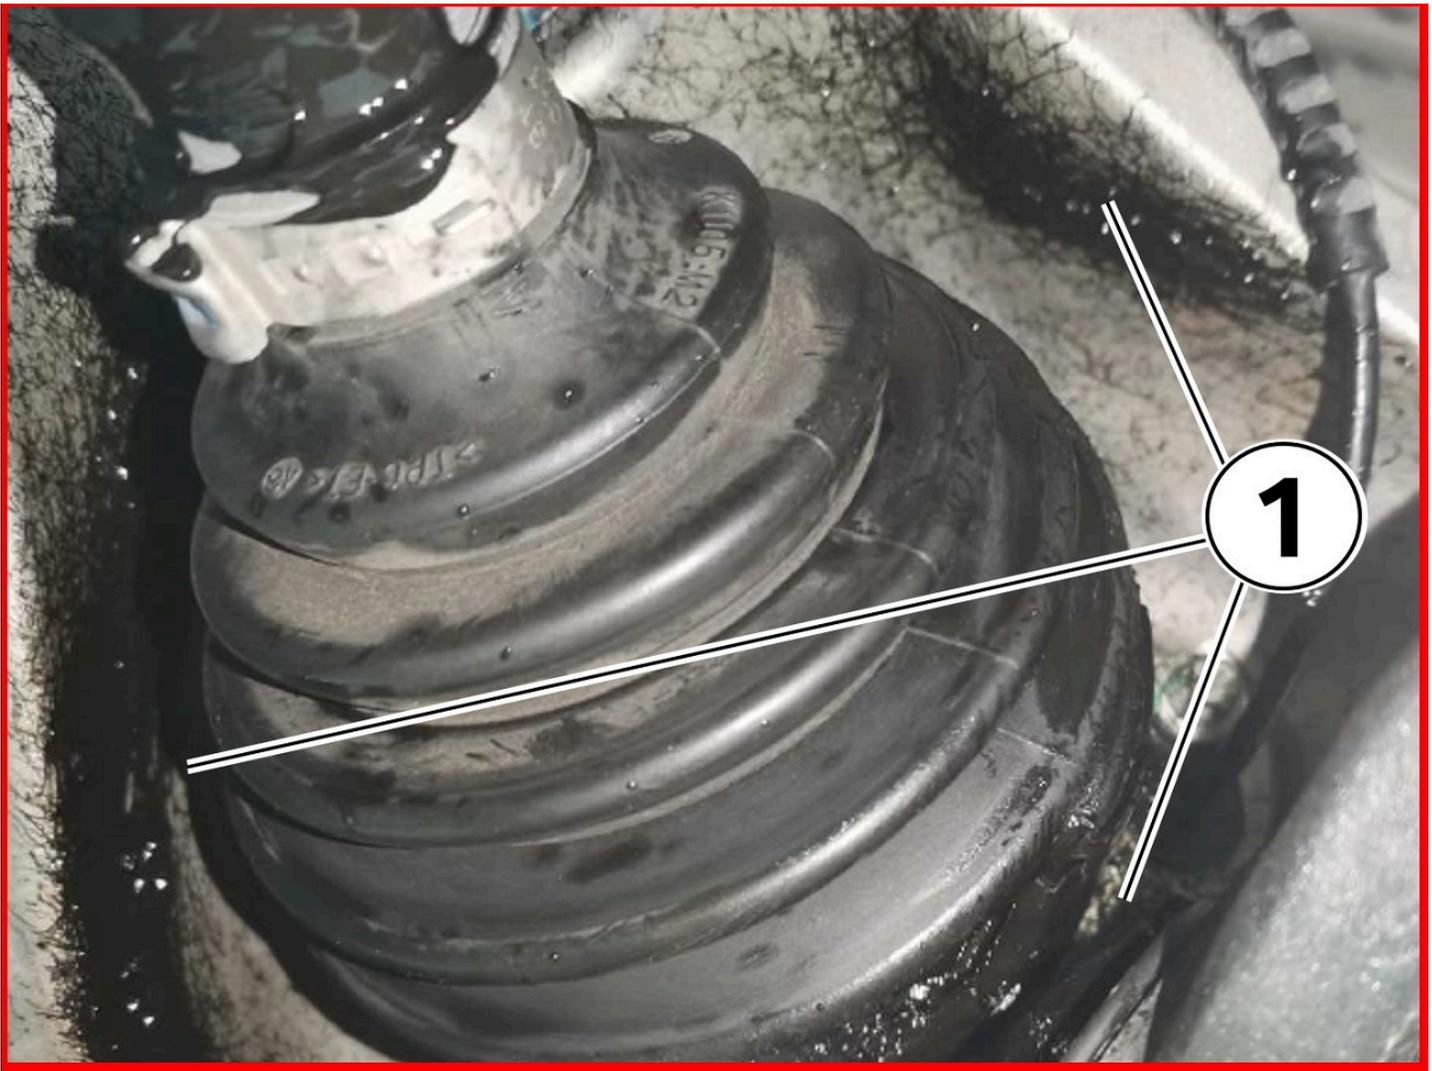
The below example is a boot that is dispersing grease around the outer carrier (1).
