SIB 32 01 26

CREAKING NOISE IN ELECTRIC POWER STEERING (EPS) NEAR END STOP WHEN TURNING LEFT

2026-01-21

E-Series	Model Description	Production Date
G45	X3 Sports Activity Vehicle	Start of production to October 31, 2025

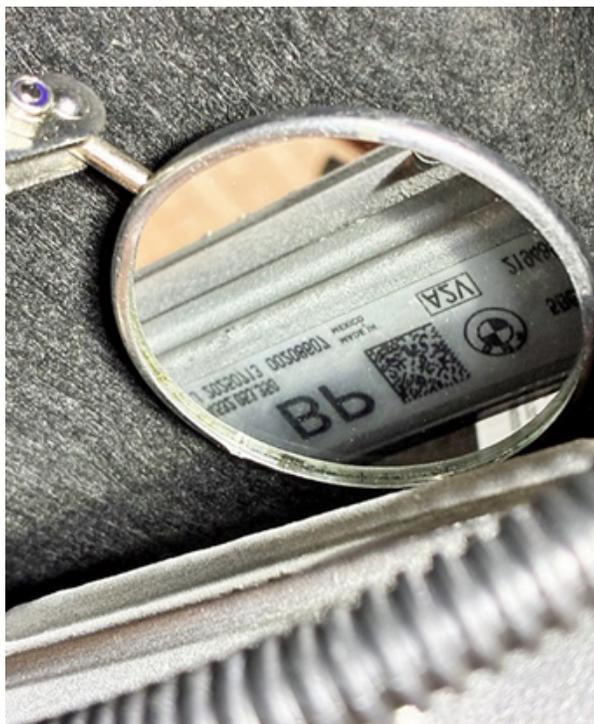
The label can be viewed from underneath the vehicle, after removing the underbody splash guard. The label is on the left half (driver’s side) of the EPS, facing upwards.

Use an inspection mirror to read and photograph the label. If the entire label cannot be captured in a single shot, move the mirror and photograph the remainder of the label.

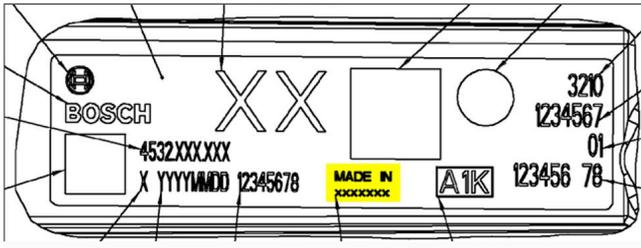
Disregard the yellow highlighted area shown on the label.

Use an additional hand lamp, or turn on the phone's flash to illuminate the label sufficiently.
