SIB 41 07 25

CRACKING SOUND FROM THE REAR WHEEL ARCH PANEL

2026-01-07

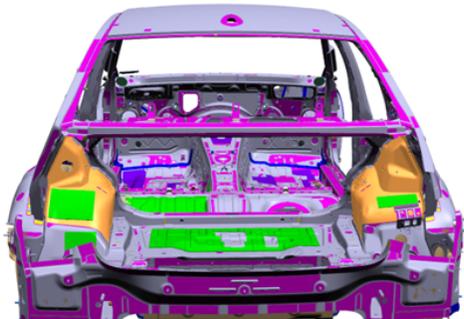
While driving on a smooth and/or uneven road, a “cracking” sound is heard from the rear wheel arch area (**highlighted in orange**) on either the right or left side.

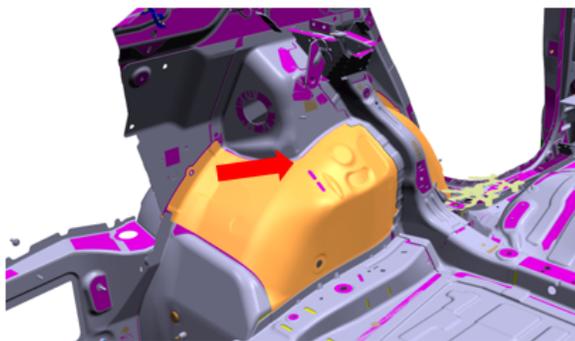
Red arrow is pointing to the area of where the sound is occurring (**with the wheel arch panel installed** (highlighted in orange; driver's side shown)).

The wheel arch support panel may slightly overlap the side frame connection under certain circumstances. Tensile and compressive loads can cause movement between the panels resulting in a “cracking” sound.

Rework the rear upper section of the left and/or right-side wheel arch panel.

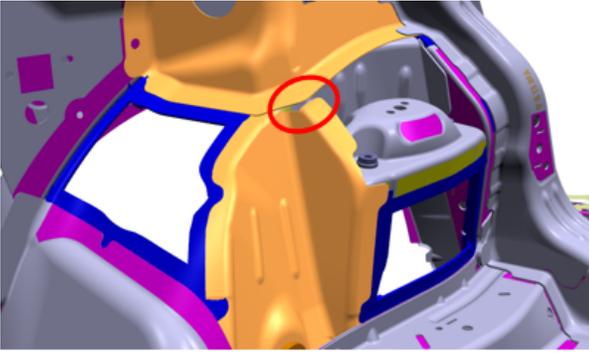
Red circle indicates the area of where the sound is occurring (**without the wheel arch panel installed** (highlighted in orange)).
