SIB 51 01 26

SERVICE ACTION: REMOVE TAILGATE OPENER LABEL

2026-01-05

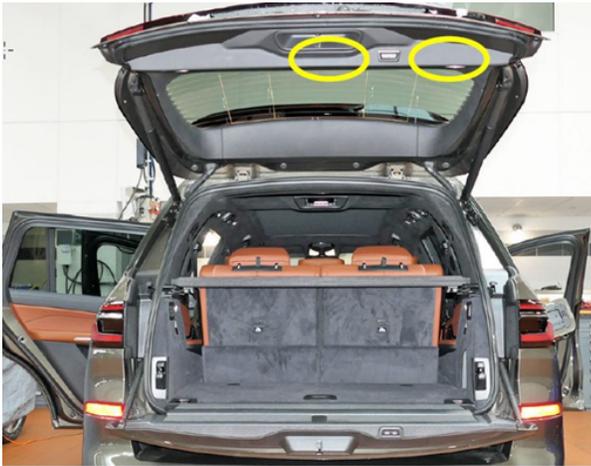
A reference label for the tailgate Smart Opener (SMO) function (aka “touchless open, or “kick to open”) was mistakenly applied to the bottom edge of the tailgate trim panel (either of the general locations circled) during vehicle production.

However, the vehicles do not have the option code for the equipment to support the SMO. The label may cause confusion, leading the customer to believe this option is available.

G07 shown; other models are similar.

Remove the SMO label.

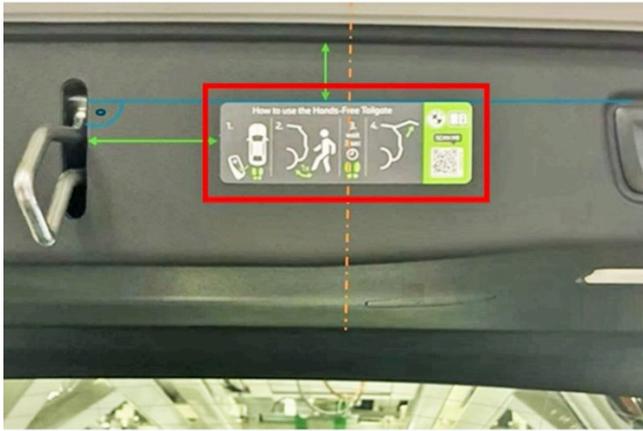
1. Open the main tailgate and look for the SMO label (in the red border) along the bottom edge of the trim panel.

- Disregard the reference lines

2. Carefully peel the label off the tailgate. If needed, apply mild heat from a heat gun with care to soften the label's adhesive.

3. Clean off any adhesive from the trim panel using isopropyl alcohol.
