SIB 51 19 25

RATTLE NOISE FROM LEFT FOOTWELL PANEL AREA

E-Series	Model Description
G60	5 Series Sedan (all models)
G90	M5 Sedan Plug-in Hybrid Electric Vehicle (PHEV)
G99	M5 Touring PHEV

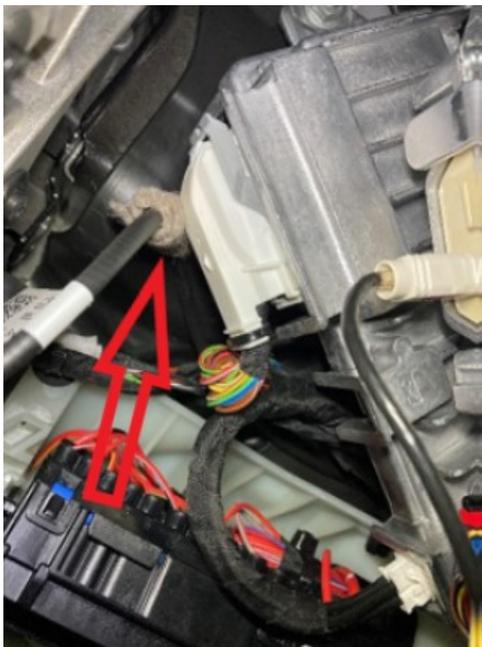
The Ultrasonic Camera Automated Parking (UCAP) control unit is too close to the front hood release Bowden cable, causing them to vibrate against each other.

Photo shows a dampening pad to highlight and demonstrate the repair.

The front hood release Bowden cable needs to be secured with felt tape in the area where it makes contact with UCAP connector.

- Remove driver-side side kick panel and lower the distribution box
- Identify where the Bowden cable is contacting the UCAP connector
- Mark the Bowden cable contact area with an item such as tire chalk
- Use the appropriate felt tape thickness (1 mm, 2 mm, or 3 mm) and length to wrap the Bowden cable in the marked area
- Tap the cable against the UCAP connector and verify the noise is no longer audible
