SIB 52 19 23

SECOND ROW 60/40 SEAT RAIL FLEX CABLE REPLACEMENT

2026-01-14

G07 (X7) SECOND ROW 60/40 SEAT RAIL

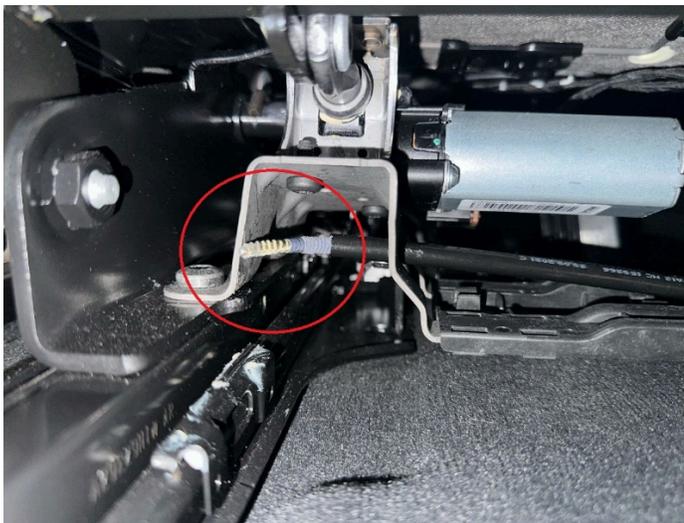
In vehicles equipped with the second row 60% / 40% split seat, the flex cable assembly can come out of the seat rail mechanism (circled). This stops the forwards and backwards travel of the seat.

Something has mechanically jammed the seat movement on one or both sides of the seat.

Locate and remove the foreign object, if still present.

Determine the extent of the damage per the various Situations below, then make the appropriate repair. There are numerous parts kits available, so you don't have to replace the entire seat rail assembly.

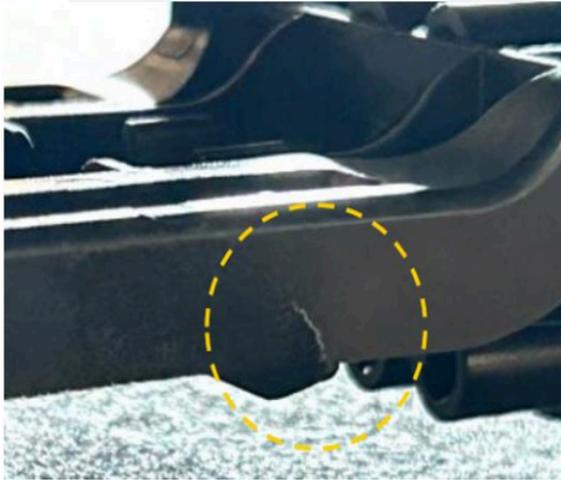
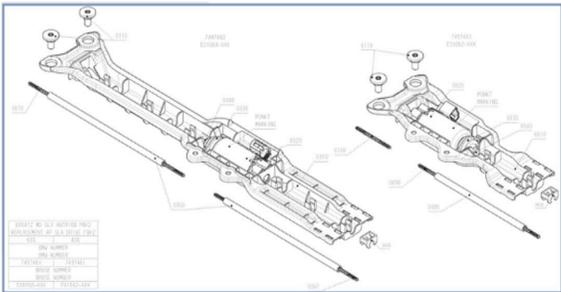
SITUATION 1

The plastic SLV Motor Carrier tray is broken.

The plastic SLV Motor Carrier tray is available with flex shaft kits.

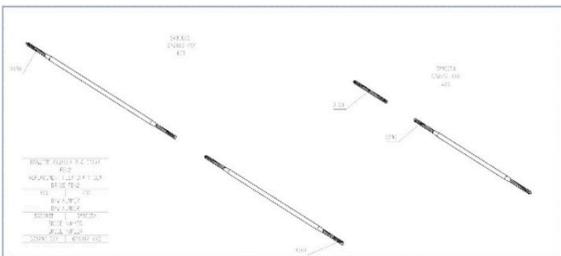
SITUATION 2

The flex cable is damaged.

If the flex cable end has been damaged, do not reuse it.

Replace only the damaged flex cable assembly instead of entire seat rail assembly. Install a new locking clip as per situation 3.

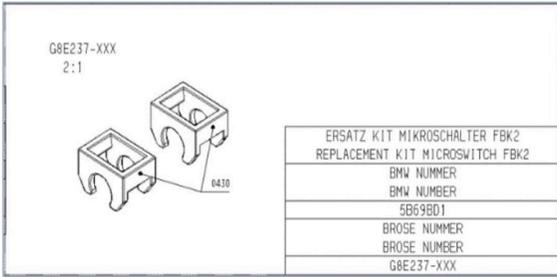
SITUATION 3

The Flex Cable has popped loose from the U-shaped flex shaft hooks. If the flex cable end is not damaged, check the U-shaped hooks on the plastic carrier.

- If the U-shaped hooks are damaged, replace SLV Motor Carrier tray (see situation 1)
- If the U-shaped hooks are not damaged, reinstall flex cable into U-shaped hooks and replace locking clip

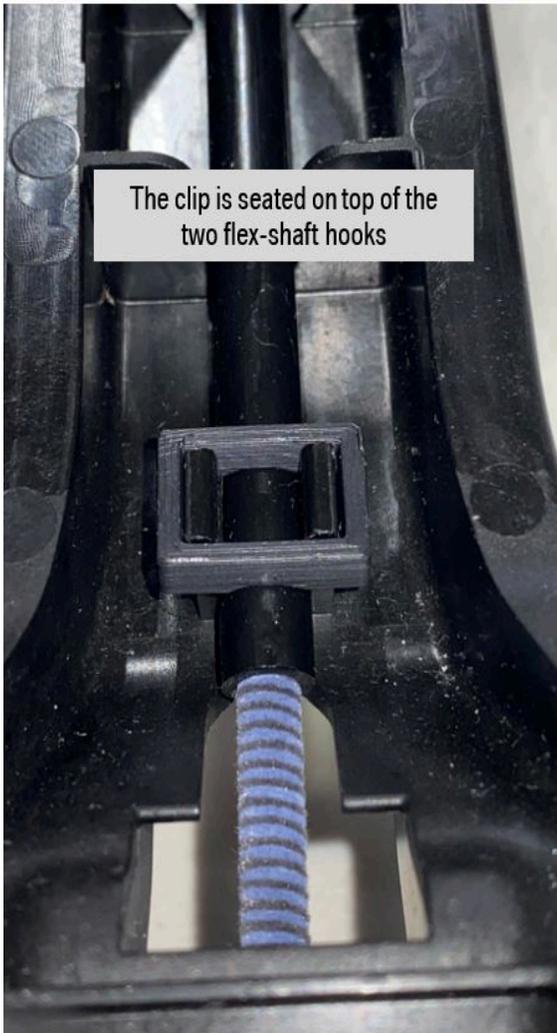
The clip is seated on top of the two flex-shaft hooks

NOTE: If this locking clip has come loose due to the cable popping free, it should be replaced.

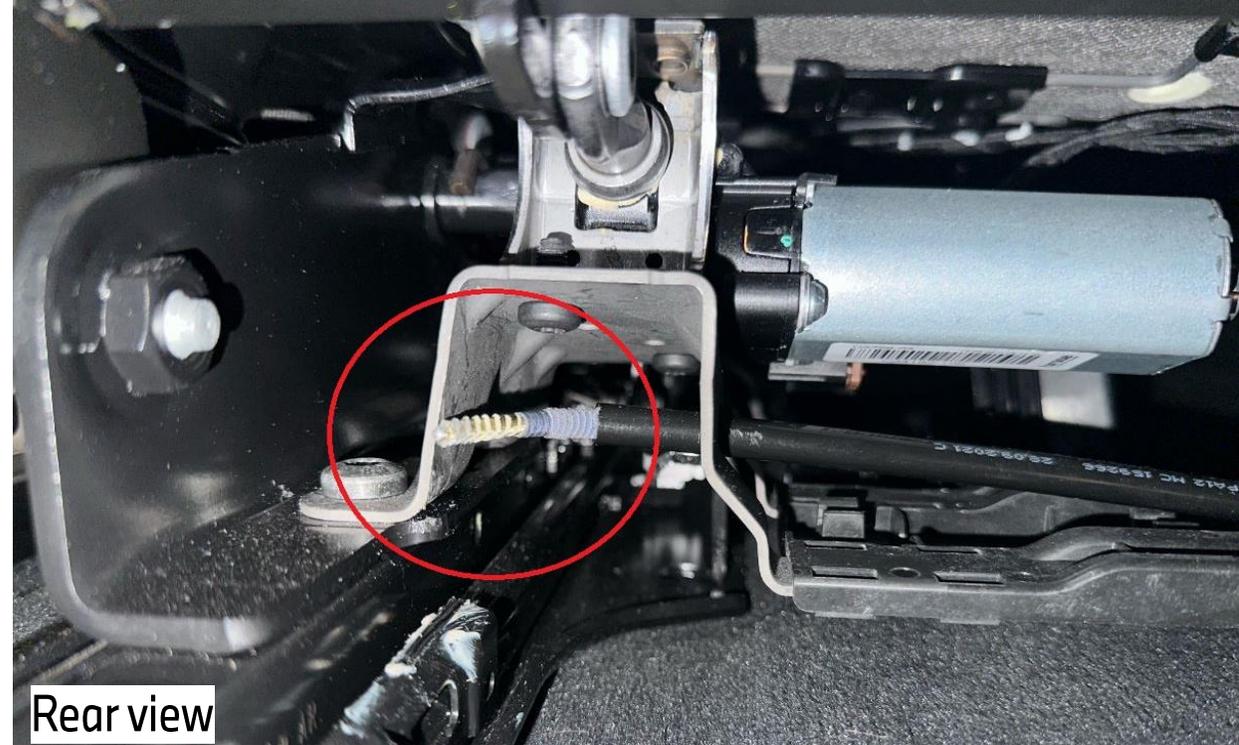
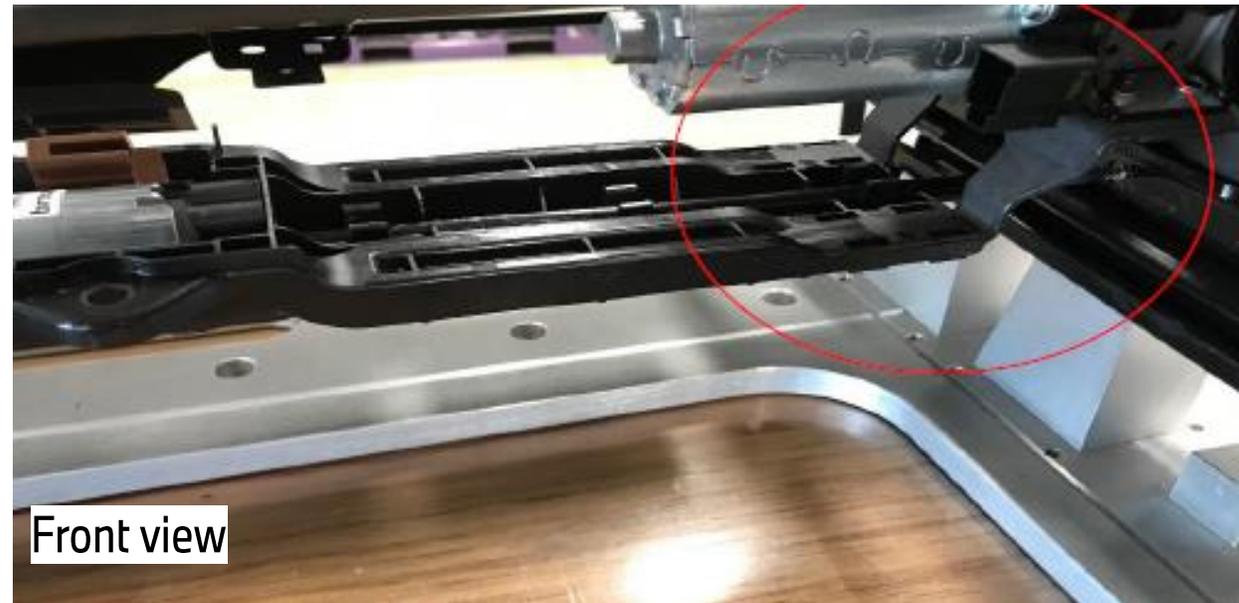
In this example the 60% seat inboard flex cable has come out of the seat rail gearbox. **The locking clip has come loose.**

This will stop the seat from moving forwards and backwards on the rails.

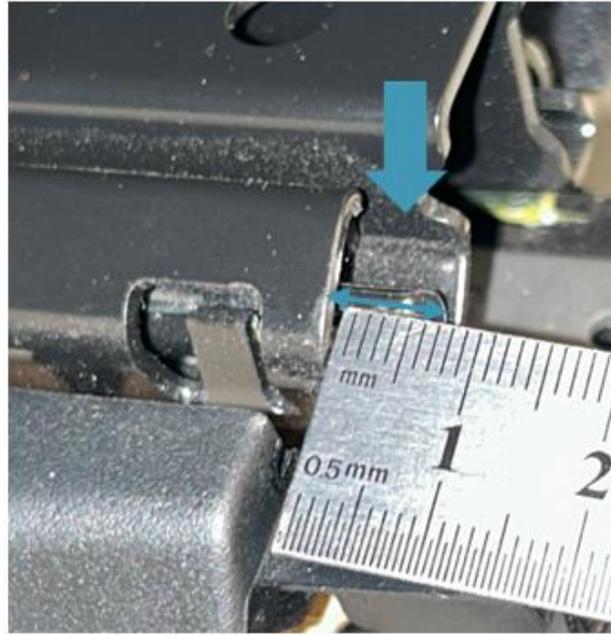
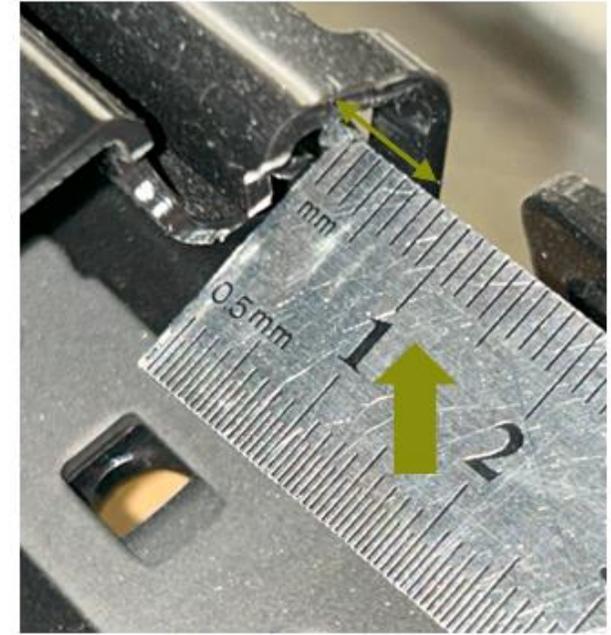
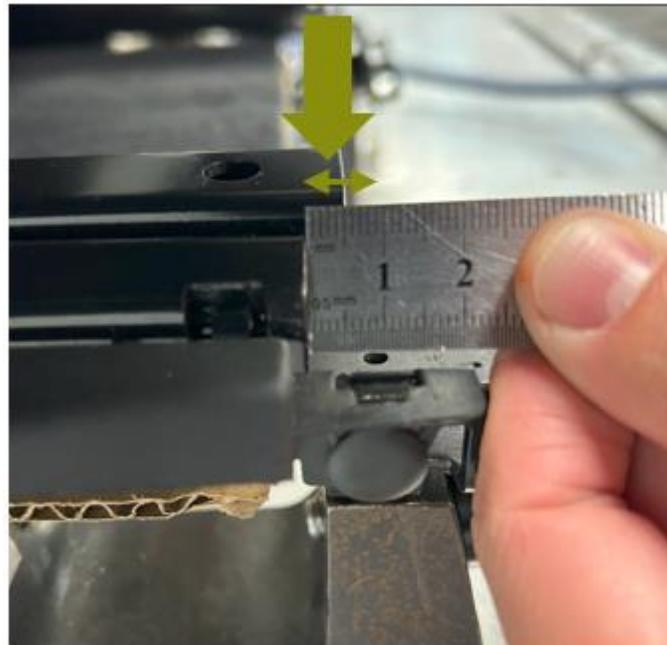
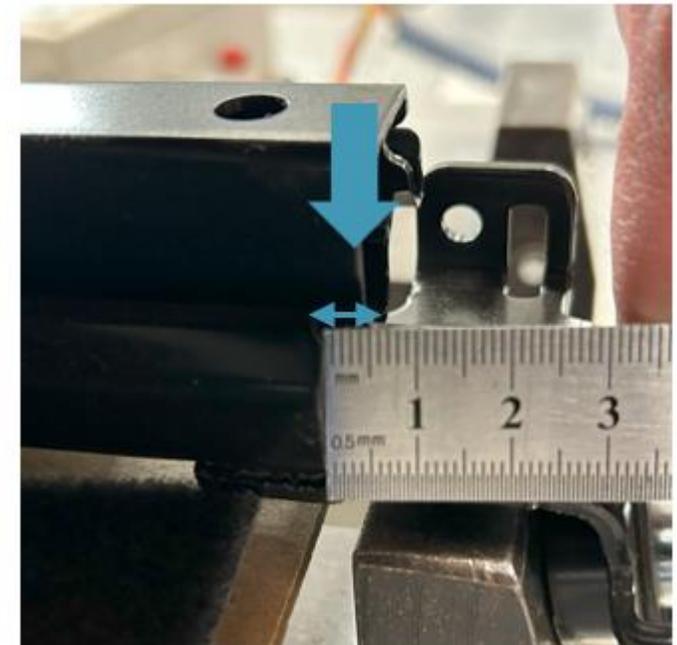
3. Measure the misalignment on both rails and compare how much the difference is. Note: Do the same process for the right side and the left side.

Left Rail: 8 mm outside Frame

Right rail: 6 mm Inside Frame

Considering that the right flex shaft is out of position, the left one must move the necessary distance so that it is aligned with the right one.

After aligning rails side to side remeasure before flex cable installation.

Now both rails are at 4 mm
