SIB 54 06 25

DELIVERY STOP: SUNROOF WATER DRAIN HOSE

2026-01-02

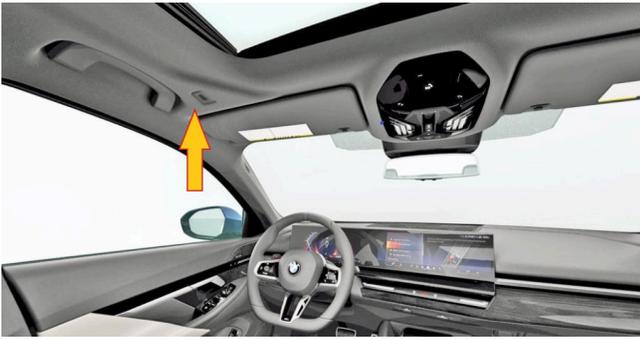
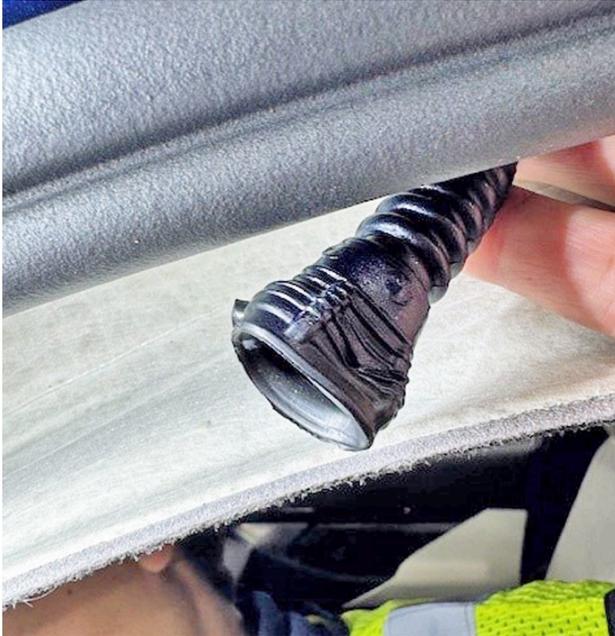
Through quality checks, it has been detected that the **front left** water drain hose for the slide/tilt sunroof is not connected.

A possibly unconnected sunroof front left drain hose can cause water ingress via the A-pillar. As a result, the floor, trim, and other components in the area of the left A-pillar may be damaged.

1. Re-attach the disconnected front left water drain hose for the sunroof.
2. Check the area of the vehicle for water ingress and renew the water damaged components.

- Lower the headlining as described in **REP 5144925 Lowering the headlining with slide/tilt sunroof**
- Arrow points to the general area of the headliner
- Attach the left front water drain hose to sunroof cassette outlet
