SIM 31 01 24

DIAGNOSING FRONT AXLE ISSUES

2026-01-02

This Service Information Bulletin (Revision 3) replaces SI M31 01 24 **dated September 2024**.

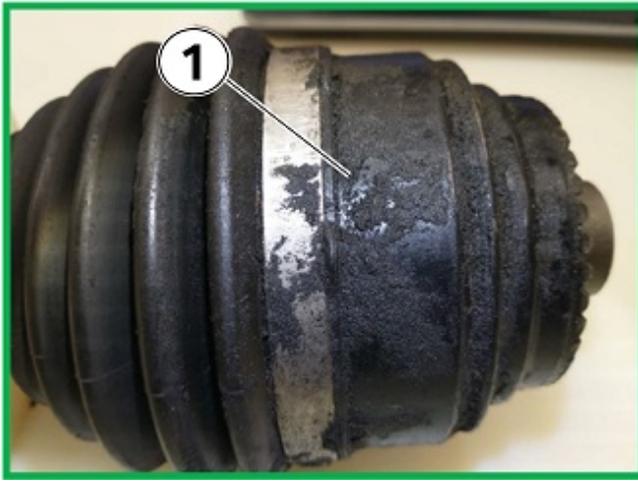
A. The following are examples of good axles/boots. Do not replace.

Example of dirt/contamination from outside influence (1).

Surface contamination and/or grease build-up is normal. Do not replace the CV boot (inner) or axle half-shaft (outer).

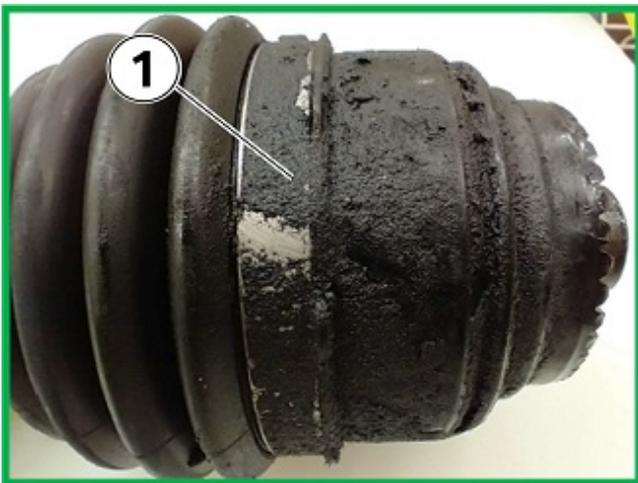
Example of dirt/contamination from outside influence (1).

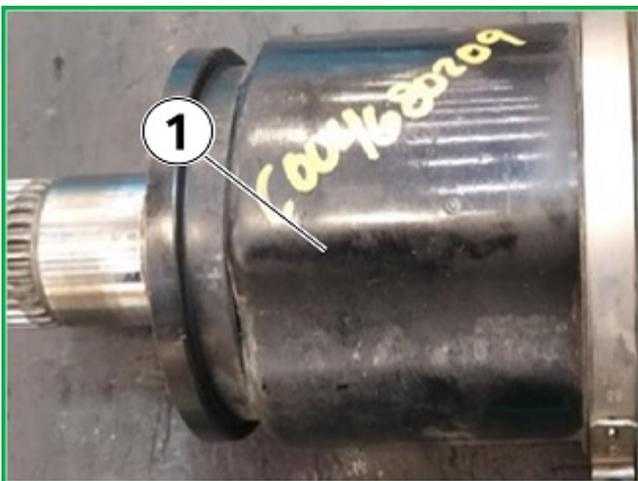
Example of dirt/contamination from outside influence (1).

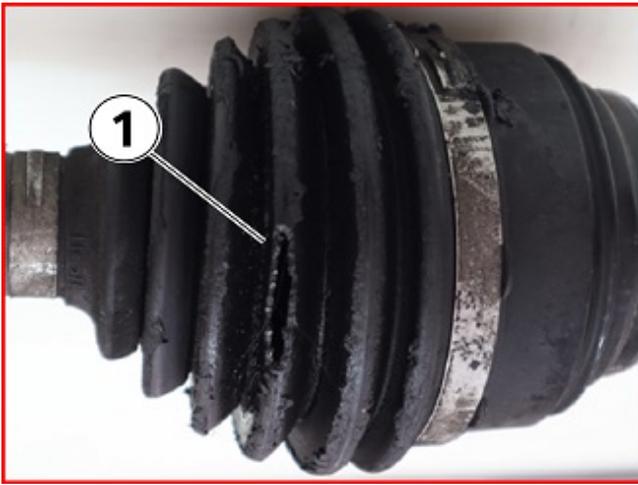
Tear in the boot (1).

B. The following are examples of torn and/or leaking CV boots that require the necessary corresponding repair to be performed (CV boot/bellows repair kit installation or axle/output shaft replacement)

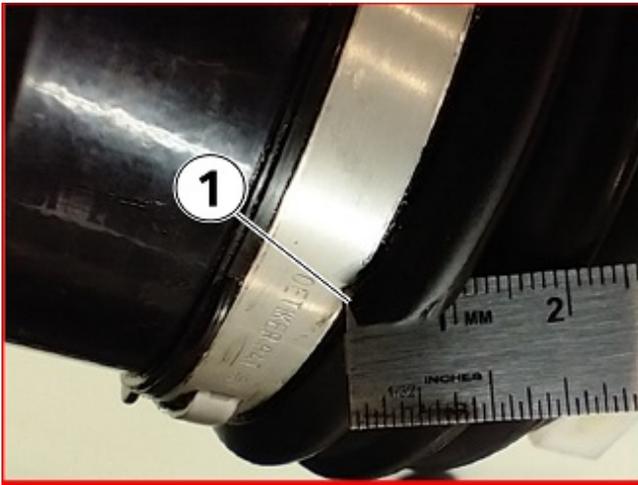
Tear or cut in the boot (1).

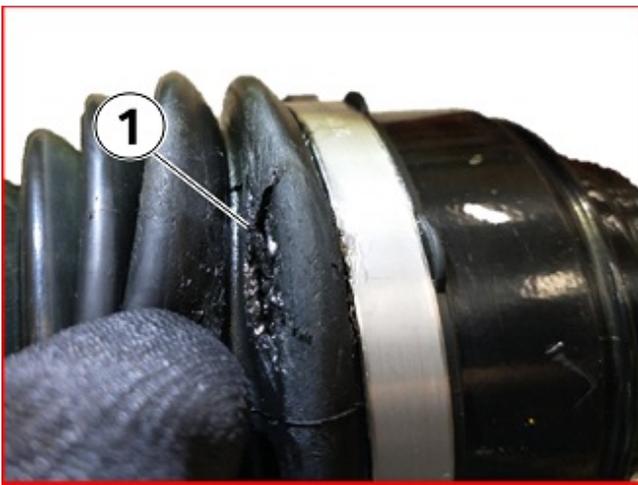
Tear or cut in the boot (1).

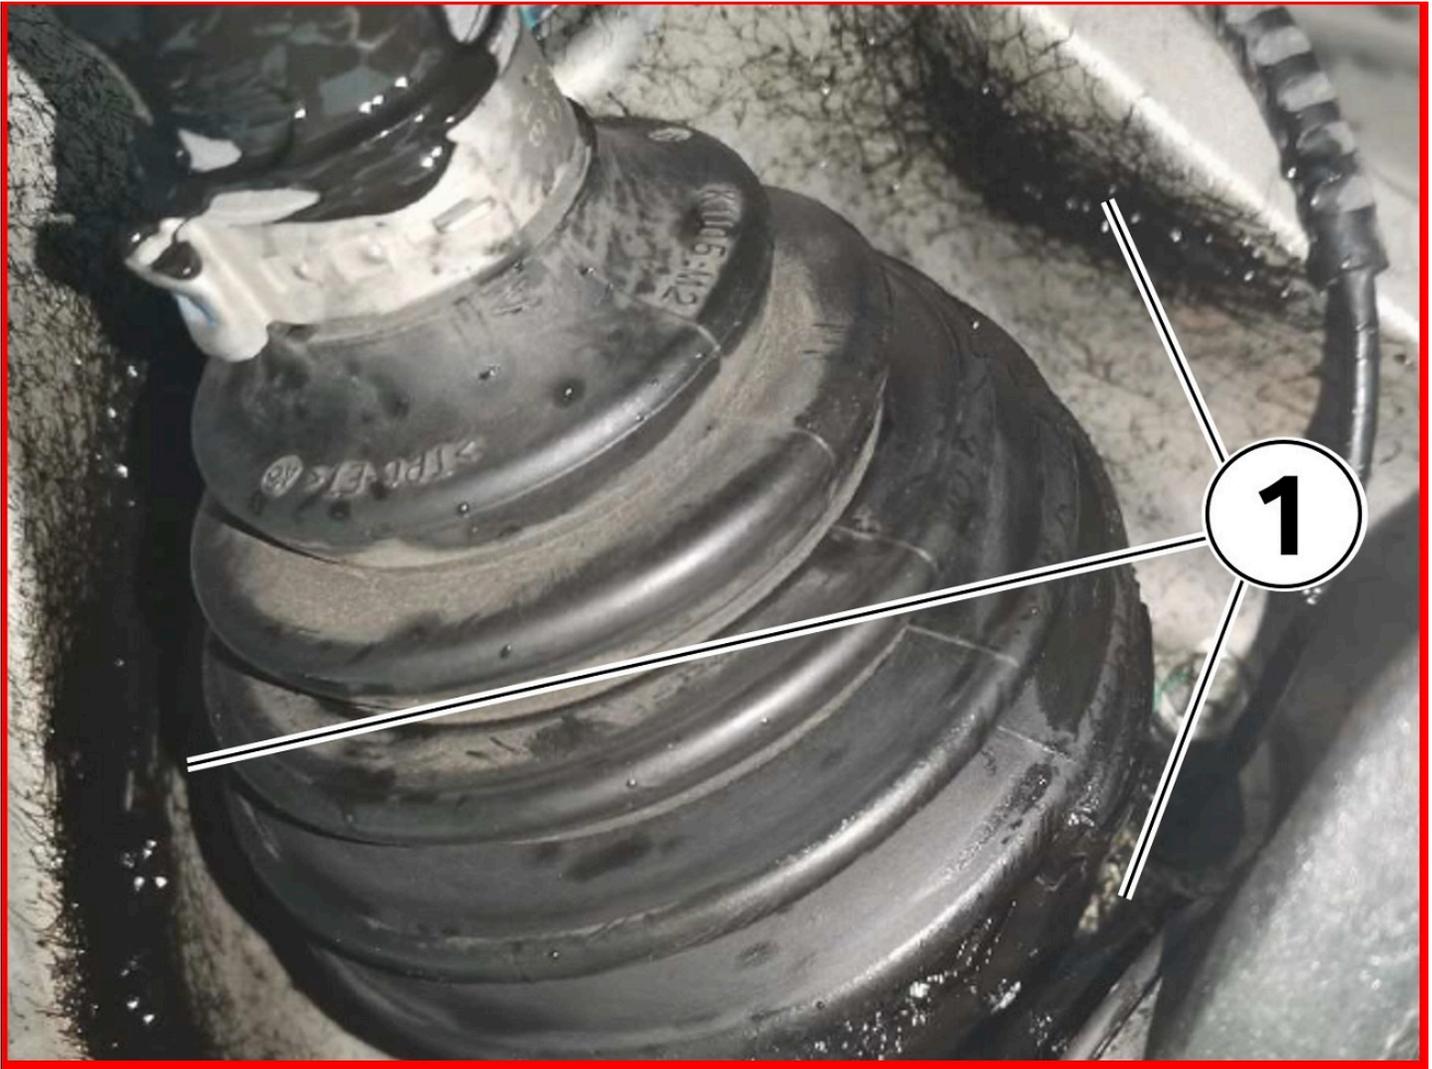
The below example is a boot that is dispersing grease around the outer carrier (1).
