# Technical Service Bulletin

<b>Topic</b>	Asterix check for My Bentley error - DTC U163D00 evident in 005F
<b>Market area</b>	China 796 VW Import Comp. Ltd (Vico), Beijing (6796), Germany E02 Bentley rest Europe (6E02), United Kingdom E01 Bentley UK (6E01), United States E05 Bentley USA and rest America (6E05)
<b>Brand</b>	Bentley
<b>Transaction No.</b>	2080195/1
<b>Level</b>	EH
<b>Status</b>	Released for publishing
<b>Release date</b>	Jan 6, 2026

## Continental GT/GTC Flying Spur | 25MY - onwards

## Bentayga Series | 25MY - onwards

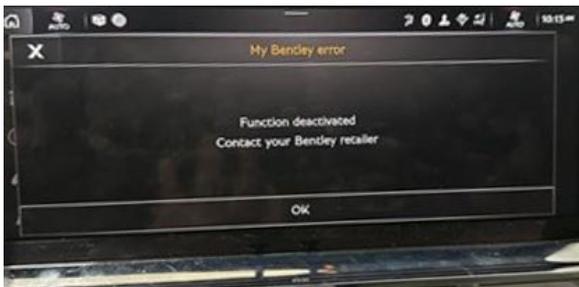
Customers experiencing a “My Bentley error” on the vehicle MIB, and are unable to use any App studio features, as per the examples in figure 1 and 2 below.

Figure 1. My Bentley error

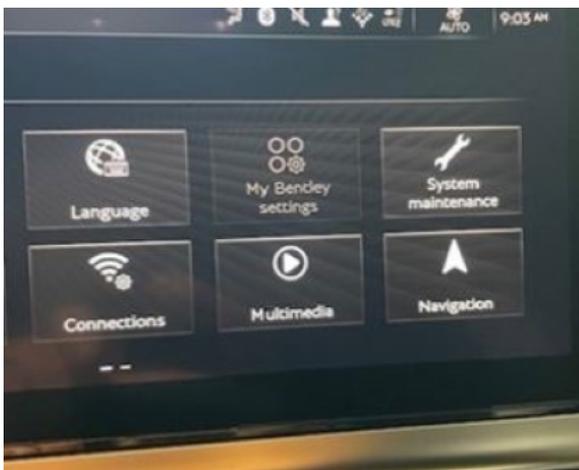
Figure 2. My Bentley settings unavailable

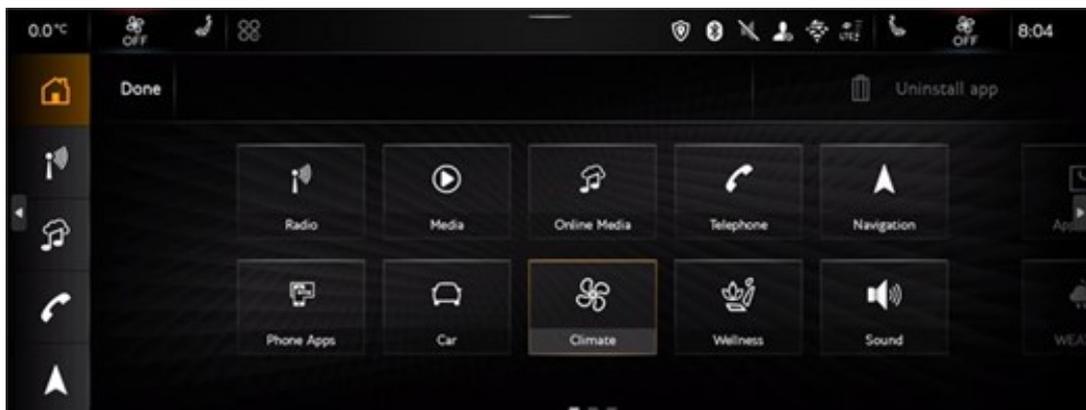
**Figure 3.** The MIB is in normal operating mode if the ambient temperature is displayed in the upper-left corner of the screen. Please note this will appear on the right hand side on right hand drive vehicles.

1. Perform a hard reset of the MMI by pressing and holding the volume button on the switch pack for 30~seconds until you see the Bentley logo re-appear on the display.
2. Check the MIB display to see what state the MIB is in, it will either be in normal operating mode or fallback mode, see figure 3 and 4 below.

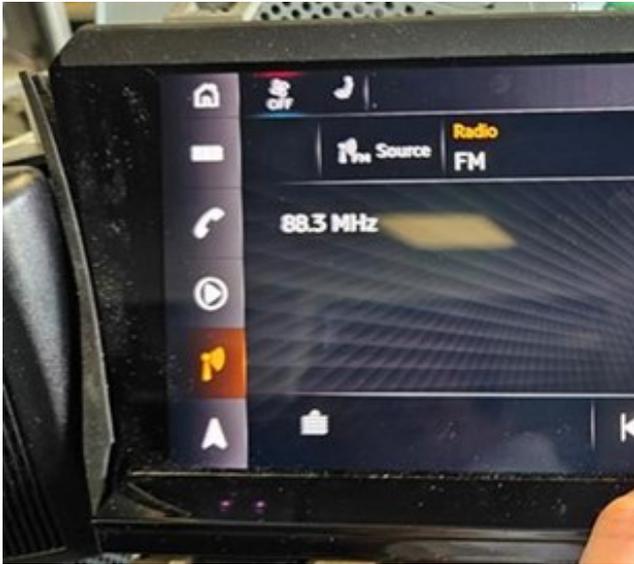
**Figure 4.** The MIB is in fallback mode if the ambient temperature is not displayed in the upper-left corner of the screen. Please note this will appear on the right hand side on right hand drive vehicles.

3. If the MIB is still in fallback mode (figure 4) perform a battery pull (terminal 30 fuse reset).

4. If the MIB state remains unchanged and still in fallback mode. Check wiring and connections  
Inspect all wiring and connectors into the Asterix module for faults or loose connections.

6. Replace the Asterix module only if steps 1–5 fail and the MIB remains in fallback mode.
