Technical Service Bulletin

Topic	Drive System Fault in Kombi with DTC P0C5100 present Continental GT/GTC/Flying Spur 25MY
Market area	Bentley: worldwide (2WBE),China 796 VW Import Comp. Ltd (Vico), Beijing (6796)
Brand	Bentley
Transaction No.	2080242/1
Level	EH
Status	Released for publishing
Release date	Jan 6, 2026

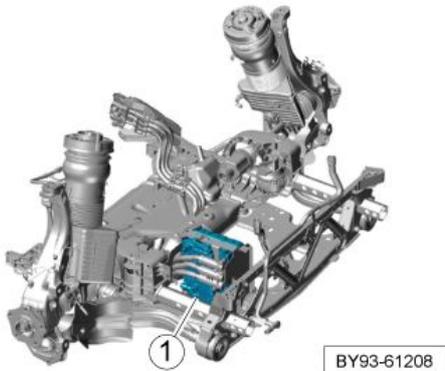
The electric drive control unit (DC/AC converter for drive motor -A37-) -1- is located on the right hand side of the engine.

2. Inspect wiring harness and connector terminals at the transmission sensor and Power Electronics (A37)

Check T8aa (8-pin connector, black), TMR (Coupling point in engine compartment, right), and T32am (32-pin connector, black) for:

- Physical damage (broken housing, bent pins, cracked insulation)
- Pin drag (verify terminal tension using correct test tool)
- Corrosion or contamination (look for rust, green deposits, dirt, oil, moisture)

To access the transmission sensor and Power Electronics (A37), follow the instructions below:

- Position the vehicle on a ramp, refer to ElsaPro Booklet 404
- De-energise the HV system, refer to ElsaPro Repair Group 93
- Disconnect the 12V battery, refer to ElsaPro Repair Group 27
- Remove the right hand front wheel, refer to ElsaPro Repair Group 44
- Remove the front right hand wheelarch liners, refer to ElsaPro Repair Group 66.
