Service Bulletin

Bulletin No.: PIC6603A

Subject: Diagnostic Tip: Service Headlamp Message - C103D sym28

Brand:	Model:	Model Year:		VIN:		Engine:	Transmission:
		from	to	from	to		
Cadillac	OPTIQ	2025		All	All	All	All

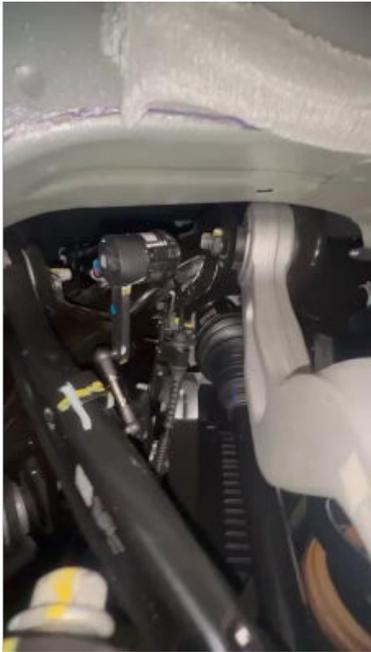
6888102

If scan tool data shows that this position to be less than 10%, with the vehicle parked on level ground, inspect the B152R leveling sensor arm for being mis-positioned, damaged or disconnected.

See example of a mis-positioned leveling sensor arm below.

If the sensor is mis-positioned, re-position sensor.

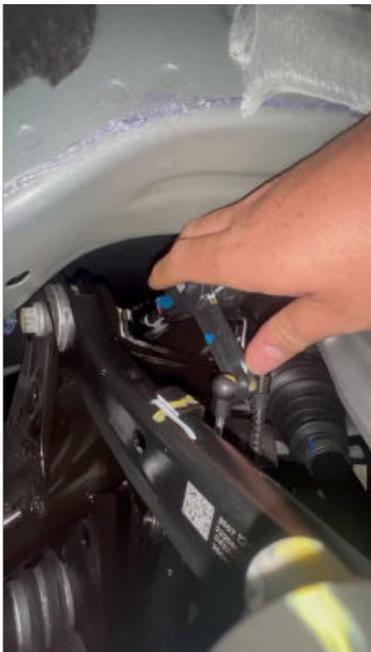
6907159

Note: Illustration below shows the correct orientation of the level sensor arm.
