RECALL: THIS MODIFICATION HAS TOP PRIORITY AND MUST BE PERFORMED IMMEDIATELY TO ENSURE CUSTOMER SAFETY

SIDE STAND SPRING AND SIDE STAND SENSOR RETAINING PLATE REPLACEMENT

2025 390 SMC R
2025 390 ENDURO R
2025 390 ADVENTURE R
2025 390 ADVENTURE X

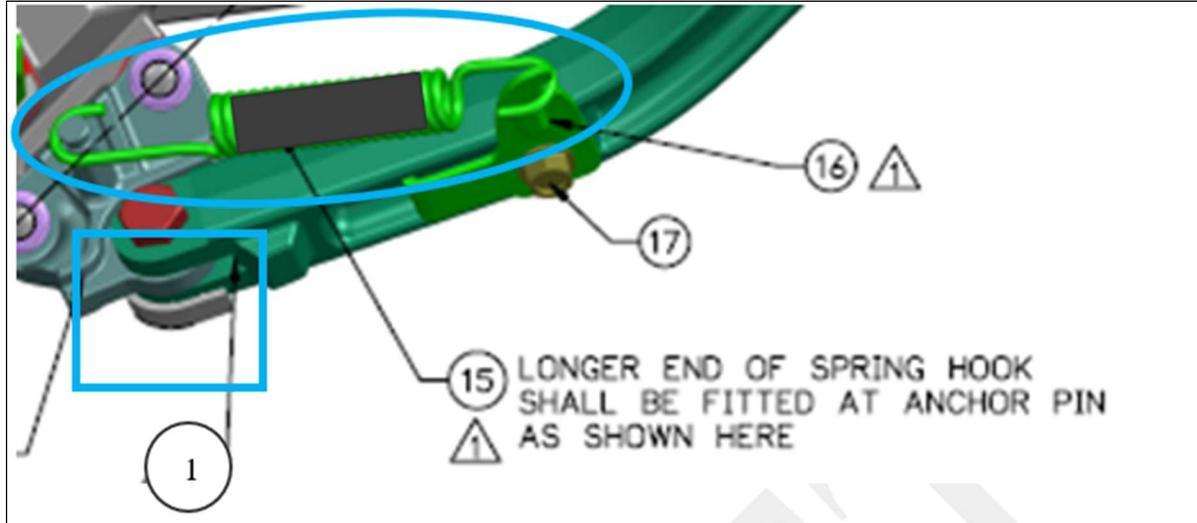
Fig. 1 – Installation position of side stand spring no. 16, position of side stand sensor retaining plate no. 1

Caution:
As damage to the currently installed side stand spring cannot be ruled out, it must be replaced and must not be reused.
- Remove the side stand, including the special nut M10X1.25 (#J910001000700) and the special screw M10X1.25XL39XBLXST (#J9000010040U0).
- Remove the side stand sensor retaining plate (#A60103029000 , No. 1 in Fig. 1) and render it unusable.
- Install the new side stand sensor retaining plate (#A60103029100). To do this, first degrease the side stand in the installation area and remove the film from the new side stand spring retaining plate.
- Install the special screw (#J9000010040U0) and nut M10X1.25 (#J910001000700) (see Table 1).
- Install the new side stand spring with rubber protector (#A60103224033).

Caution:
Note the installation position (see Fig. 1).
- Use Action Code (03_2599896_01) when submitting the TI claim. Attach photos of the removed original side stand spring and the side stand sensor retaining plate to the claim.

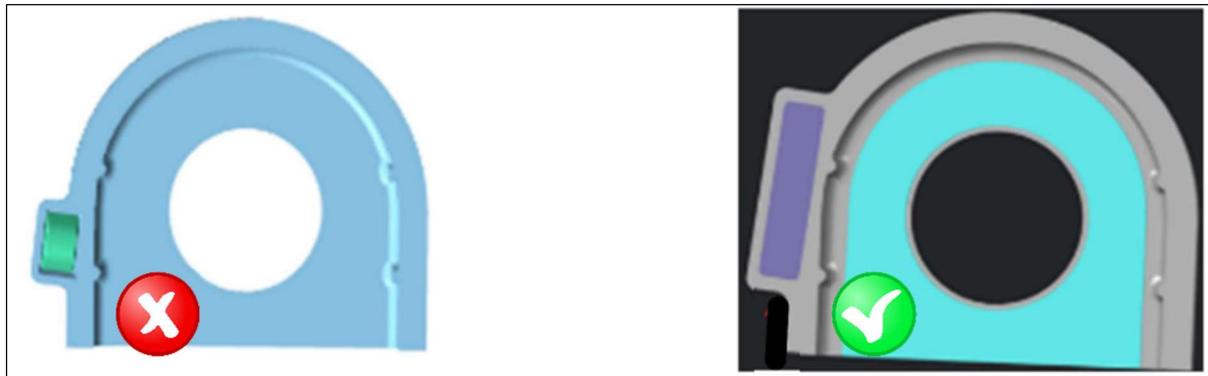
In addition to replacing the side stand spring affected motorcycles must also have a new side stand sensor retaining plate (**#A60103029100**) installed at the same time. The new side stand sensor retaining plate shifts the trigger range of the side stand switch.

Fig. 2 – Comparison of side stand sensor retaining plate – detail of magnet
