Service Bulletin

Bulletin No.: PIT6473

Subject: Service Forward Collision or Forward Collision Unavailable Messages with U3000 SYM49 set current

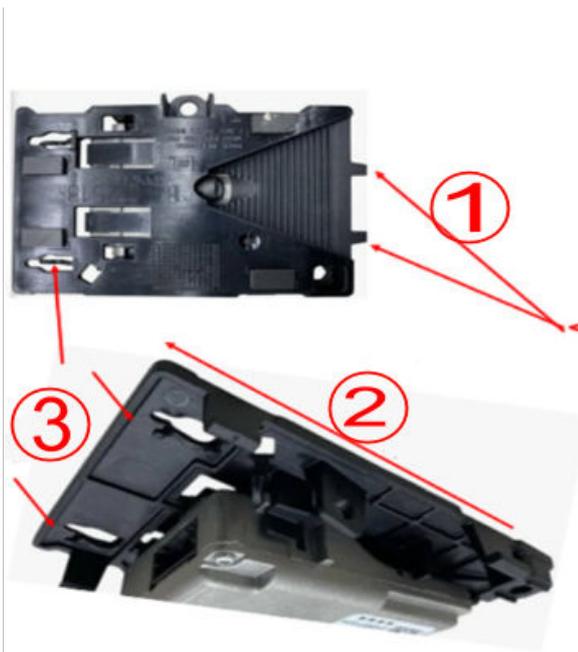
7050857

- 1) Alignment tabs
- 2) Push in direction of arrow to release lift tabs
- 3) Lift tabs

STEP 2. Remove B174W FVCM brackets from interior windshield (refer to pictures below).

STEP 8. Reinstall the FVCM bracket, FVCM, mirror and trim. (review and inspect the FVCM tabs to ensure they are properly seated).
