Service Bulletin

Bulletin No.: PIC6628D

Subject: Windshield to Dash Valence Foam Seal Mis-positioned

Brand:	Model:	Model Year:		VIN:		Engine:	Transmission:
		from	to	from	to		
Cadillac	OPTIQ	2025	2026	All	All	All	All

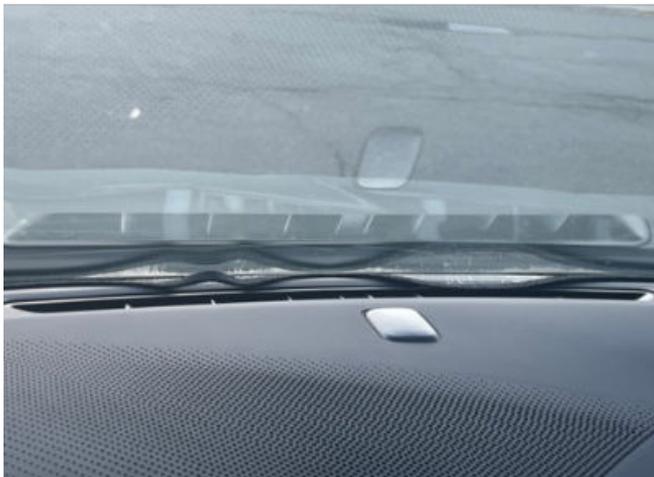
7012512

Involved Region or Country	GMNA, Europe
Condition	Customers may comment that the foam seal at the base of the windshield, will be visible from either the outside of windshield or from inside the interior when looking at the front of the instrument panel.
Cause	Foam Seal Adhesive.

The foam windshield seal will be visible from either the windshield OR from inside the interior when looking at the front of the instrument panel.
