MAS004999 RU 26-01

Rapid Update 810 MC20 Ceiling Light Clip Position Check

DATE: January 13, 2026

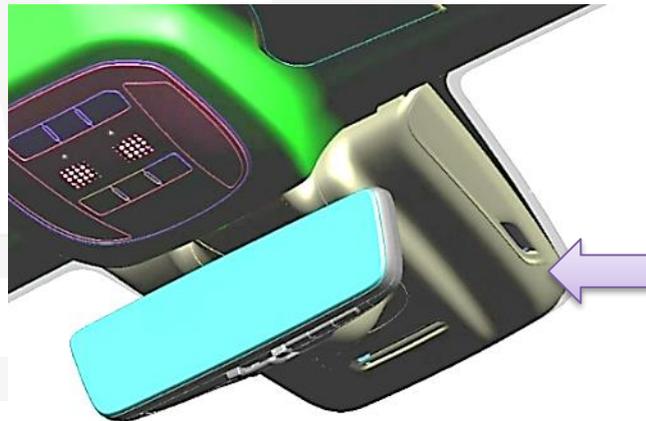
1. Always check ModisCS+ to see if the vehicle is involved in this action and if it has not been previously performed.
2. Make sure to always apply interior protection whenever performing repairs inside the vehicle.
3. To check that the clip is correctly secured in its seat, remove the front trim of the interior rearview mirror, following the procedure given in the workshop manual:
 - a. **9.35.032 - FRONT REARVIEW MIRROR COVER - Removal/refitting or replacement**

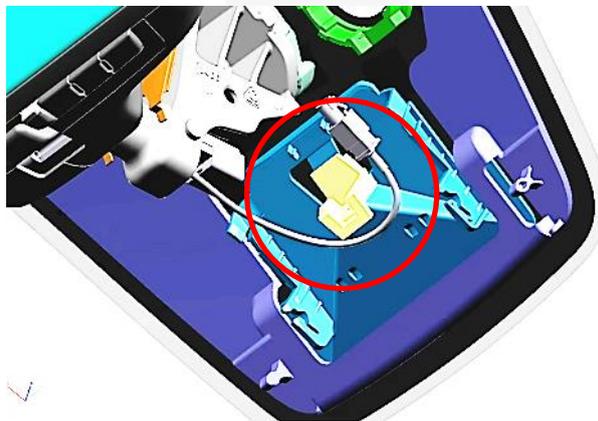
2. Locate the clip and check that it does not move from its seat.

3. If the clip is loose or out of its housing, reposition it and press firmly until you hear a distinct "click." This sound confirms the clip is **fully engaged** and locked into place.
