RAPID UPDATE

Rapid Update 812 Grecale – Multi SW Upgrade Pack

DATE: January 28, 2026

VEHICLES INVOLVED: (M182) Grecale MY23, MY24 and MY25

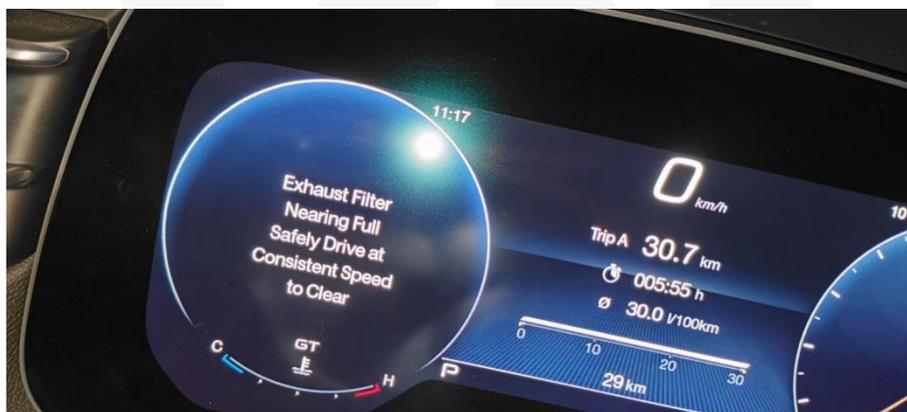
- Using MD-EVO, clear DTCs.
NOTE : Following the update, in very rare cases, the following message may appear on the screen.

This message does not indicate any technical problems with the car and simply suggests that an extra urban cycle should be performed at cruising speed to facilitate spontaneous GPF regeneration.

Technically, this message is activated when the GPF is about 50% full, in a non-critical condition. In some cases, the message may appear on pre-delivery vehicles if frequent cold engine start/stop cycles have been performed. Again, this message is to be regarded as a technical suggestion and should in no way be seen as a vehicle malfunction.

The reason why this warning has been implemented in this new software version is to inform the customer in good time so that the vehicle can be kept in perfect working order. Therefore, no further action is required by the workshop should this message appear following the update. **TCM SW Update (some MY23 only)** We also ask you to inform the customer of both the new warning function and the possible need to drive an extra-urban cycle. For this reason, any request for supplementary work under warranty concerning this issue will be rejected.
