Service Bulletin

Bulletin No.: PIC6511C

Subject: Diagnostic Tip - Unwanted Park Assist Indication

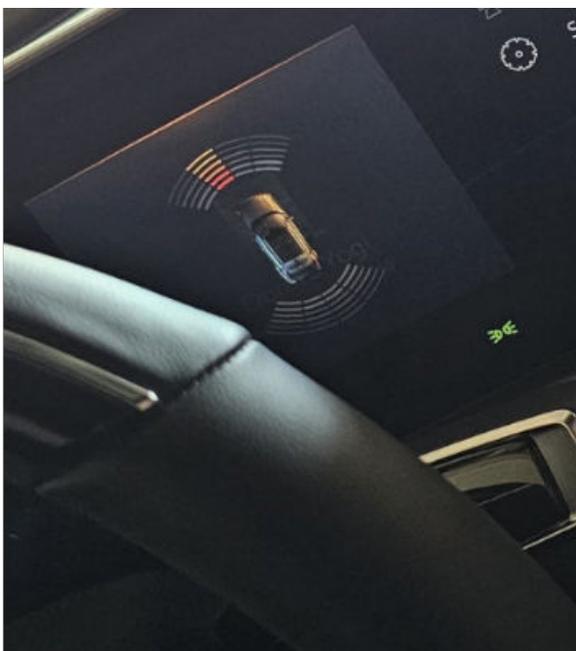
6383071

Example of Park Assist indicator.

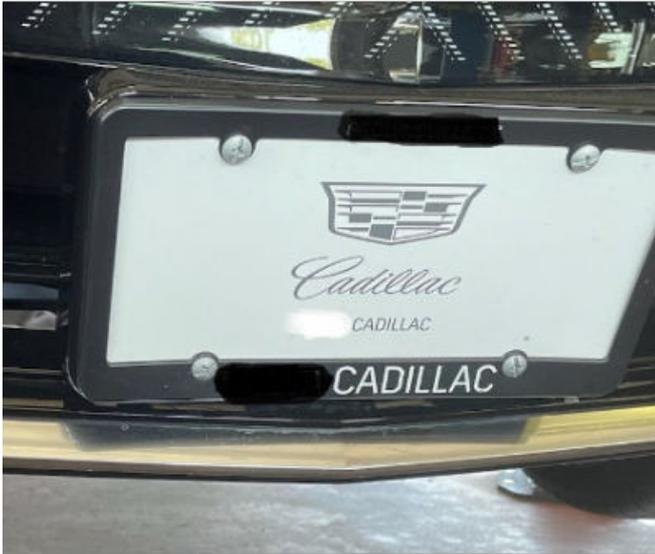
6383072

Involved Region or Country	North America
Condition	A customer may comment that the Park Assist will indicate an object detected intermittently from either the left or right front middle sensors.
Cause	Possible interference from front License Plate Frame.

1. Check for a License Plate Frame to be installed on the front License Plate similar to the picture above.
2. If a License Plate Frame is present, remove the frame and re-evaluate for the concern.
3. If the concern is no longer present, do not re-install the License Plate Frame.
4. If the concern is still present, refer to normal SI Diagnostics.
