Service Bulletin

Bulletin No.: PIT6477A

Subject: Unable to Perform GDS2 Automated Bleed After Master Cylinder Replacement

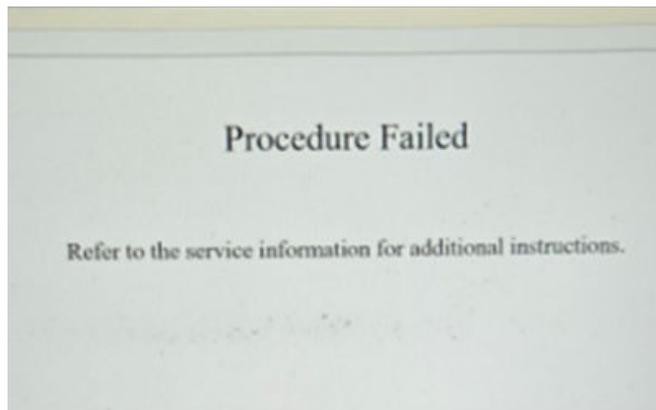
7058016

Involved Region or Country	North America
Condition	Some Technicians may notice that they get an error screen when trying to perform the automated bleed after master cylinder replacement, (See Error Screen Below).
Cause	Software Anomaly with GDS2 Software.

In some cases, performing a 12V battery disconnect for several minutes and then attempting the GDS2 automated bleed procedure a second time has allowed the procedure to successfully complete.

If you continue to have issues, then engineering is investigating the concern. The PI will be updated or replaced with a TSB once a determination has been made

Do not replace the A104 Brake Master Cylinder assembly as this will not correct the issue.
