Service Bulletin

Bulletin No.: PIP5921B

Subject: Diagnostic Tip: Possible No Start, Engine Noise Or SES Lamp with DTC P0011 P0016 Current Or History

Brand:	Model:	Model Year:		VIN:		Engine:	Transmission:
		from	to	from	to		
Cadillac	CT4-V	2020 - 2023		All	All	2.7 L3B	All
Chevrolet	Silverado 1500	2019 - 2023		All	All	2.7 L3B	All
GMC	Sierra 1500	2019 - 2023		All	All	2.7 L3B	All

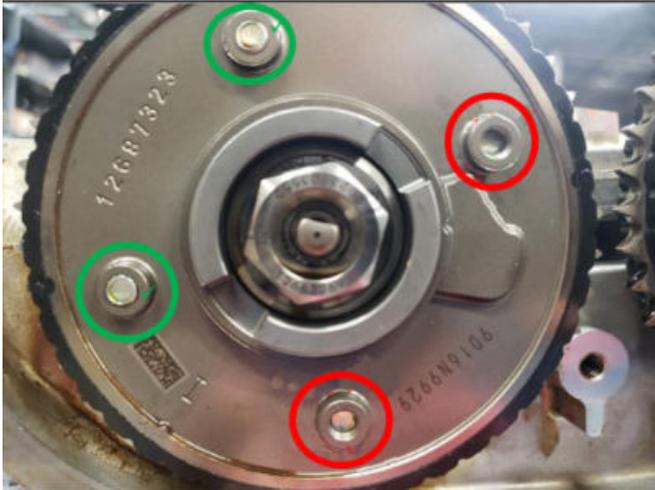
6340517

Picture below showing front side of Intake Cam Actuator. Circled in green and red are the actuator screws.

Note: Circled in red the threaded portion of the screws are below the surface indicating these are loose and have likely contacted the Cam Carrier face.

Note: If there are no signs of damage to the Cam Carrier face from the Intake Actuator screws then replace the Intake Cam Actuator using the latest Service Information.

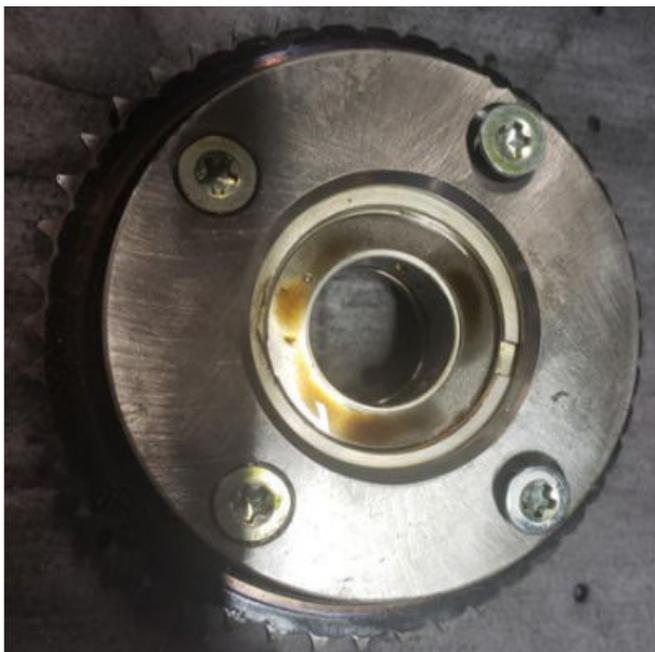
6340515

Back side of Intake Cam Actuator

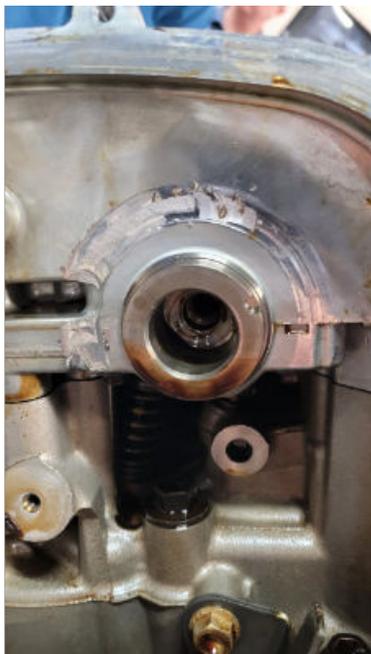
6331433

Picture below showing damage done to front face of Cam Carrier when the Intake Cam Actuator cover plate screws come loose and make contact.

If the Cam Carrier face has been damaged from an Intake Cam Actuator cover plate screw backing out then replacement of the engine assembly and turbocharger will be recommended due to metal debris in the engine from Cam Carrier face.

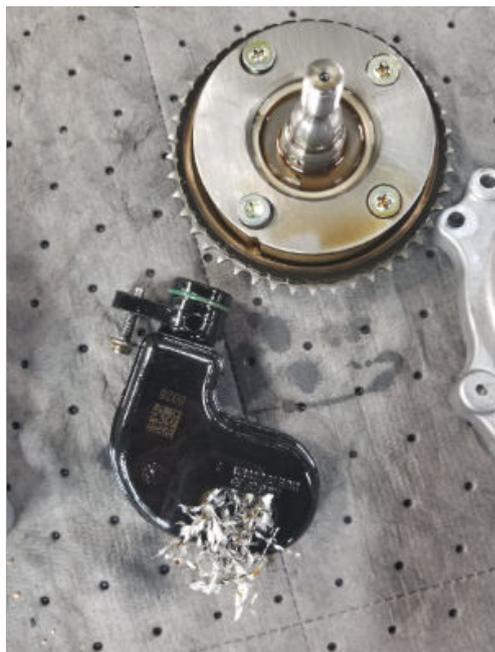
6331432

Picture below showing torx screws on the Intake Cam Actuator that have come loose and the amount of aluminum debris in the pick up tube that's possible when the screws contact the Cam Carrier face.

If the Cam Carrier face is not damaged and there is no abnormal metal in the engine oil then replace the Intake Cam Actuator, any necessary components and change engine oil and filter.
