TECHNICAL SERVICE BULLETIN, VIN: WSB-07 Open Trail Secondary Alternator Replacement

Technical Service Bulletin WSB-07 Repair Instructions

Models: 2025 & 2026 Open Trail Motorhomes

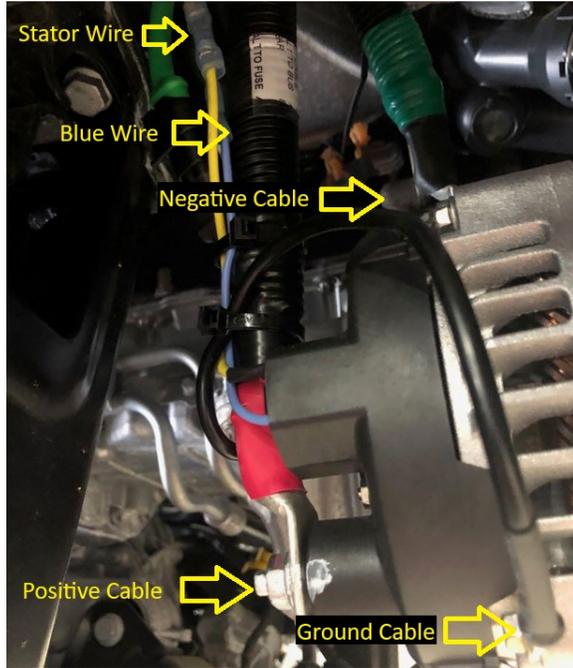
It has come to our attention that on certain 2026 Open Trail Motorhomes, the engine may begin to charge the batteries before the engine reaches 1200 rpms, which does not meet Mercedes Benz requirements. To meet the Mercedes Benz requirement that no power transfers from the engine while the engine is running below 1200 rpm, a new secondary alternator with updated firmware will need to be installed.

2. Remove existing secondary alternator from mount. Remove positive cable and wrap cable end with electrical tape to prevent any contact. Remove negative cable and then use wire cutters to remove blue wire. Remove ground cable. See Figure 2 for secondary alternator diagram.
3. Install new secondary alternator (5169450). Connect positive cable and torque to 18 ft-lbs. Connect negative cable and torque to 18 ft-lbs. Use a butt connector to connect blue wire. Locate yellow stator wire located in the harness and use butt connector to connect to yellow stator wire on alternator. Connect ground cable and torque to 30 ft-lbs. See Figure 2 for new secondary alternator diagram.
