## SERVICE BULLETIN

**APPLICABILITY:** 2023-25MY Legacy & Outback  
 2024-25MY Impreza & Crosstrek  
 2025-26MY Forester  
 2024-25MY WRX

**NUMBER:** 15-328-26  
**DATE:** 01/12/26

**SUBJECT:** Apple CarPlay & Android Auto application performance & possible no USB power with Base CP 1.5 Head Unit -Auxiliary USB-A Terminal / Design Change

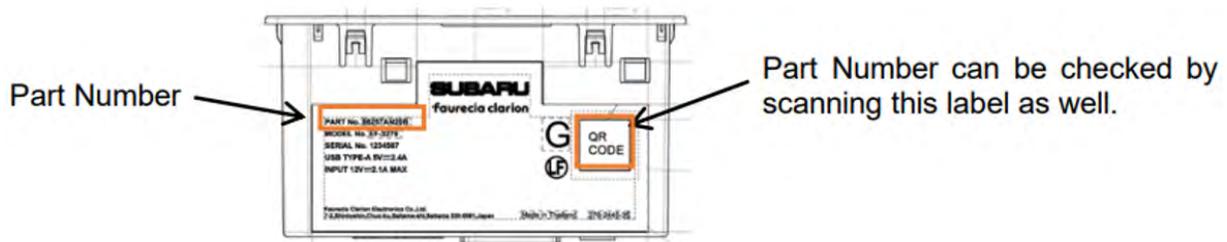
Inspect the part number of the currently installed USB hub. This requires removing the port to access the hub. The part number is printed directly on the hub and is accompanied by a QR code that can be scanned for identification.

If the part is identified as a pre-countermeasure version, replace the USB hub with the updated component.
