SIB 51 02 26

CENTER CONSOLE ARMREST BUTTON FALLS OUT

2026-01-21

E-Series	Model Description
G45	X3 Sports Activity Vehicle

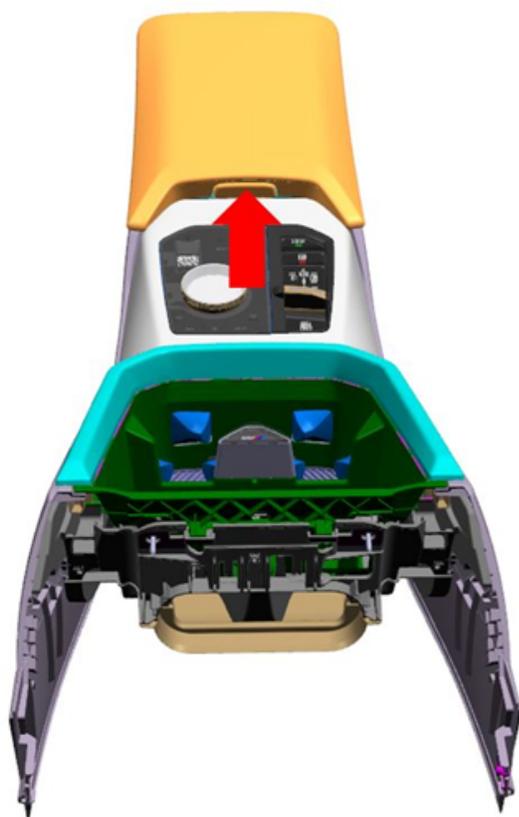
The center console armrest unlock button (arrow) pops out when attempting to open, and/or when closing the center console armrest.

Viewed looking rearward.

Unfavorable fitment of the lock button in the center armrest.

Replace the center armrest lock button with an updated part, version AI 02 or higher (located on the parts label).
