SERVICE PROGRAM BULLETIN

APPLICABILITY: 2025 Solterra **NUMBER:** WRF-25
SUBJECT: Solterra Power Distribution Box Replacement **DATE:** 01/15/26

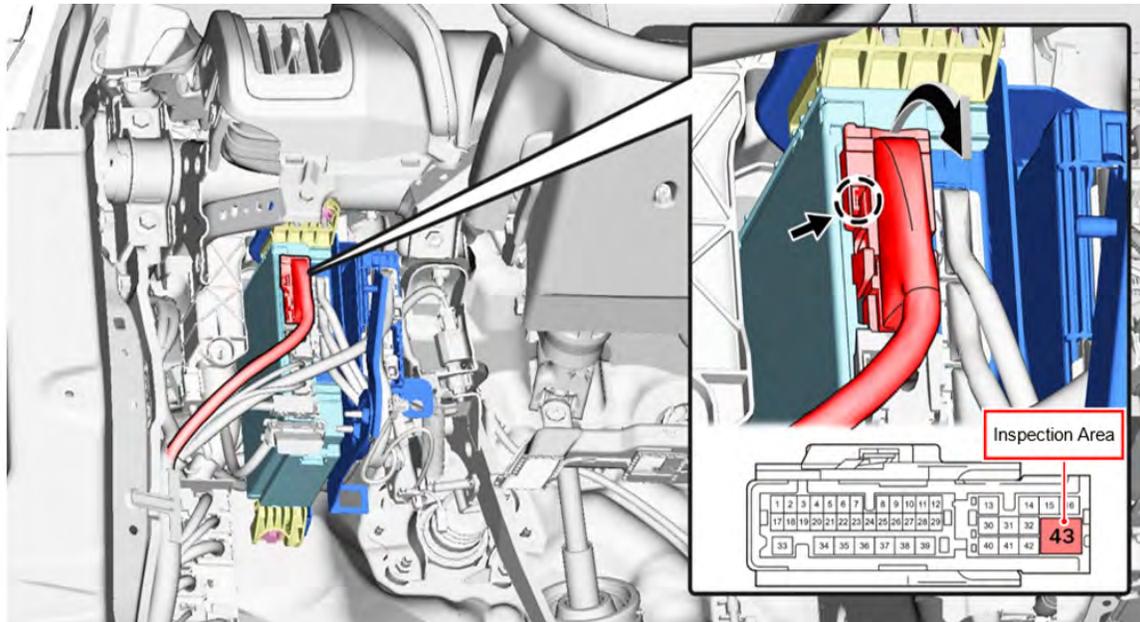
Step 3: Inspect connector No. K123, terminal 43, for any signs of damage. Minor rounding of the corner is acceptable - refer to the image below for examples.

If no damage is found, continue to Step 4. If terminal 43 is damaged, contact Techline via TechShare. Refer to the TechTIP Special Edition: *Techline Case Submission Now Through TechShare* for additional instructions. Select the case type as **Body Electrical** and complete the **WRF-25** worksheet, ensure to attach clear pictures that clearly show the condition of the connector, terminal, and wiring harness.

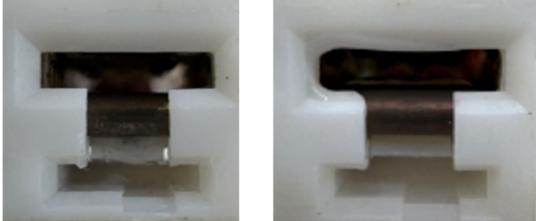
OK	<p>No Melt Damage (minor rounding of corners is acceptable)</p>

<p>Continue with replacing the power distribution box assembly with a new one.</p>
NG	<p>Melt Damage Present (With visible burn marks)</p>
