SERVICE PROGRAM BULLETIN

APPLICABILITY: 2026MY Forester **NUMBER:** WRH-25
SUBJECT: Rear Door Latch & Actuator Assy Replacement **DATE:** 01/15/26

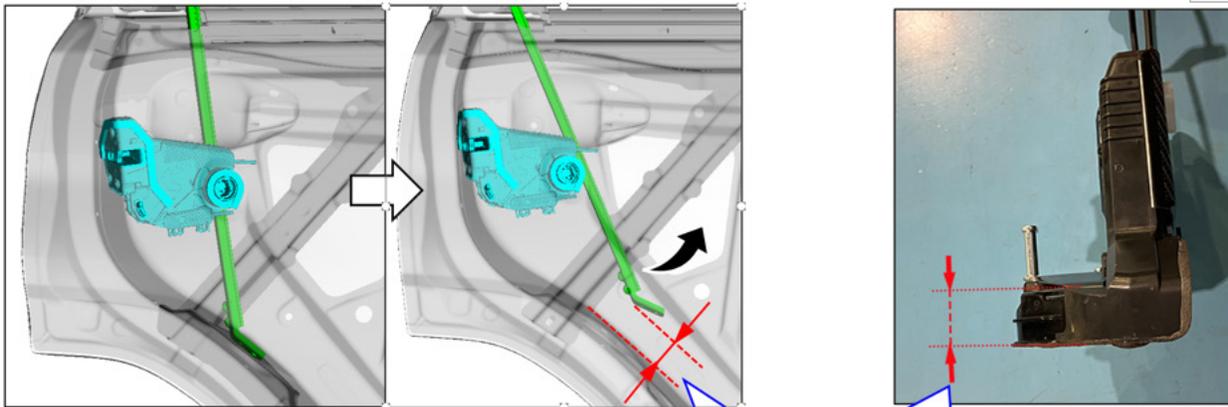
DO NOT move the sash farther than required as this can cause **DAMAGE** to the sash.

1.8 Remove the rear latch and actuator assembly.

Note: With the lower sash bolt removed, there will be enough clearance to pass the actuator past the sash.
