SERVICE INFORMATION BULLETIN

APPLICABILITY: 2026MY Outback **NUMBER:** 15-331-25R

SUBJECT: Infotainment Concern Data Collection and Sharing Guidelines for Denso Gen5 CP25 System **DATE:** 12/02/25

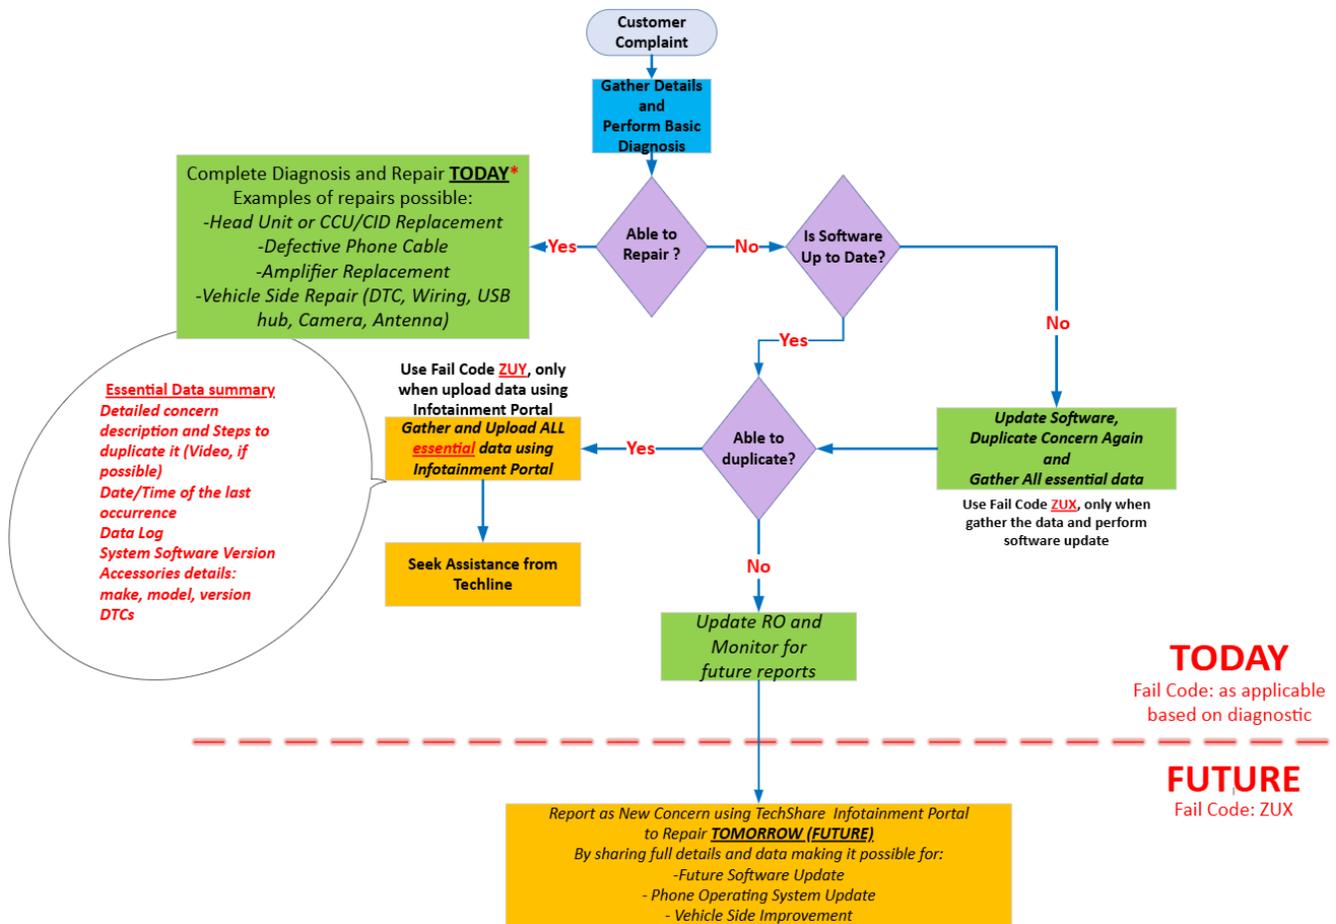
Infotainment Concern Diagnostic and Reporting Flow

*** NOTE:** In case of Black Display concern confirm it is duplicated with the latest software version. If yes, it would be due to the hardware failure in the CCU (Cockpit Control Unit) part of CP25 system. CCU replacement is advised as the next step to repair this concern. Please follow proper exchange procedure.

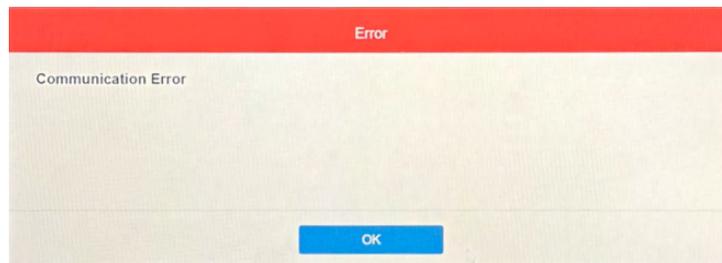
Caution: If you encounter an error shown below, it is due to communication error between the vehicle and your PC running SSM5. Please confirm Electronic Parking Brake is ON. If yes, please verify your connection and confirm SSM5 is still in sync and running.
