SIB 52 07 25

M5 HEAD RESTRAINT GROANING NOISE

2026-01-28

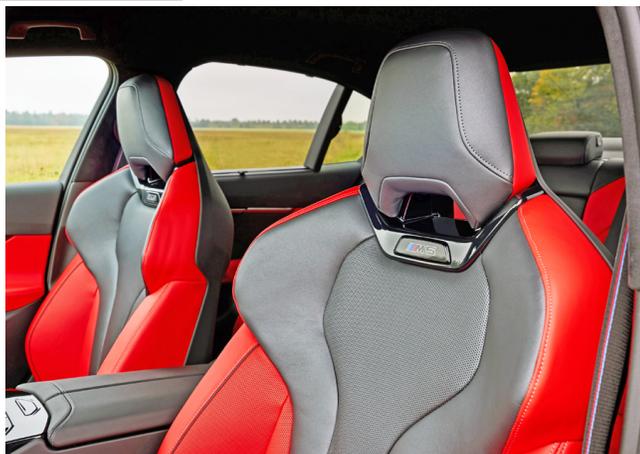
The decorative trims on the head restraints of the driver's seat and front passenger seat cause groaning noises on any route, at any temperature, even in a slightly reclined position.

The edge of the aperture trim rubs against the seat leather upholstery at the point of contact.

Replace the aperture trim on both seats in case of a noise concern with revised part number 52 10 7885235.
