PRODUCT CAMPAIGN BULLETIN

APPLICABILITY: 2026MY Forester **NUMBER:** WRG-25

SUBJECT: Safety Recall and Stop Sale: Rear Gate Stay Bracket **DATE:** 01/30/26

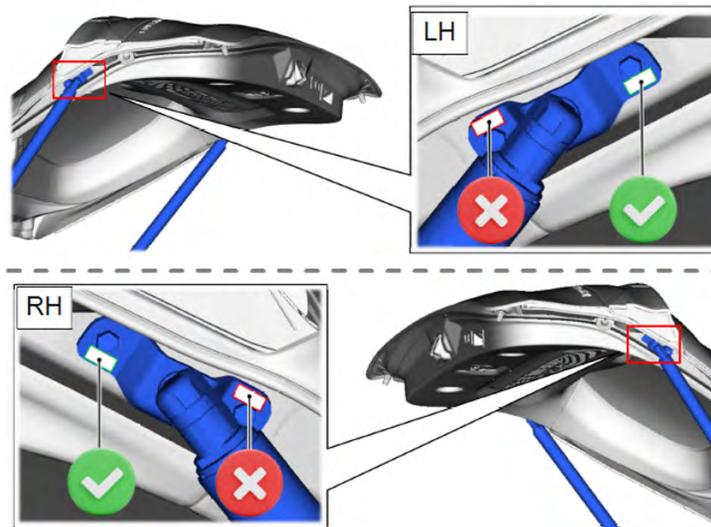
Step 1) Open rear gate, inspect the location of the bracket identification mark.

Is the mark at the top of the bracket with the gate open?

No – Go to replacement procedure for the applicable rear gate model.

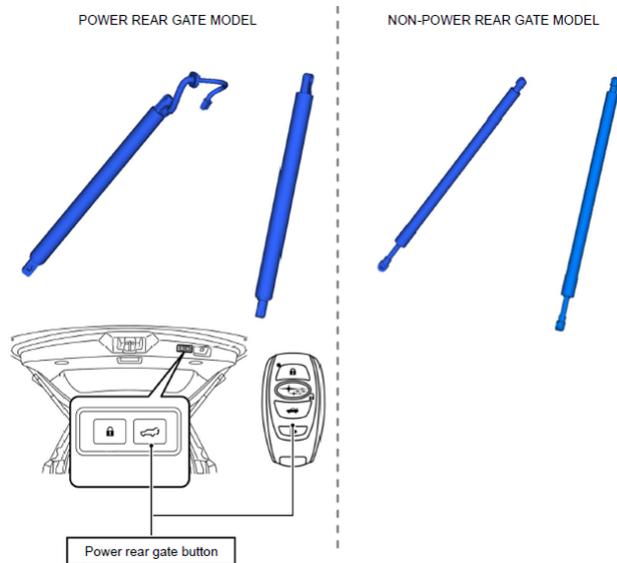
Step 2) Inspect the rear gate stays.

Are they the correct stays for the rear gate model?

No - Go to replacement procedure for the applicable rear gate model.

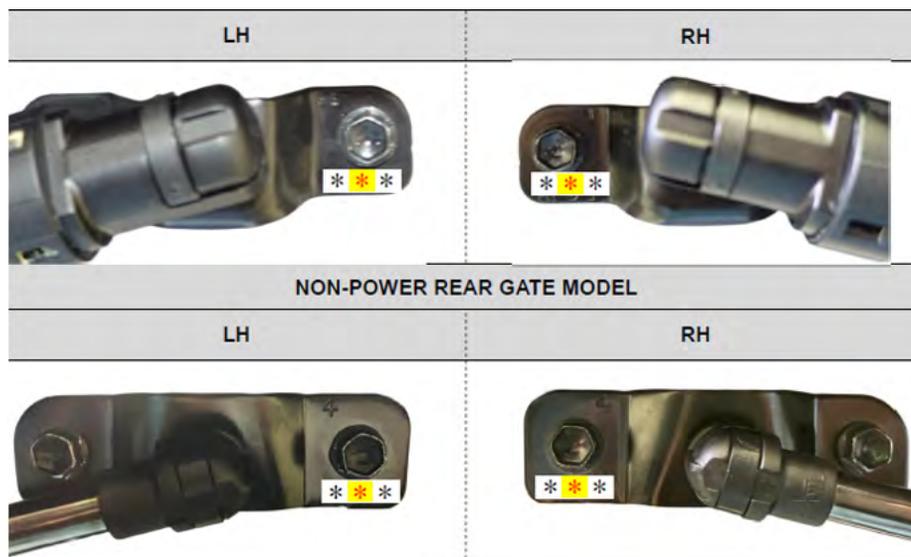
Step 3) Inspect rear gate stay bracket identification mark to ensure it is correct for rear gate model.

Check the middle digit of the identification mark:

The middle digit will be either P or N. P brackets are for power rear gates, and N brackets are for non-power rear gates.

Is the middle digit correct on both rear gate stay brackets?

No – Go to replacement procedure for the applicable rear gate model.
