**SERVICE BULLETIN**

**APPLICABILITY:** 23-25MY Outback/Legacy Models (including Wilderness models)  
 23-25MY Ascent Models  
 24-26MY Impreza  
 24-26MY Crosstrek (including Wilderness models)  
 24-25MY WRX  
 25-26MY Forester  
 26MY Forester Wilderness

**NUMBER:** 15-305-22R  
**DATE:** 11/15/22  
**REVISED:** 01/20/26

**SUBJECT:** Reprogramming File Availability for Optimization of Gen 4.5 Denso CP1.5 Infotainment Systems

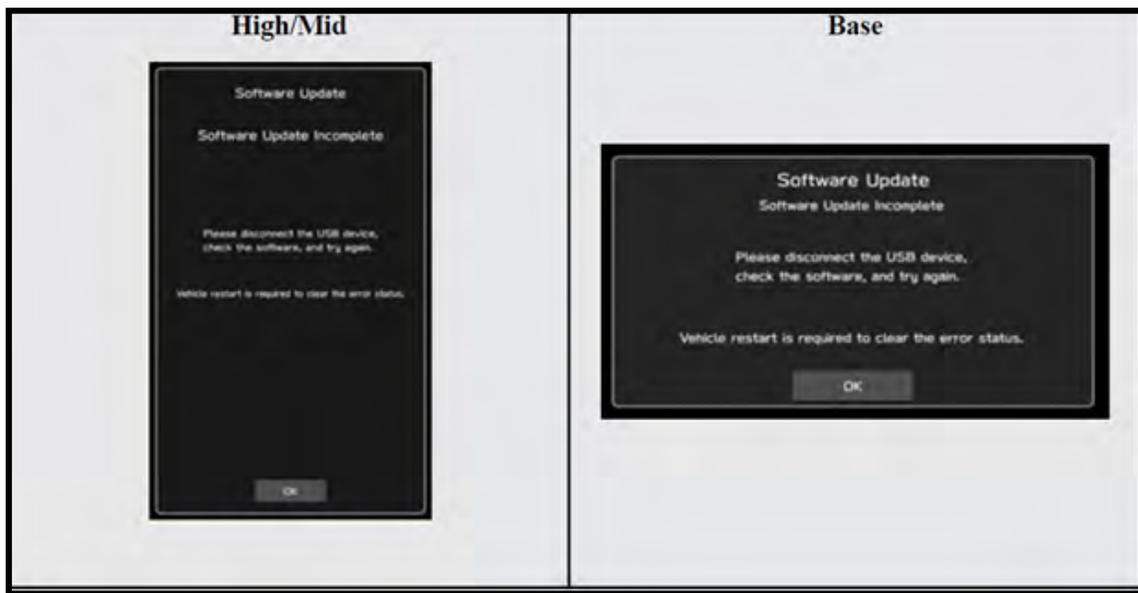
If you get the message **Software Update Incomplete** as shown below, please don't replace the hardware but retry updating the software according to the instructions in [Appendix 6](#).

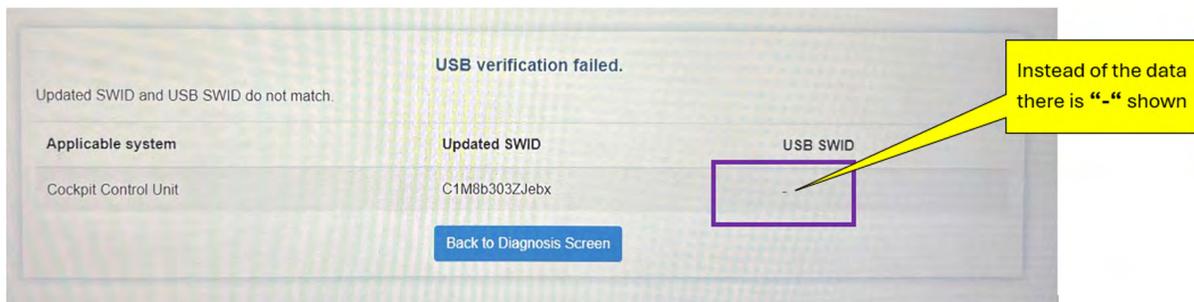
**IMPORTANT NOTE:** In rare cases when the CCU does not complete the USB authentication check in time resulting in the message box below.

- Perform a soft reset of the CP1 by holding down the CID volume knob. Please leave USB Drive connected.
- Once the CP1 has restarted, retry step ii on the previous page and then press the “Start Reprogramming” button. Please wait for 2 minutes after CP1 has restarted, before press the “Start Reprogramming” button.
- If the same failure is encountered again, please proceed with the diagnostic of failure by checking the USB drive data integrity.

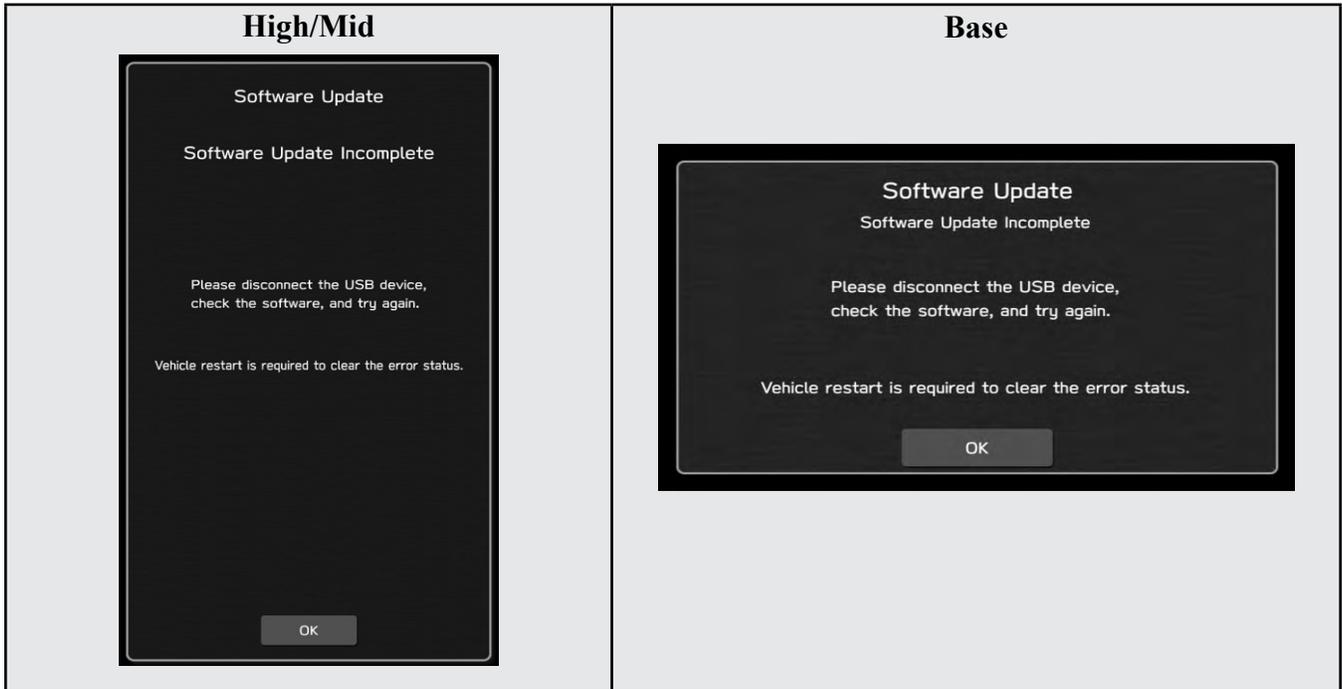
### 1-1. Select OK in the screen below

- If the first attempt of update fails with the message below, follow the steps described below 1-2 to 1-8 before retrying the software update.
