SIB 54 01 26

RATTLE NOISE COMING FROM REAR OF HEADLINER

2026-01-30

E-Series	Model Description	Production Date
F96	X6 M, Competition	From SOP

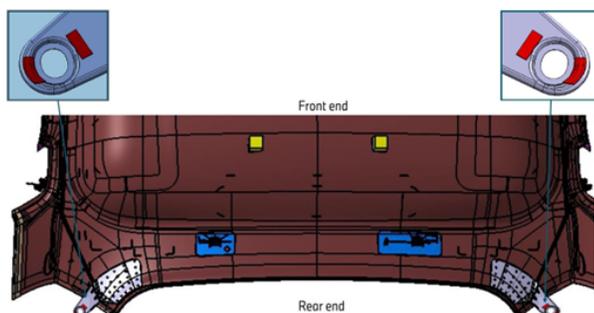
A “rattling” noise may be heard from the rear portion of the headliner when traveling over rough surfaces.

The rear headliner support brackets are not tightly fitted to the roof.

Install felt tape (red sections) on the left and right support brackets where they contact the metal roof.
