**Date:** January 20, 2026  
**Subject:** APU Failed Current Sensor Replacement  
**Location:** e-Tech Library  
**Revision Summary:** Update part number. Updates or new content highlighted in **yellow**.

**Units:** All APU (TriPac 3, Evolution, Envidia, and Envidia 2) units manufactured prior to December 2, 2025.

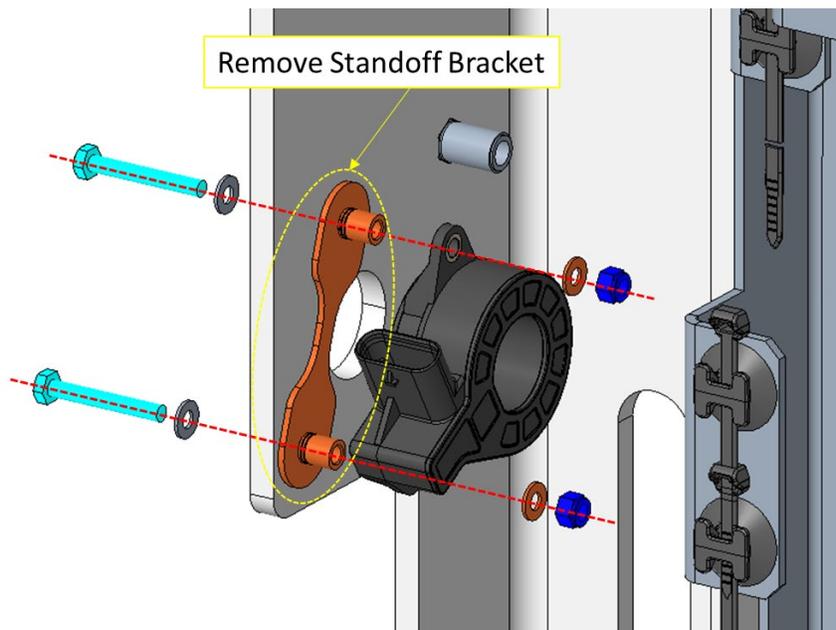
**Description:** If an APU current sensor has failed on a unit manufactured prior to December 2, 2025, replace with an updated current sensor Part Number 401928. For units after this date, the standoff bracket is incorporated into the sensor.

1. Power off the HMI and disconnect positive (Red) battery cable from the battery terminal.
2. Disconnect sensor connectors and remove hardware. Remove standoff bracket.
3. Install new updated current sensor Part Number 401928 and torque nuts to 9 in-lbs.
4. Reconnect battery cable and sensor connectors.
5. Discard hardware in the kit.
