Preview Solution CBR-2399-9

Daycab Cab Roof Antenna Misalignment Causing Water Intrusion

Published 20 January 2026

Volvo Chassis - VN (4)
Mack Chassis - AN (4), PR (4)
Model year 2025

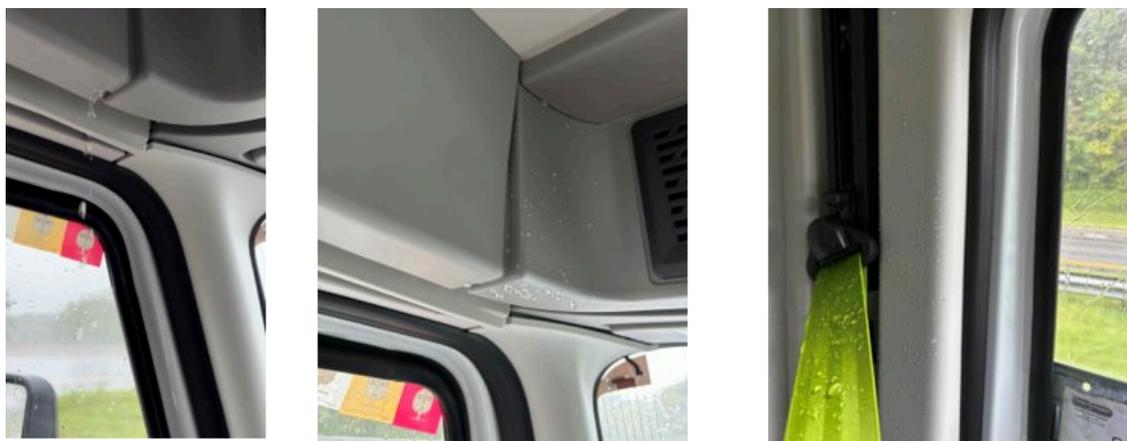
A mismatch between the cab roof hole geometry and the antenna in Daycab models has been identified, leading to potential water leaks into the cab.

Bad sealing because of the wrong fitting of the antenna in the roof

- Use installation steps to ensure proper alignment of the antenna with the cab roof hole.
- Ensure the antenna "clicks" securely into place.
- Confirm that all four corners of the antenna are properly aligned with the cab roof opening to eliminate air gaps.

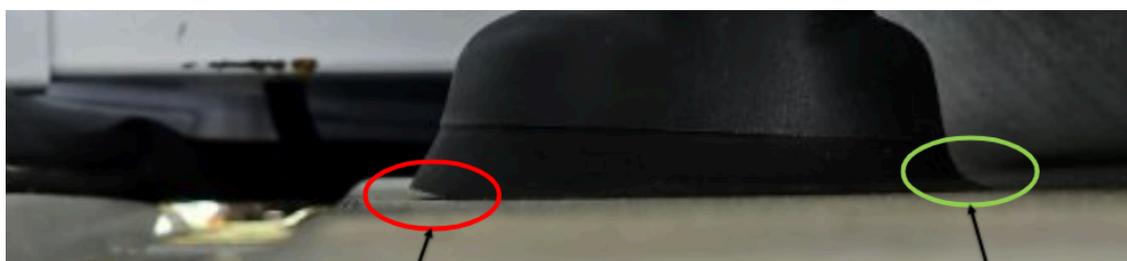
Correct sealing.

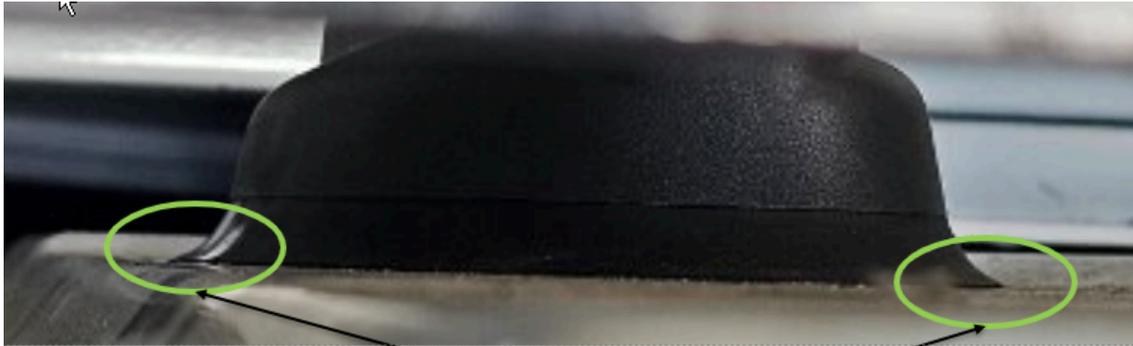
Correct sealing.
