Preview Solution CBR-976-7

Volvo Chassis - I-Shift Transmission - Moisture / Contamination Found In The Transmission Electronic Control Unit (TECU) Air Ports And Control Housing

Published 9 January 2026

Volvo Chassis - VT, VAH,VHD,VNL,VNR,VNM,VNX
Model Year - 2017 to current

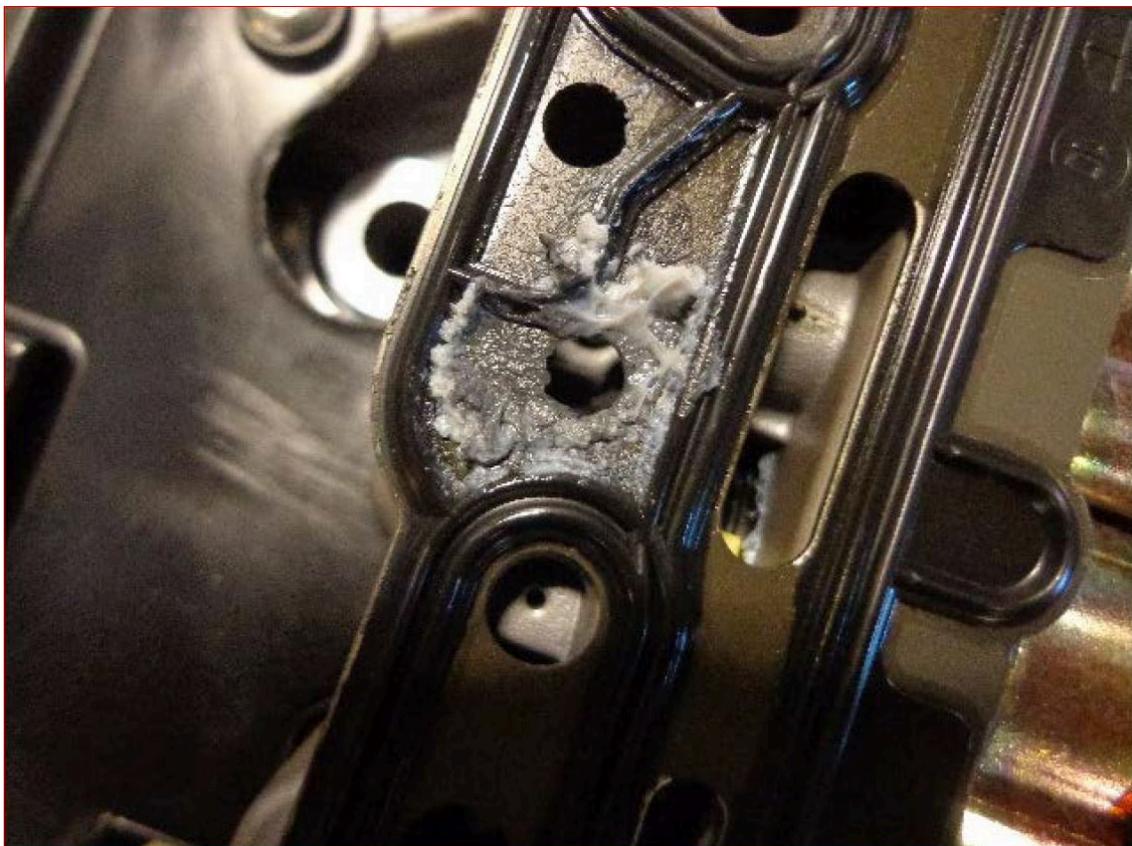
If a Volvo chassis equipped with an I-Shift transmission is found to have moisture or contamination present in the TECU air ports or control housing, this indicates moisture entry into the system.

True moisture contamination will cause the internal assembly grease to discolor to grey and/or black and may also be accompanied by visible water beading in the air ports. If these conditions are present, the source of the moisture or contamination must be identified and corrected to prevent repeat failures.

If moisture intrusion is determined to be the result of an ineffective or malfunctioning air dryer, the resulting failure is not warrantable.

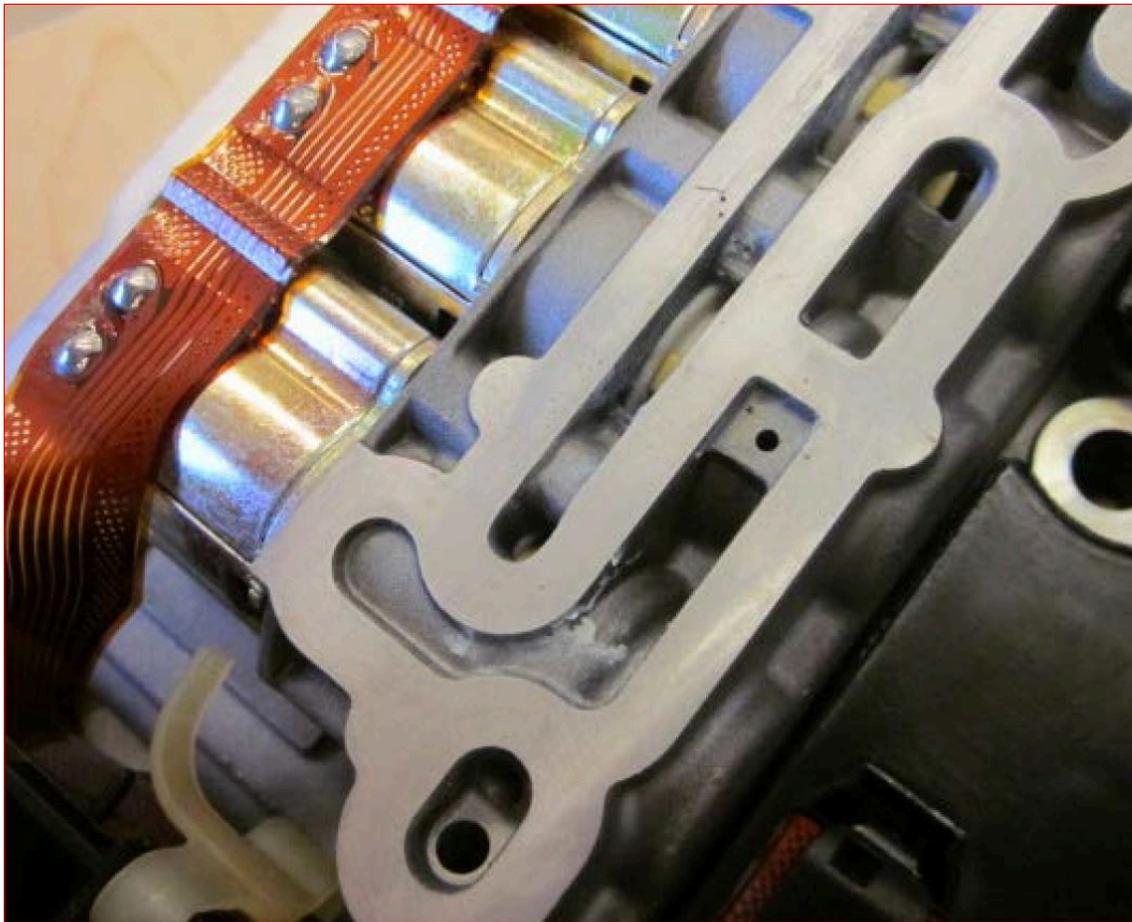
Residual assembly grease that may purge from the ports during normal operation is considered normal and does not indicate contamination or a failure condition.
