SERVICE BULLETIN

Subject: TS30 Camera Connection Improvement

Bulletin No: TS30-FC-2502

Vehicle Model: TS30

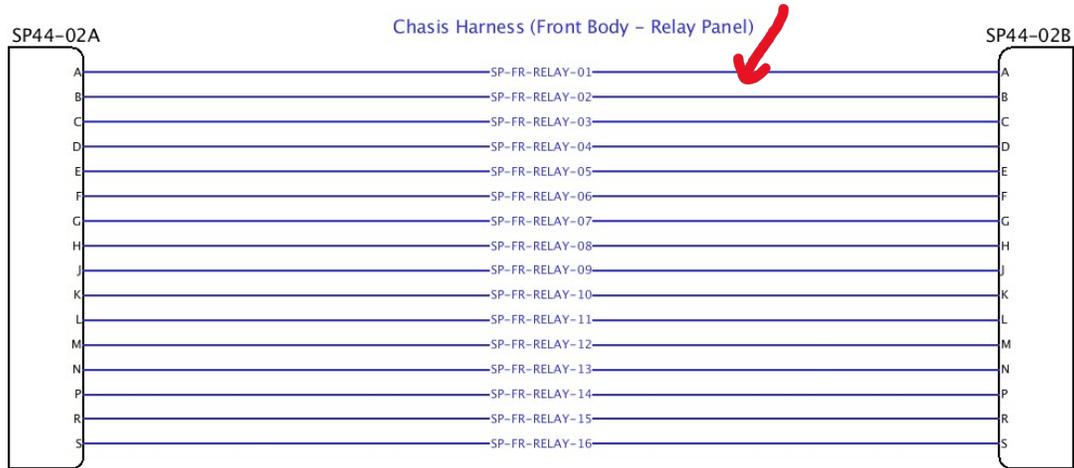
Note: Pay attention to the cable number connected to the A pin on the socket. The SP-FR-RELAY-01 cable connection is located on the A pin of the SP44-02A and SP44-02B sockets. Spare cables have blue color.

7. Remove the white plug on the A pin of the mating socket.
8. Connect the cable labeled with terminal number 9402-78Y to the A pin with the plug removed.

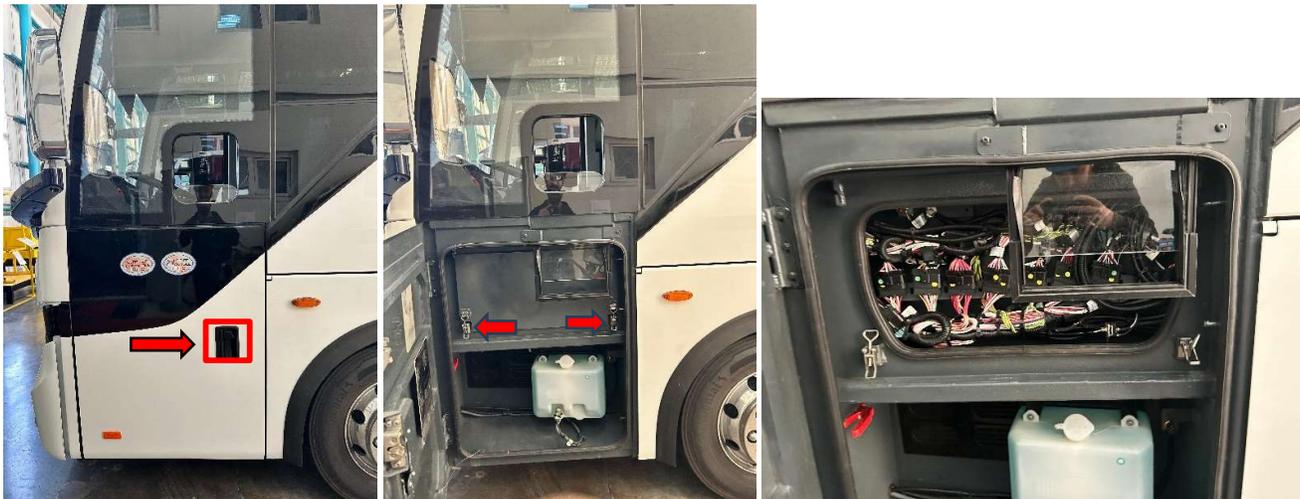
Switchbox Images

You can access the switchbox area by opening the slots in the areas shown in the figures.

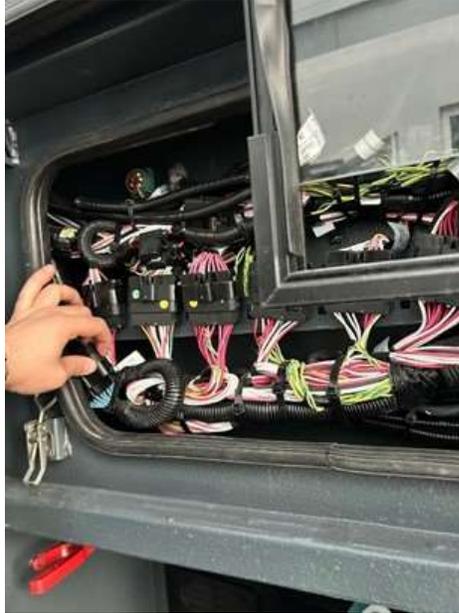
Note: The SP-FR-RELAY-01 cable connection is located on pin A of socket SP44-02B

1. Find the spare cable socket numbered SP44-02B located in the switchbox area.

2. Disconnect the white plug on the A pin of the mating socket.
3. Insert the 9402-78Y terminal into the white cable with part number 9401-372, which is 3 meters long.
4. Connect cable number 9401-372, plugged into terminal number 9402-78Y, to pin A with the plug removed.
