Preview Solution CBR-2408-16

Air Production Modulator (APM) DTC C10129B - High/Excessive Flow - VN (4) - PR (4)

Published 8 January 2026

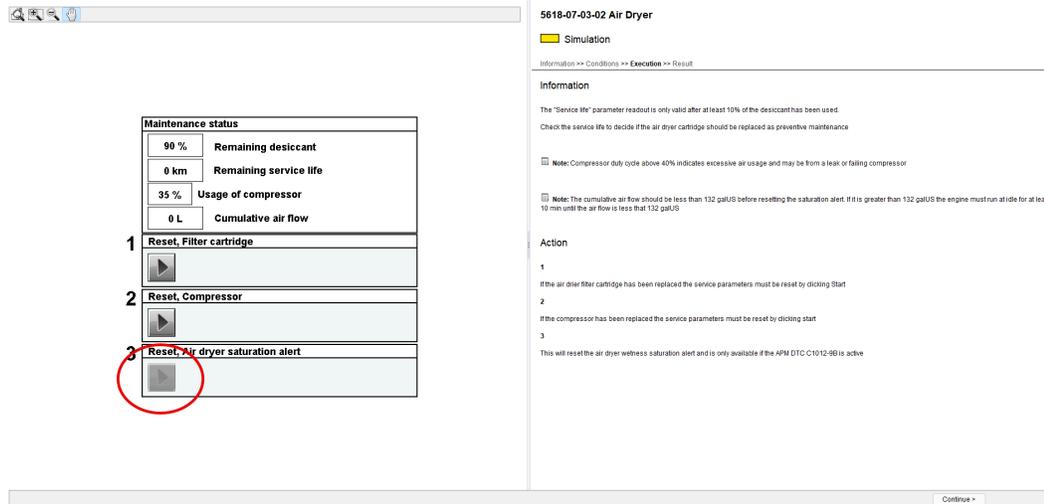
Note: Step 3 is only available if code C10129B is active.

- 5. Begin TT operation 5618-07-03-02 Step 3.**
