# Preview Solution CBR-2440-3

## Mack Chassis - Model LR - Linear Assist Cylinder Repair

Published 8 January 2026

Mack Model LR

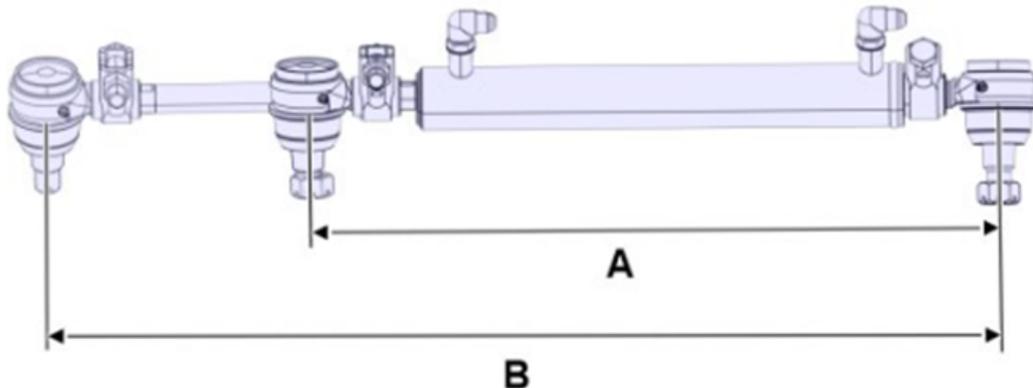
A	Compressed Length	24.88 ± 0.06 inches (632mm ± 1.6)
B	Extended Length	38.62 ± 0.06 inches (981mm ± 1.6)

#### 3. Set the length:

- Adjust the assist cylinder to the required length.

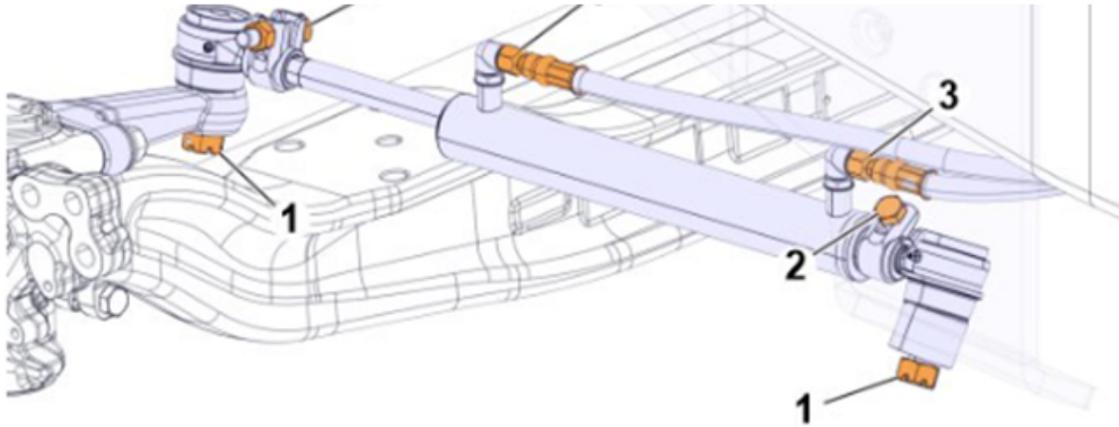
1	Ball Joint, Nut	340 ± 20 NM (25
2	Ball Joint, Clamp, Nut	68 - 81 NM (50
3	Steering, High Pressure Pipe, Nut	60 ± 3 NM (44

#### 4. Retorque hardware:

- Follow the retorquing procedures outlined in the Impact instructions to ensure all hardware is tightened to the correct specifications.
