Preview Solution CBR-2548-1

Shock Interference With "Z" Springs

Published 20 January 2026

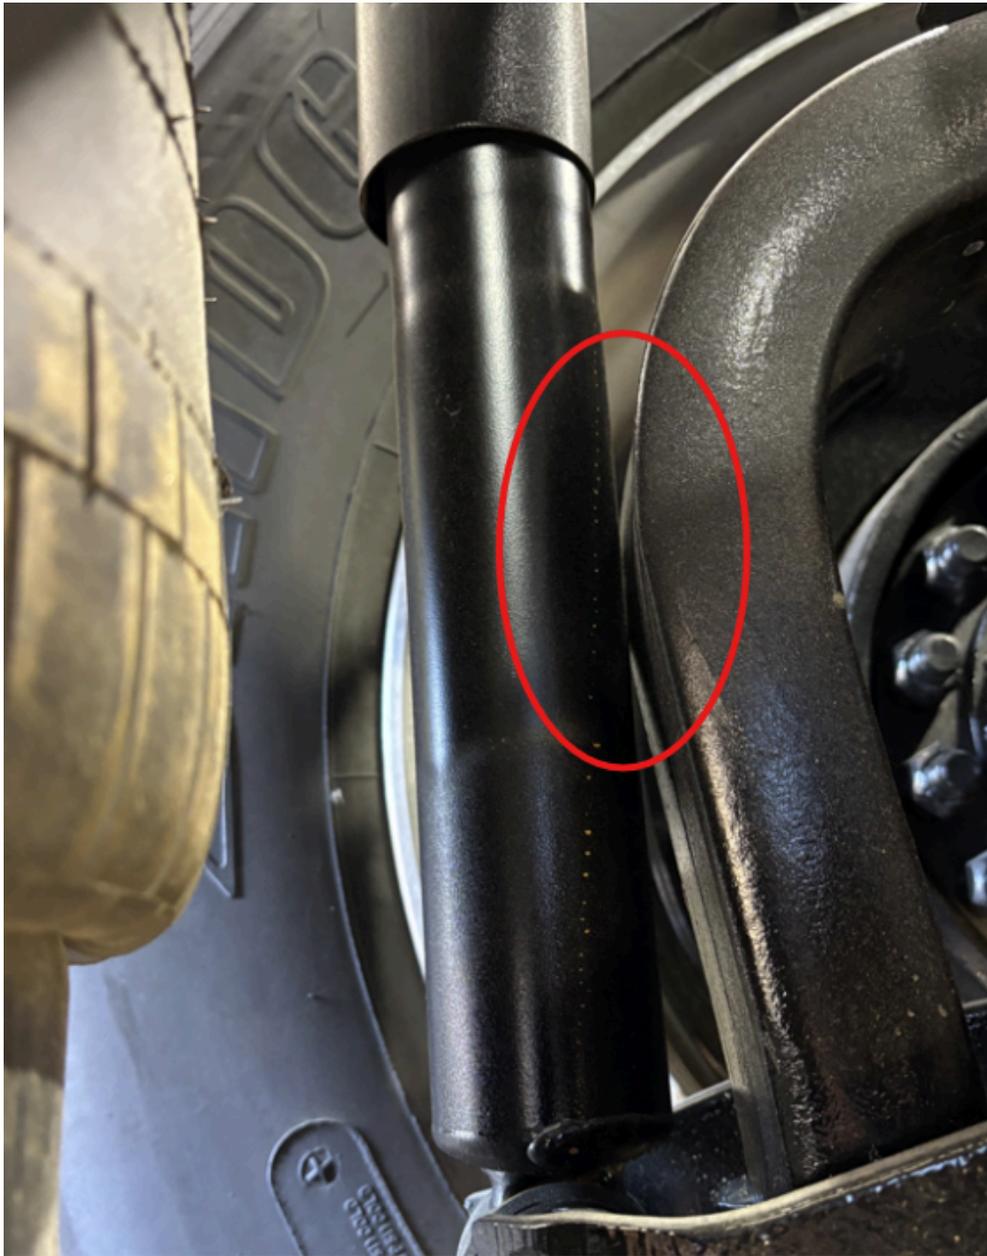
Some vehicles may experience **shock absorber interference with the "Z" springs** on the rear drive axle.

The existing shock mounting bracket may allow insufficient clearance between the shock absorber and the "Z" spring, resulting in contact or interference during suspension movement.

Replace the current shock bracket with the **legacy shock bracket** to give sufficient clearance between the shock absorber and the "Z" spring.
