Technical Service Bulletin

Subject: WRINKLES ON LEATHER SEAT SURFACE OF NEW (UNSOLD) VEHICLE OR ON NEW UPHOLSTERY UNDER WARRANTY REPAIR	Bulletin No.: 09-001/26
	Last Issued : 01/06/2026

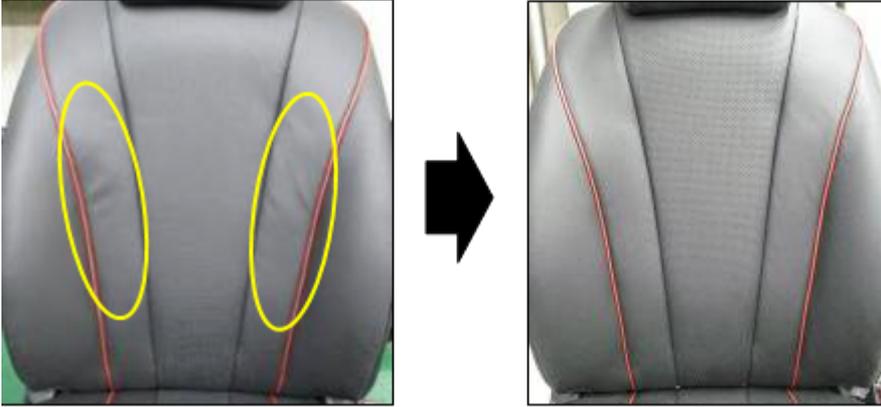
There are wrinkles on the leather seat cushion and/or seat back surface at PDI, when new vehicle is delivered, or when new upholstery is installed under Warranty repair.

6. Wrap the bottom of iron by the water-soaked cloth.
7. Stretch the wrinkled portion of seat surface by hand.
8. Run the iron with the cloth on the wrinkled area, as shown below.

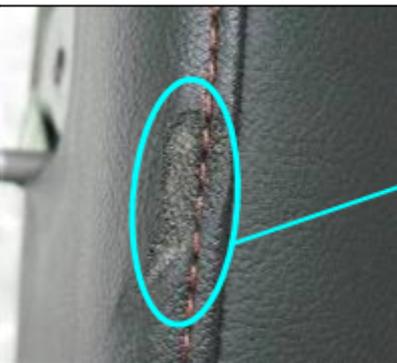
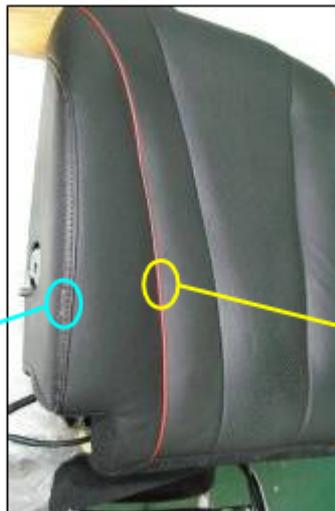
Damaged seat side trim

- **DO NOT** keep the iron in the same area for a long time. Doing so could damage the seat surface, as shown below.
- **DO NOT** run the iron without a water-soaked cloth, especially over the seat trim beading and seat side trim areas.
