Subject: POWER WINDOW DOES NOT WORK PROPERLY AND/OR ABNORMAL NOISE WHEN OPERATING	Bulletin No.: 09-007/26
	Last Issued : 01/30/2026

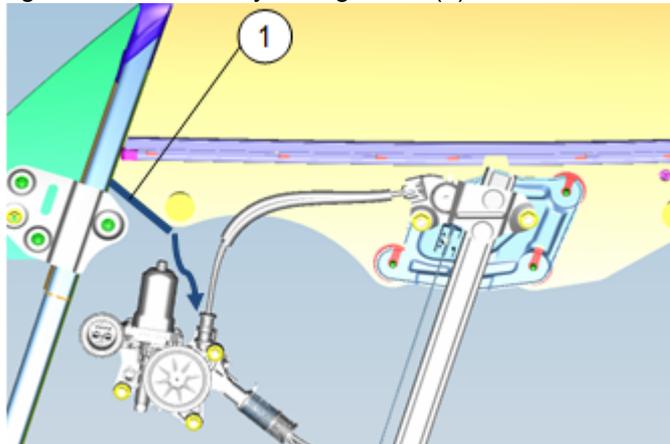
Some vehicles may exhibit the power window(s) not working properly (window does not move or has fallen into the door) and/or making an abnormal noise while operating the power window switch. This may be caused by the cable of the power window motor being damaged from water entry through area (1) of the front beltline molding.

Convertible Top: To eliminate this concern, the shape of the door glass **has been** modified during mass production to prevent water entry to the power window regulator.

1. Verify the customer concern.
2. Replace the power window regulator with a new one and attach the rubber seal to the front glass to prevent water entry into the door.
