EGR Valve Diagnosis & Cleaning (and EGR Cooler Cleaning) – OM642, Sprinter 906/907

Topic number	LI14.20-N-073867
Version	11
Function group	14.20 - Exhaust gas recirculation
Date	1/16/26
Validity	906, 907 Sprinter with OM642 V6 Diesel Engine
Reason for change	OP.no

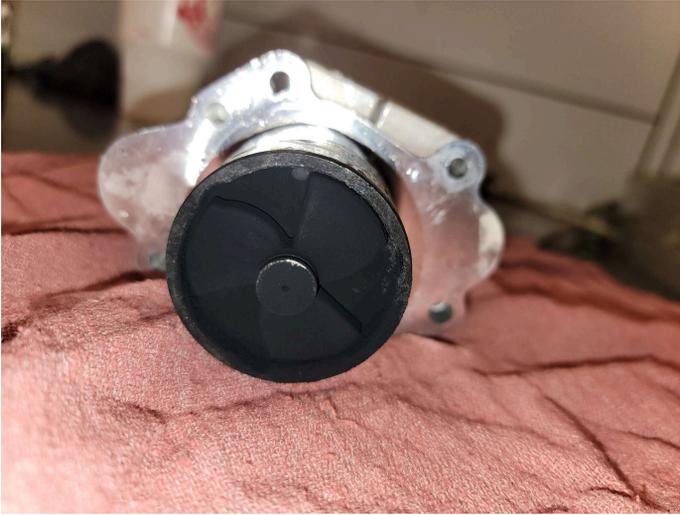
File	Description
OM642 EGR Valve before 1.jpeg

Soot deposits between the EGR Valve blade and seat leading to the EGR Valve no longer being able to meet the desired target of the EGR Valve position controller.

Bottom of sooted EGR Valve.
OM642 EGR Valve before 2.jpeg

1. Connect diagnostic unit (see AD00.00-S-2000-04E).
2. Perform an initial quick test, conduct a dynamic EGR valve check, and store the fault freeze frame data (see AD00.00-S-2000-04E).
3. Procedure in the event of an initial complaint of the EGR valve:
 - Clean the EGR Valve with TUNAP 926® (BQ6670128) by performing the steps below. NOTE: Part number BQ6670128 will transition to A 000 989 46 10 09 once existing inventory is depleted.
4. Procedure in the event of post-initial complaints of the EGR valve:
 - Procedure in the event of a repeated complaint of an EGR valve that has already been cleaned:
 - EGR valve must be replaced.
 - Check EGR track (EGR cooler, EGR bypass flap, and EGR single pipe) for carbonization, and replace if necessary in the event of significant carbonization.

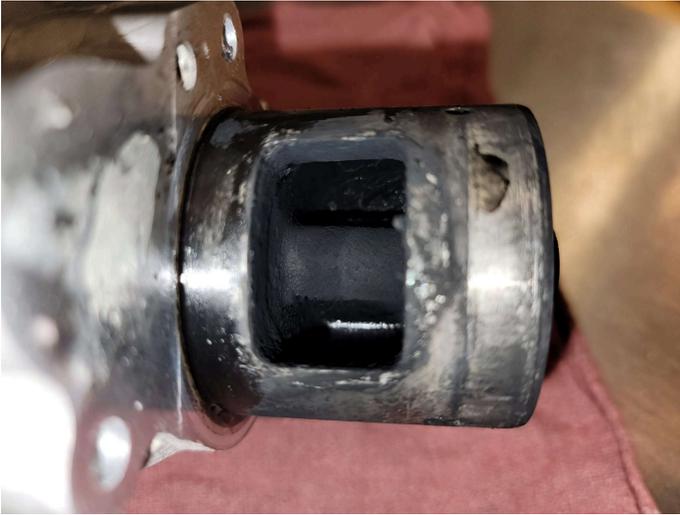
Side view of sooted EGR Valve.

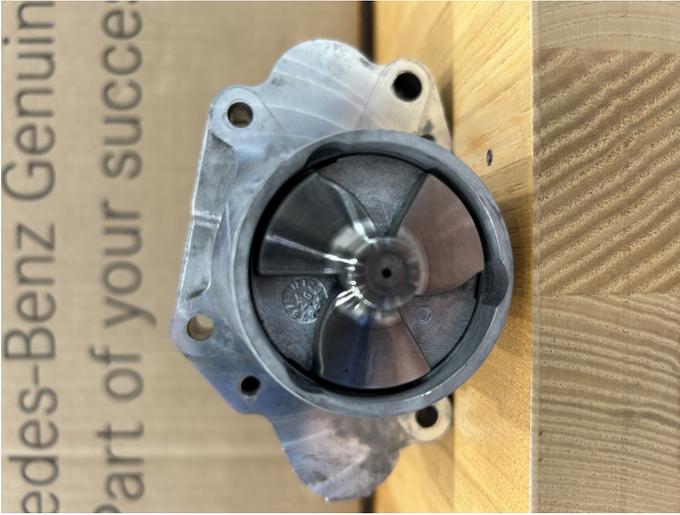
Attachments	
File	Description
EGR Valve Electrical Fault Codes.pdf	List of EGR Valve Electrical Fault Codes.
OM642 EGR Valve Cleaning Instructional Video using TUNAP 926®.mp4	OM642 EGR Valve Cleaning Instructional Video using TUNAP 926.
TUNAP 926® MSDS.PDF	TUNAP 926 MSDS.
OM642 After Cleaning 1.JPG	Bottom view of cleaned EGR Valve looking at blades.

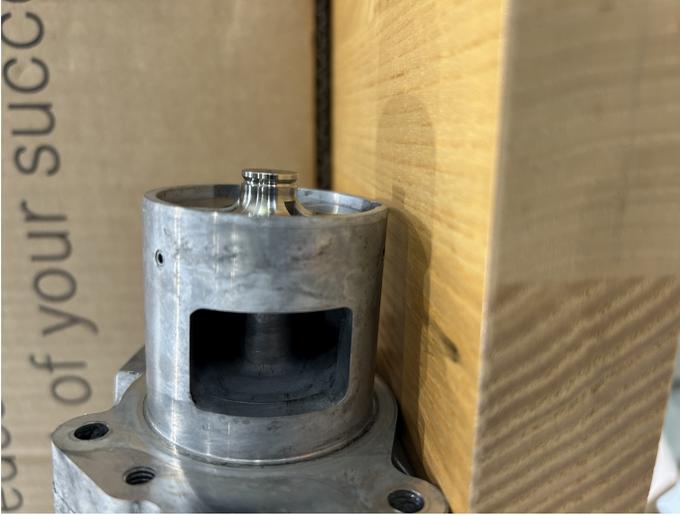
OM642 EGR After Cleaning 2.JPG	Side view of cleaned EGR Valve.
