Check engine light active - Fault P3007F1, P3007F2, P300CA8, or P300CA9 present in CDI control unit

Topic number	LI14.30-N-075882
Version	7
Function group	14.30 - Secondary air injection
Date	1/23/26
Validity	Model 907 with engine 654
Reason for change	Complaint update

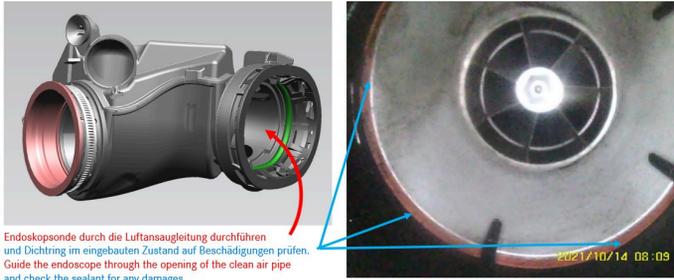
Attachments	
File	Description
<p>Dichtring_Sealant.jpg</p>

- If there is a leakage upstream of the exhaust gas turbocharger (see "Dichtring_Sealant.jpg").
- If the housing intermediate flange at the high-pressure EGR valve (where the exhaust back pressure sensor connects) is carbonized or clogged, or if there is carbonization/incomplete sealing of the high-pressure or low-pressure EGR valves. (See "Gehaeusezwischenflansch_intermediate_flange.jpg" and "verstopfter_Gehaeusezwischenflansch_clogged_Intermediate_Flange.jpg.")

<p>Endoskopspeende durch die Luftansaugleitung durchföhren und Dichtring im eingebauten Zustand auf Beschädigungen prüfen. Guide the endoscope through the opening of the clean air pipe and check the sealant for any damages</p>	
<p>Gehaeusezwischenflansch_Intermedidate_Flange.jpg</p>

- Inspect the sealing ring between the exhaust gas turbocharger and the clean air line for damage with an endoscope (see annex "Dichtring_Sealant_nok").
- Repair/replace as needed.

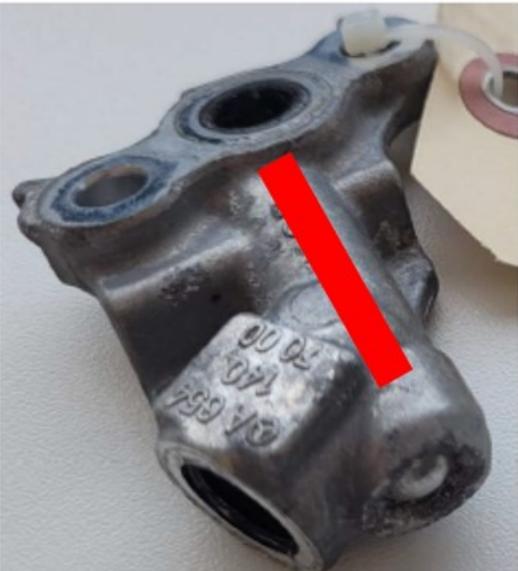
- There is carbonization or incomplete closure of the high-pressure exhaust gas recirculation valve, especially in the housing intermediate flange at the EGR valve (linked to the exhaust back pressure sensor).

1) Inspect the housing intermediate flange on the high-pressure exhaust gas recirculation (EGR) valve, specifically at the connection for the exhaust back pressure sensor. Use a flashlight to check for any inconsistencies or carbon buildup.

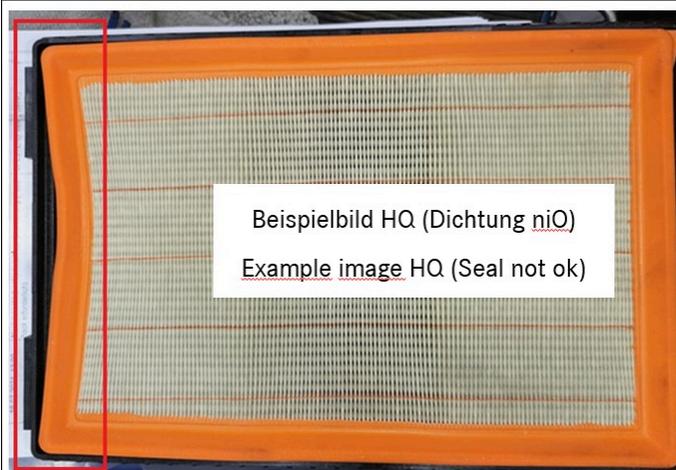
<p>Luffilter_air_filter.jpg</p>

- If engine timing is misadjusted.
- There is a defective hot film mass air flow sensor or a hot film mass air flow sensor that is affected by incorrect airflow (this can be due to a clogged or deformed air filter). Refer to the attached file "Luftfilter_air_filter."

- Visually inspect the air filter for blockages, severe soiling, deformation, or damage (see "Luftfilter_air_filter").
- The fault may be set if the hot film mass air flow sensor (MAF) element is oiled.
- Replace air filter/MAF as needed.

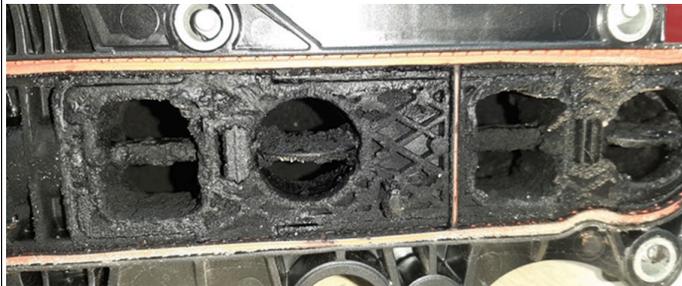
[Saugrohr_Intake_manifold.jpg](#)

- Note: Only relevant if the correction value in load range 1 is less than -8%.
- If the intake manifold (charge air distribution line) or charge air cooler is carbonized (see "Saugrohr_intake_manifold.jpg").

- There is a leak downstream of the exhaust gas turbocharger.
- The charge air distribution line (intake manifold) is heavily carbonized (see "Saugrohr_intake_manifold.jpg").
- There is carbonization or incomplete closure of the high-pressure exhaust gas recirculation valve, especially in the housing intermediate flange at the EGR valve (linked to the exhaust back pressure sensor).
- There is a defective hot film mass air flow sensor, or it is affected by incorrect airflow due to a clogged or deformed air filter (see "Luftfilter_air_filter").

- Inspect the following for severe carbon build-up or other inconsistencies:
- Intake manifold (charge air distribution line) – see "Saugrohr_intake_manifold.jpg."
- Housing intermediate flange at the high-pressure EGR valve (exhaust back pressure sensor connection, use a flashlight).
- Only necessary if the air intake correction value in load range 1 is less than -8%.
- Charge air cooler.
- Initiate repairs/cleaning as needed.
- If issues are found in the intake manifold, also check the cylinder head intake ports.
