Subject: DOOR BELTLINE MOLDING LOOSE OR FELL OFF	Service Alert No.: SA-004/26
	Last Issued : 01/20/2026

2023- 2026 CX-50 (All)

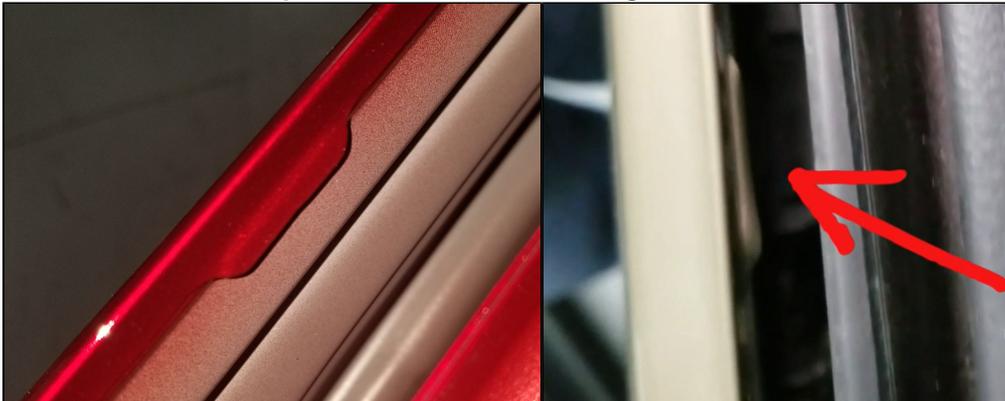
3. Use a hooked tool (e.g. a crochet hook) to straighten the bent tabs. The tabs may be bent in or out.

- If the tab is bent inward, the belt molding will not hold in place. When removed, the belt molding's internal clips can be damaged where it was properly held in place. DO NOT try to reuse it.
- If the tab is bent outward, the belt molding's internal clips can be damaged during the installation and it will not hold in place. It must be replaced.

4. Replace all loose beltline moldings.
