Technical Service Bulletin

Topic	Belt tensioner damper replacement guidelines V8 Kovomo
Market area	Bentley: worldwide (2WBE),China 796 VW Import Comp. Ltd (Vico), Beijing (6796)
Brand	Bentley
Transaction No.	2079600/1
Level	EH
Status	Released for publishing
Release date	Jan 20, 2026

Guidelines regarding the replacement of a Belt Tension Damper

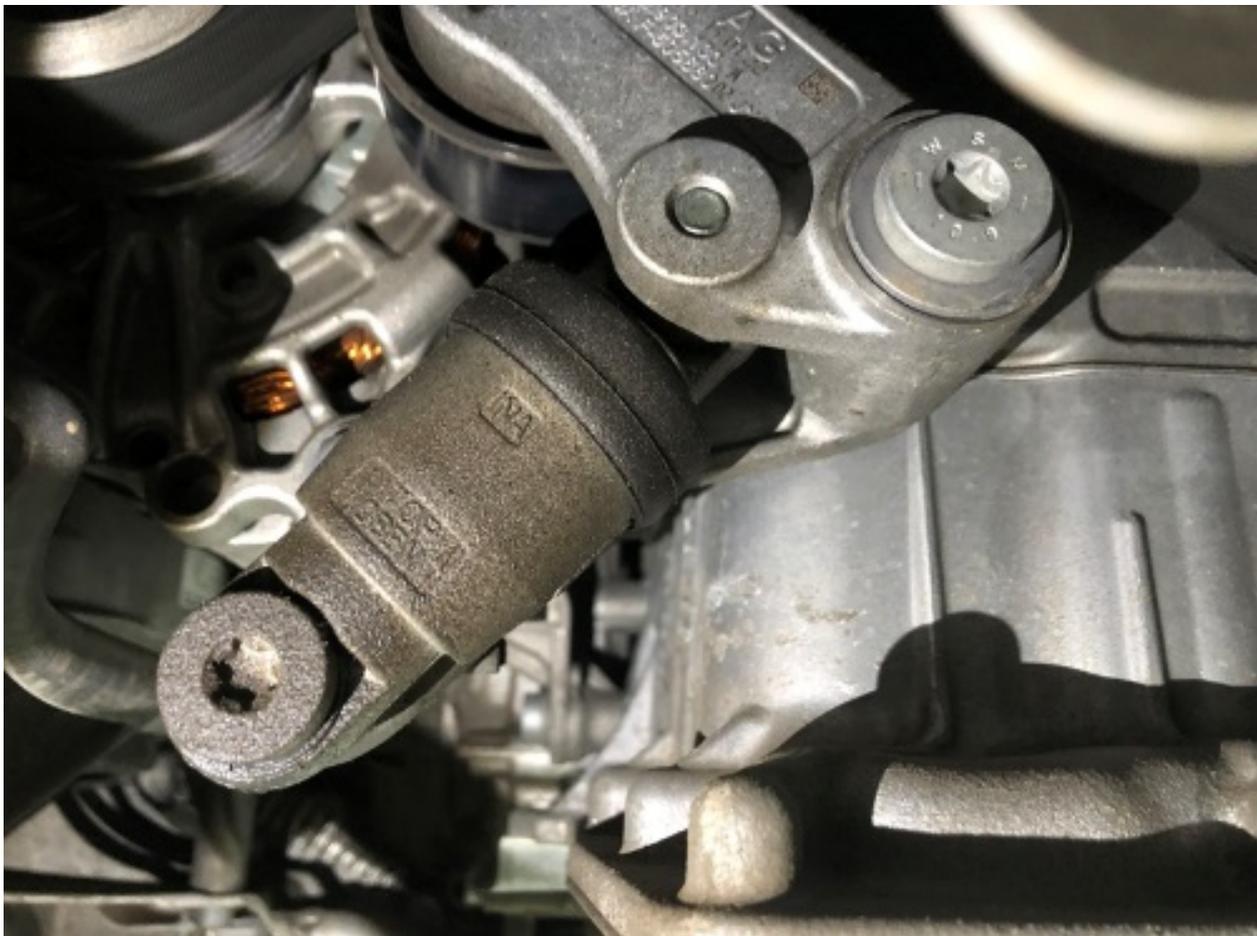
Figure 1 below shows an example of dry oil stain marks on the belt tension damper. In this instance, the belt tension damper **SHOULD NOT** be replaced. Unless it is accompanied by a customer complaint of noise or a drive belt not compliant with serviceability guidelines.

In the event dry oil stain marks as shown above (figure 1) are spotted at service and no complaint of noise is received from the customer with the drive belt confirmed as OK as per serviceability guidelines. The operative should clean the affected area using a suitable cleaning agent. DO NOT replace the belt tension damper in this scenario.
