Field campaign

Topic	EPAS harness over check Continental GT 26MY (SC26/01)
Market area	United States E05 Bentley USA and rest America (6E05)
Brand	Bentley
Transaction No.	2080623/1
Campaign number	ED80
Note	
Type	
US code

Technical background

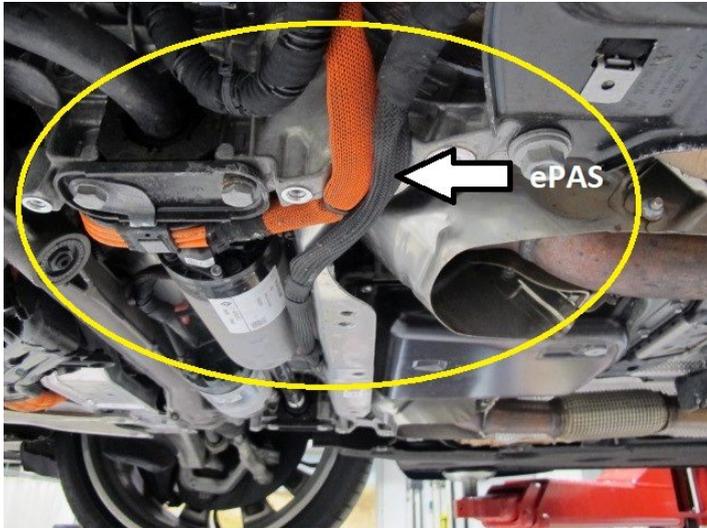
Figure 2. (Image shows correct harness orientation) Electro-mechanical power steering (ePAS) harness location,

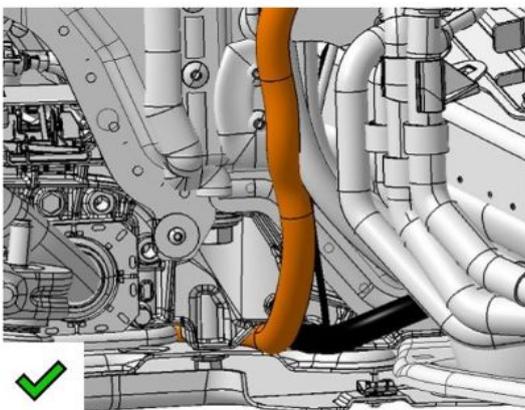
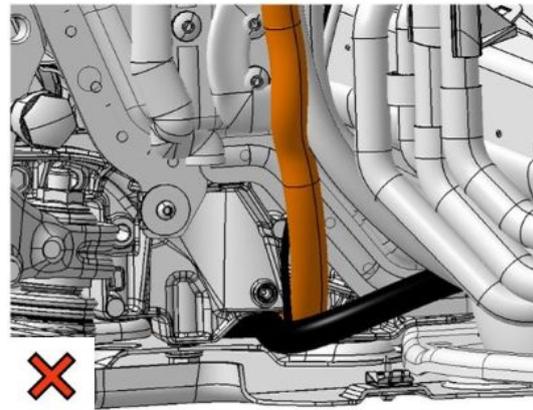
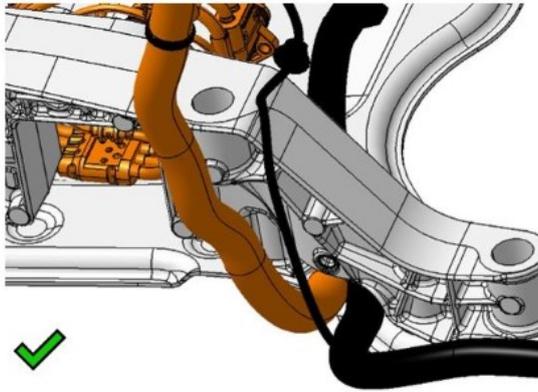
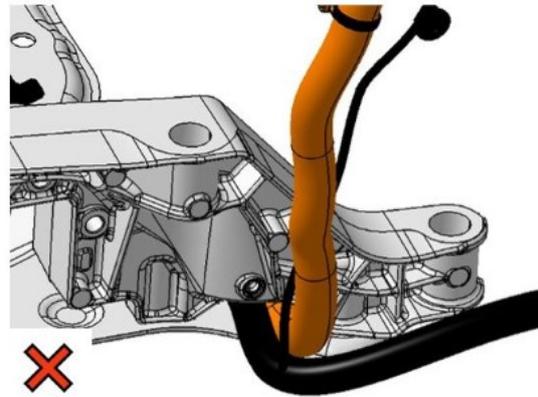
Figure 3. OK and NOK visuals

Confirm the ePAS harness orientation is incorrect for the vehicle hand of drive (see Fig 3.).

6. Correct routing should follow LHD specification, see OK and NOK visuals below for reference.

7. Remove cable tie bracket(s) securing the harness.
8. Carefully reposition harness to correct orientation:

9. Ensure harness follows the factory routing path and is clipped into all designated retainers.

10. Refit cable tie bracket and confirm harness is free from obstruction.
