Technical Service Bulletin

Topic	Window Drop Glass Operation Continental GT/GTC 25-26MY
Market area	Bentley: worldwide (2WBE),China 796 VW Import Comp. Ltd (Vico), Beijing (6796)
Brand	Bentley
Transaction No.	2080372/1
Level	EH
Status	Released for publishing
Release date	Jan 20, 2026

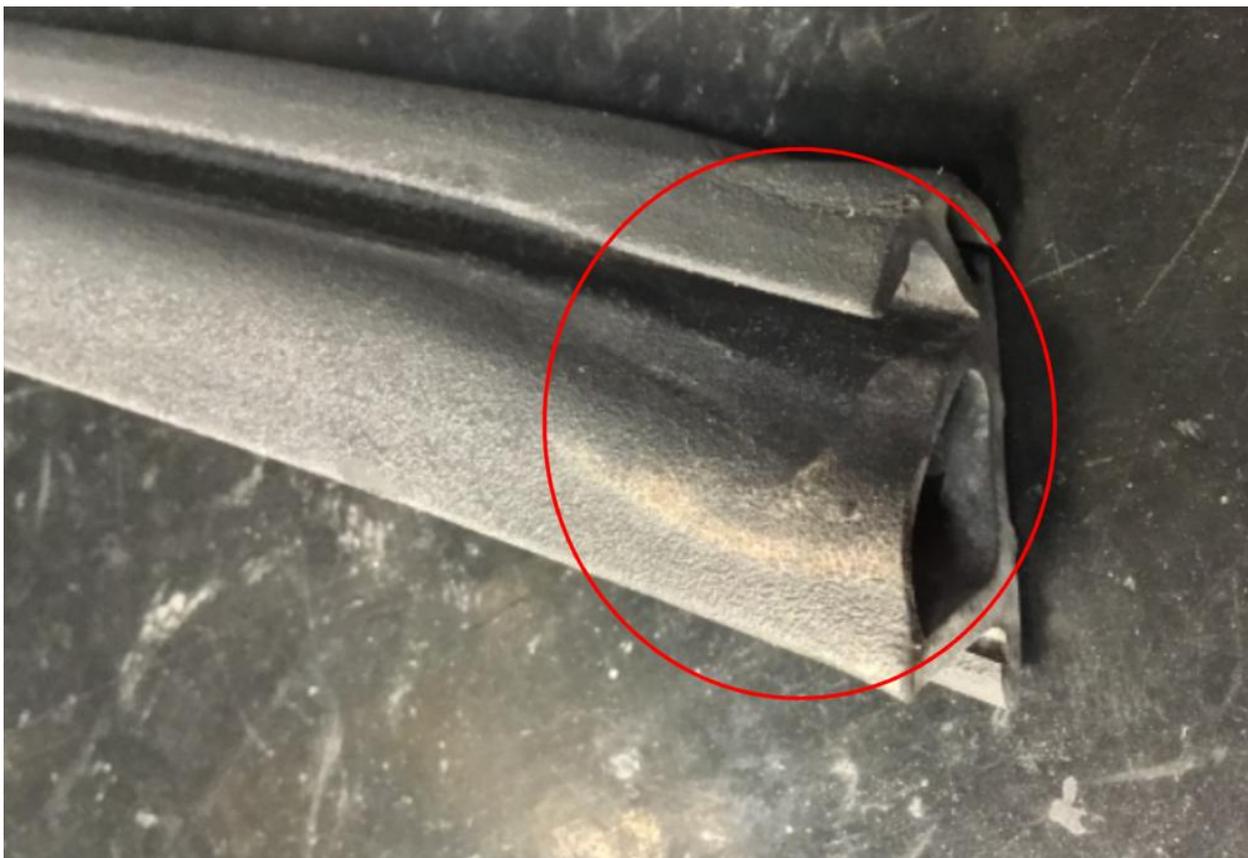
Figure 1

- Damage
- Splits
- Tears
- Misalignment
- Incorrectly fitted / located
- Drop glass seal deformation (see Figures 1 and 2 as examples)

NOTE: Any issues found with the window seals must be rectified before conducting the remaining steps

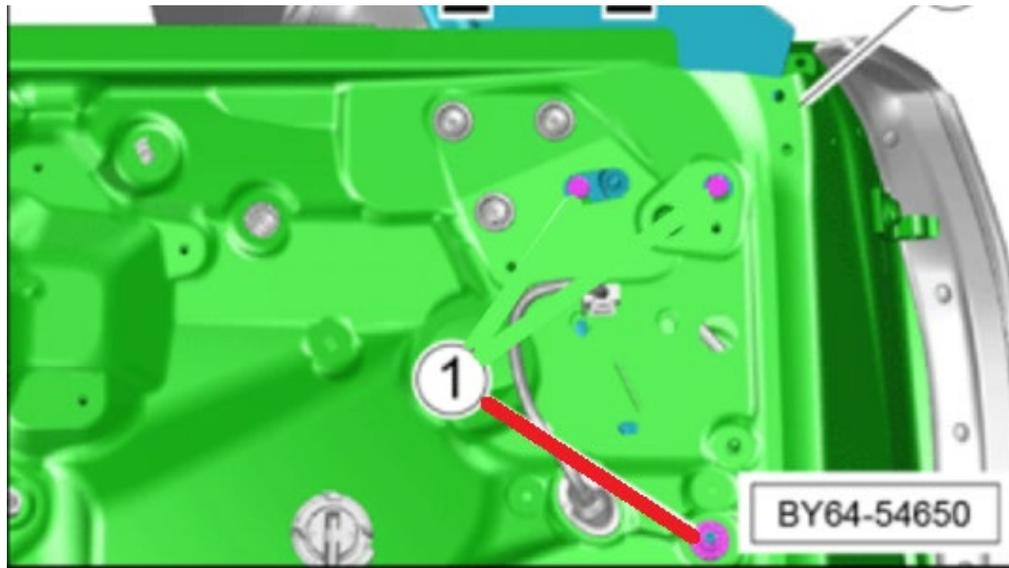
Figure 1. Image for reference, glass does not require removal from vehicle

The measurement between the bottom of the mounting washer and division bar frame, is 12.5mm.

1. loosen the lock nut.
2. Screw the adjuster fully clockwise until it bottoms out on the frame.
3. Unscrew the adjuster counterclockwise by four complete turns.
4. Resecure the lock nut.

Finally, set the height and profile to the TPI specification before proceeding to the next step.

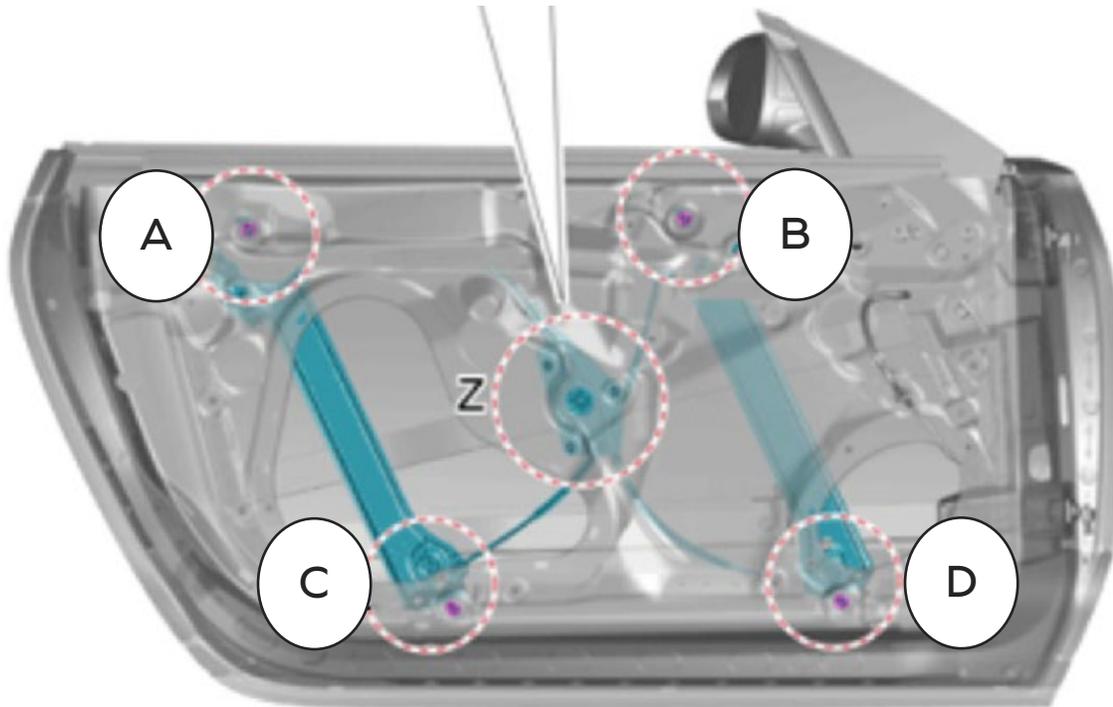
Figure 2

Regulator adjusters A, B

D = To reset this adjuster without removing the quarter glass fully screw in clockwise until hard stop, then unscrew 8.5 turns anticlockwise relock the lock nut.

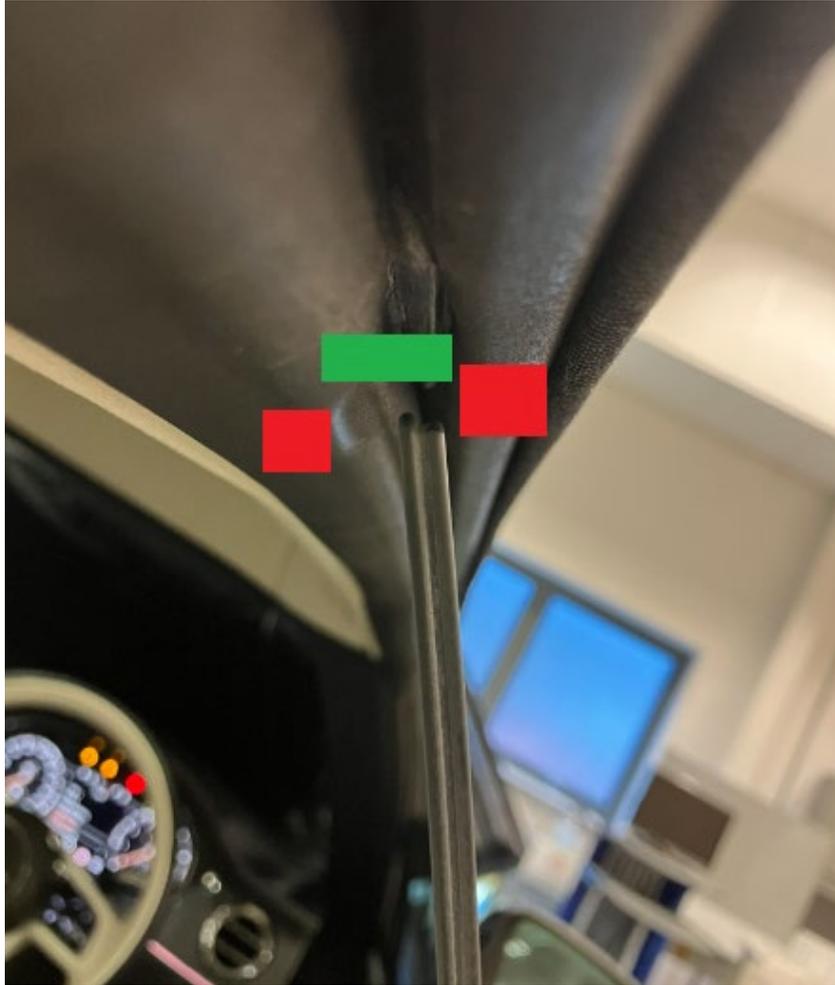
Front Window example showing correct operation

Windows should enter cant rail seal smoothly, making contact with green area.

For the front door, poor door profile point is a major contributing factor here and should be checked/adjusted if window found to be entering seal incorrectly.

If this is not correct, it will cause the window to bounce back causing a loss of basic settings.

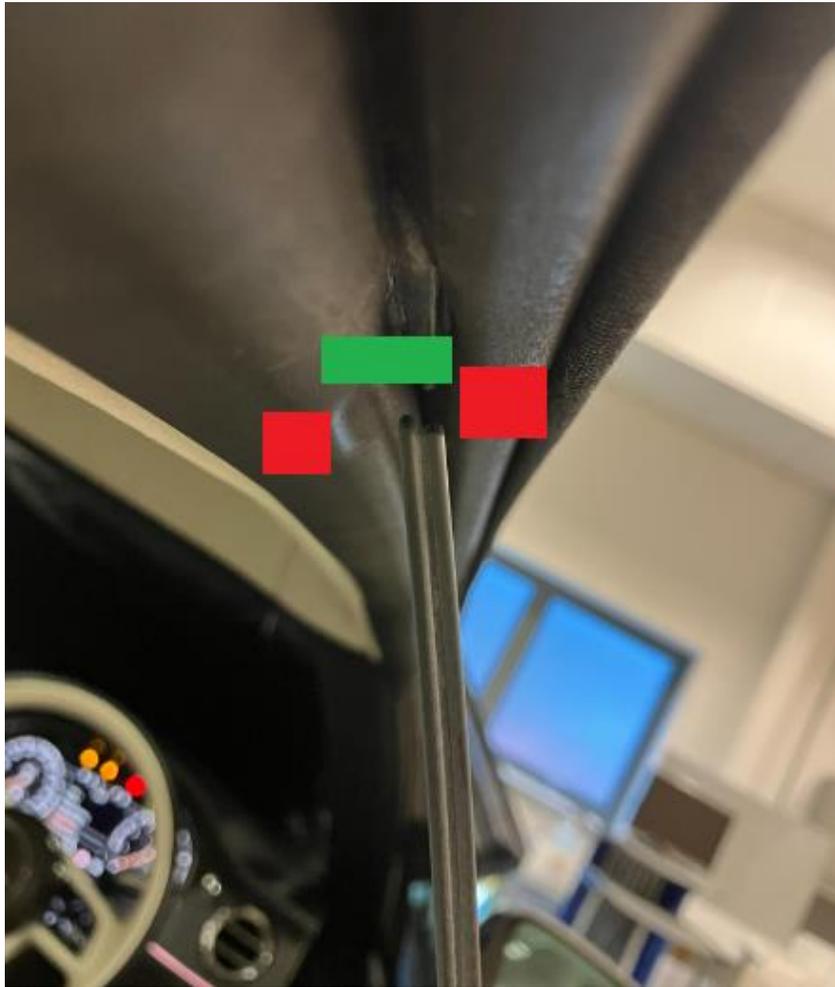
Front Window example showing correct operation

Windows should enter cant rail seal smoothly, making contact with green area.

For the front door, poor door profile point is a major contributing factor here and should be checked/adjusted if window found to be entering seal incorrectly.

If this is not correct, it will cause the window to bounce back causing a loss of basic settings.
