Technical Service Bulletin

Topic	Window Drop Glass Operation Continental GT/GTC 19-24MY
Market area	Bentley: worldwide (2WBE),China 796 VW Import Comp. Ltd (Vico), Beijing (6796)
Brand	Bentley
Transaction No.	2080375/1
Level	EH
Status	Released for publishing
Release date	Jan 20, 2026

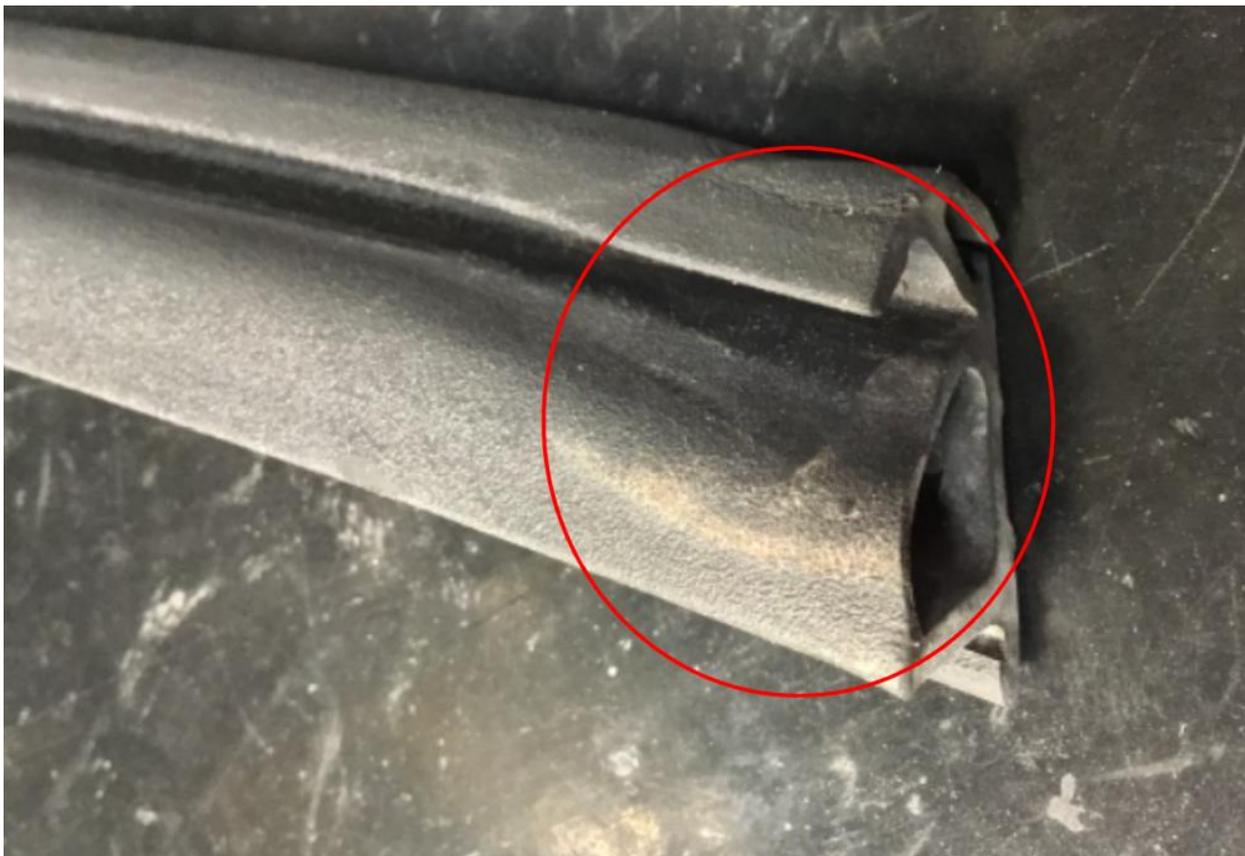
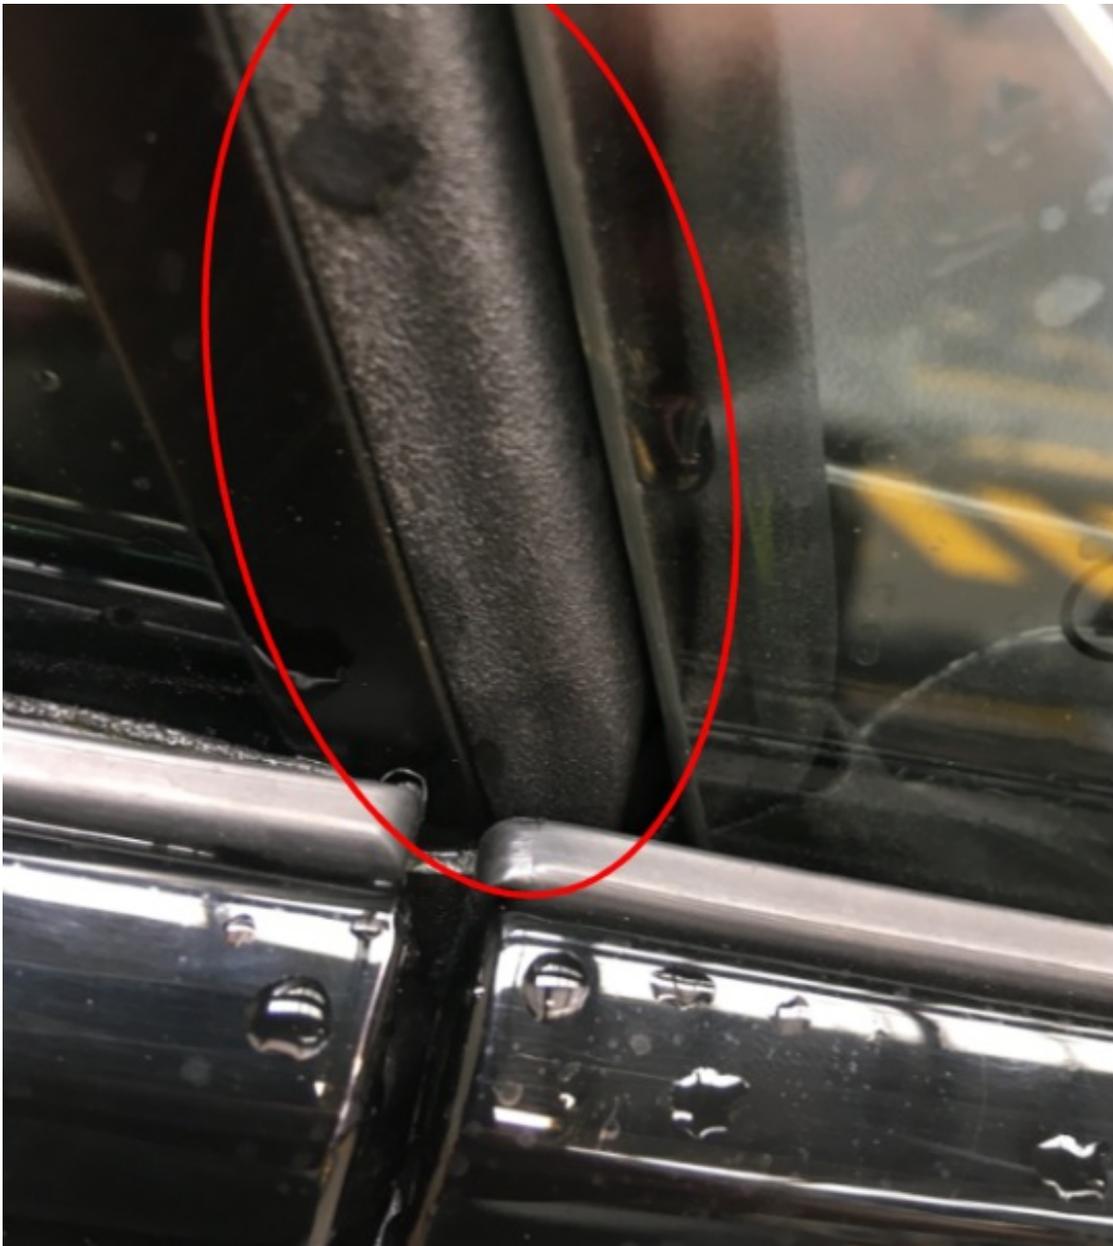
- Damage
- Splits
- Tears
- Misalignment
- Incorrectly fitted / located
- Drop glass seal deformation (see Figures 7 and 8 as examples)

NOTE: Any issues found with the window seals must be rectified before conducting the remaining steps

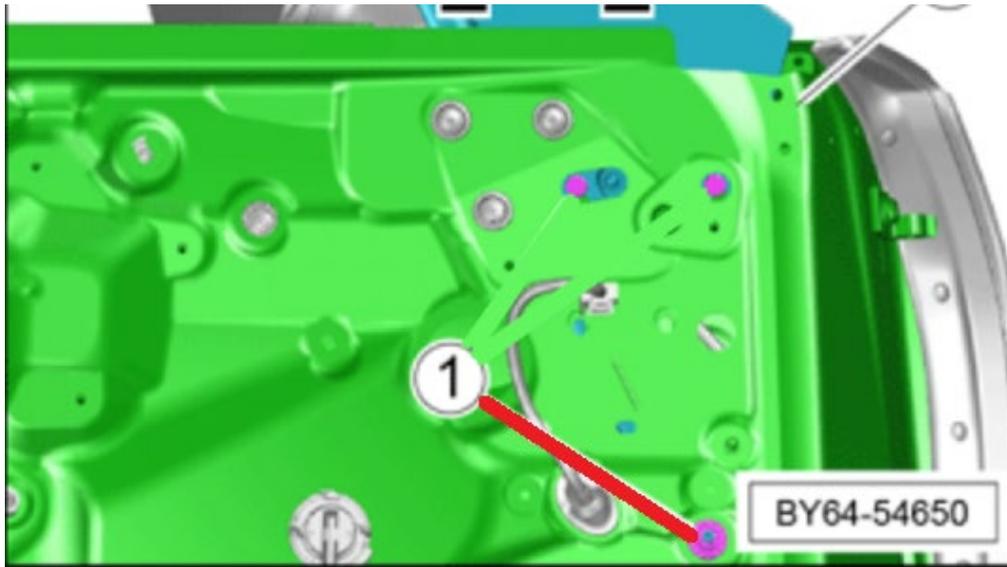
Front quarter glass adjuster reset - 1

Figure 1. Image for reference, glass does not require removal from vehicle

The measurement between the bottom of the mounting washer and division bar frame, is 12.5mm.

1. loosen the lock nut.
2. Screw the adjuster fully clockwise until it bottoms out on the frame.
3. Unscrew the adjuster counterclockwise by four complete turns.
4. Resecure the lock nut.

Finally, set the height and profile to the TPI specification before proceeding to the next step.

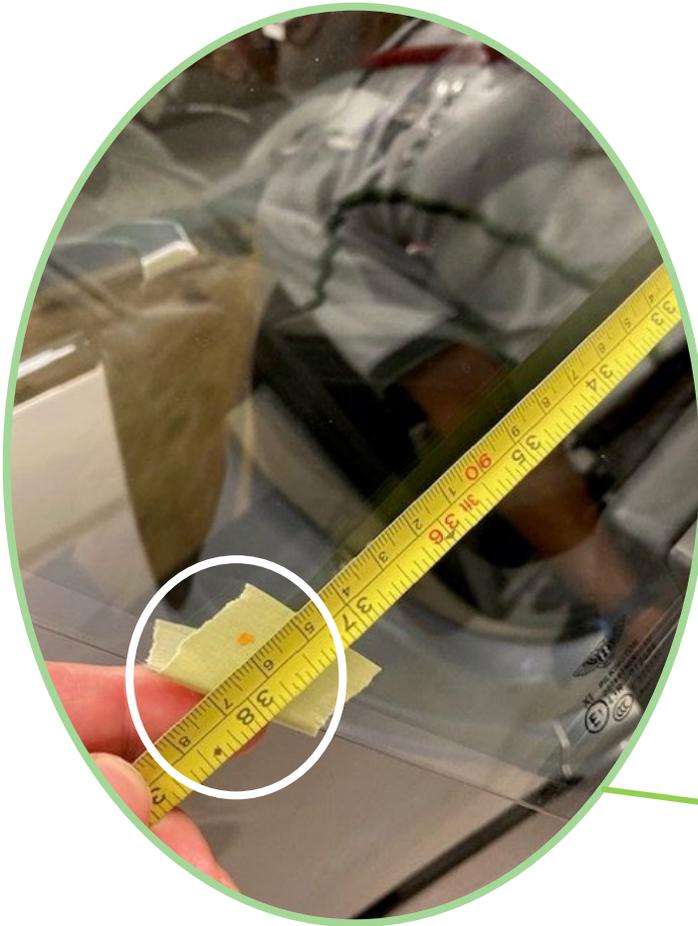
Measuring from front div bar to rear of the glass

Specification
971mm \pm 1mm

If out of specification, refer to the next slide to adjust the glass position

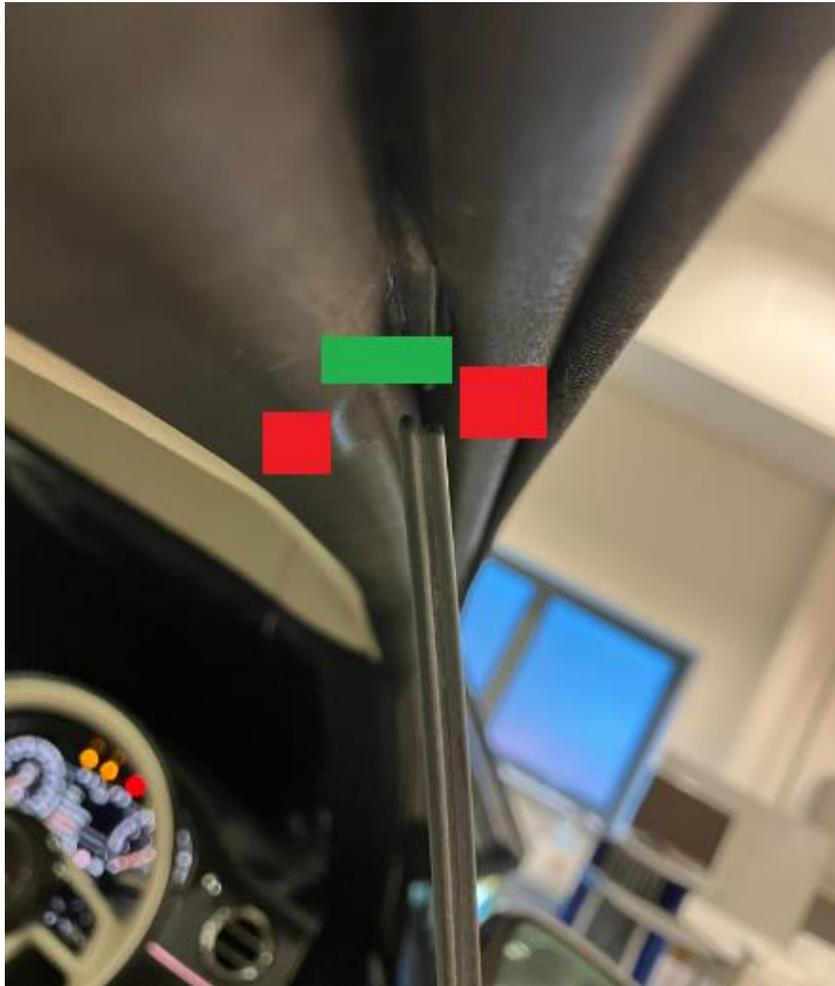
WINDOW ENTRY INTO CANT RAIL/ROOF SEAL

Front Window example showing correct operation

Windows should enter cant rail seal smoothly, making contact with green area.

For the front door, poor door profile point is a major contributing factor here and should be checked/adjusted if window found to be entering seal incorrectly.

If this is not correct, it will cause the window to bounce back causing a loss of basic settings.
